THE PAINT LOSS OF CALLMANDER'S STAINED GLASS WINDOWS

An investigation of the prevalence and causes
behind the paint loss on Callmander and Svenska
Glasmåleri AB's stained glass windows

Degree project for Master of Science with a major in Conservation
2023, 30 HEC
Second Cycle
2023/25

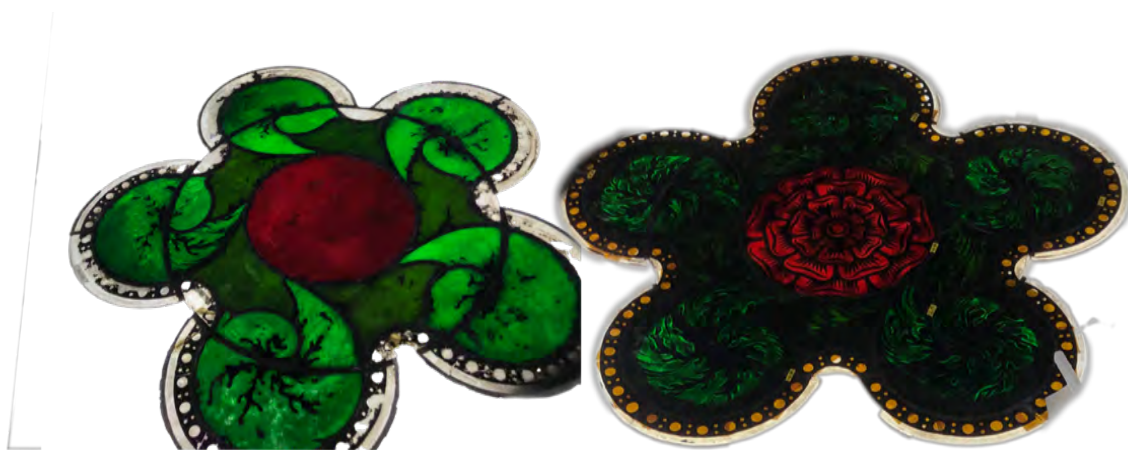
Figure 1. Two stained-glass panels made by Callmänder from the Father's window in Uppsala Cathedral. The right one was refired with new grisaille paint in 1970. Photo: Eisfeldt, 2020

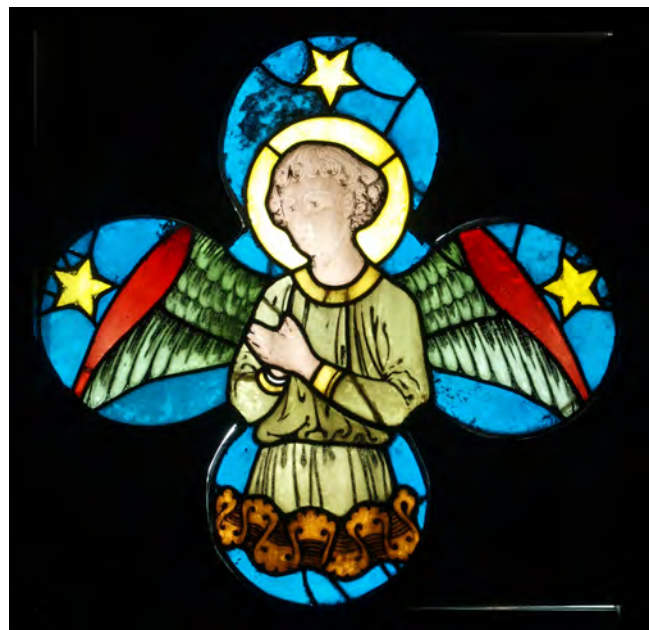
At this time the window had severe paint loss which had seriously discarded the readability and disfigured faces and hands of the figures. At parts the loss had almost created a type of "negative" image (fig 5). Moreover, the texts had also turned unreadable. Beside paint loss, the windows had problems with several past restorations. The restorations had been performed with cold paint. Paint had also been consolidated with epoxy. The paint consolidated with epoxy had started

Figure 5. Photo with transmitted light, showing a panel of the Son's window in Uppsala Cathedral, before conservation. Photo: Uppsala domkyrkas glasmålningsateljé, 2014

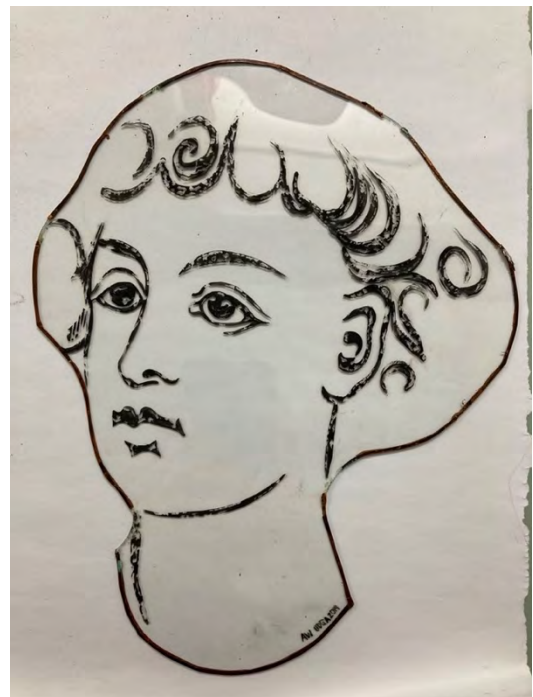
Figure 6, Backing glass made for the panel shown in fig 5. Signed "UDGA 2014". Photo: Uppsala domkyrkas glasmålningsateljé, 2014

To address the question, a seminar was held together with an advisory group including experts, art historians and conservators. At this meeting it was decided that the infills which were visually disturbing could be retouched with tracing lines, and that the former infills with mismatched color would be replaced - partly as their purpose was lost, partly as it was not original material but also, because it had shown most of them were in borders and it could be done without harming original material. The new panels were dated, signed, and the old ones were stored. At the seminar it was also decided that hands, faces and inscriptions would be "retouched" by backing plates painted with trace lines of grisaille paint (fig 6). The result of a first test can be seen in figure 7 and 8. The backing plates were not sealed, to not create a microclimate. It was also decided that a

protective glass would be placed on the outside, to halt the deterioration. Based on research the glass was installed to give an area between protection glass and original ventilated with indoor air (Kvarnström & Andersson, 2017).

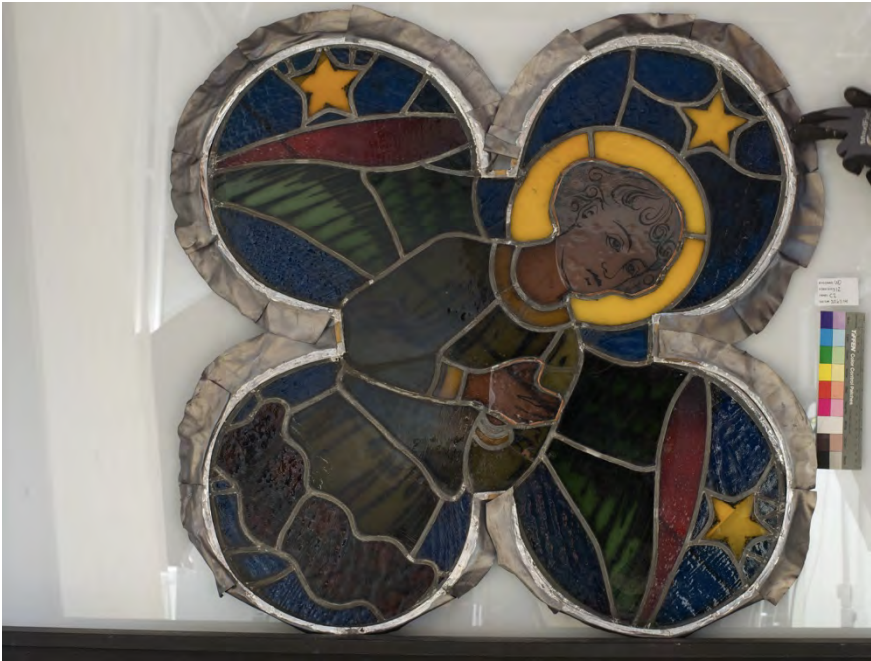
Figure 7. Photo of the panel in reflective light, backside, after conservation and with a painted backing glass for the face and hands. Photo: Uppsala domkyrkas glasmålnings ateljé, 2014

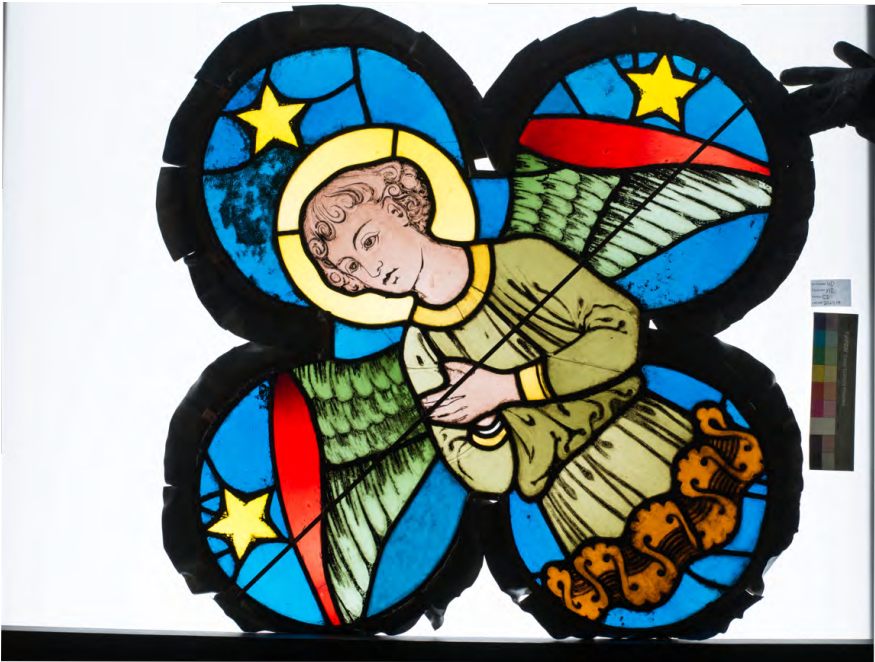
Figure 8. Photo of the panel in transmitted light, frontside, after conservation and with a painted backing glass for face and hands. Photo: Uppsala domkyrkas glasmålnings ateljé, 2014

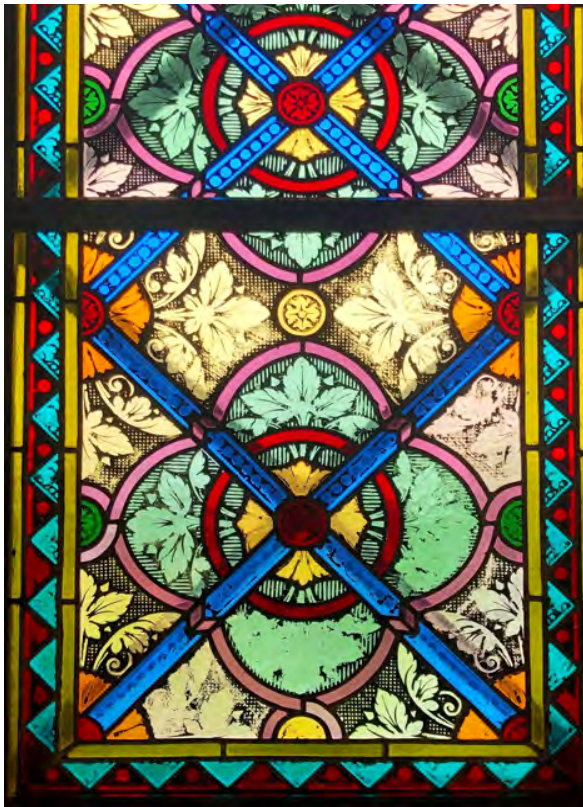
For the windows in the nave, the paint loss was perceived to appear quite randomly, this can be seen in figure 30 and 31, where some panels with the most paint loss are situated next to the ones in the best condition.

Figure 30. Photo of the bottom of the left window in figure 29. Photo: Eisfeldt, 2022

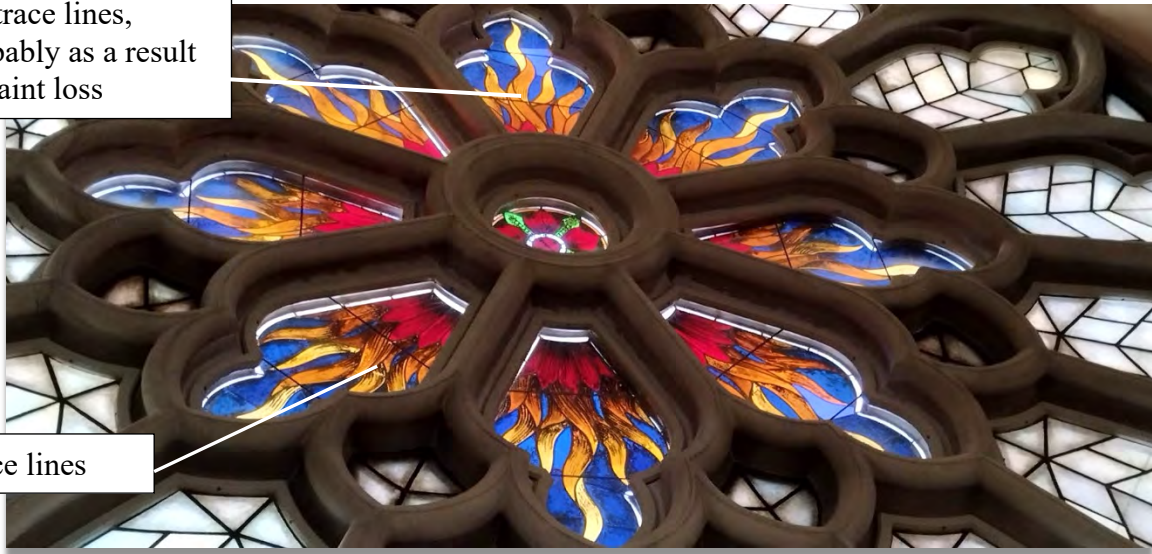
Figure 44. The west rose window of Oscar Fredrik's church. In the photo paint loss is visible, and can be seen especially on the upper side of the window. Photo: Eisfeldt, 2022

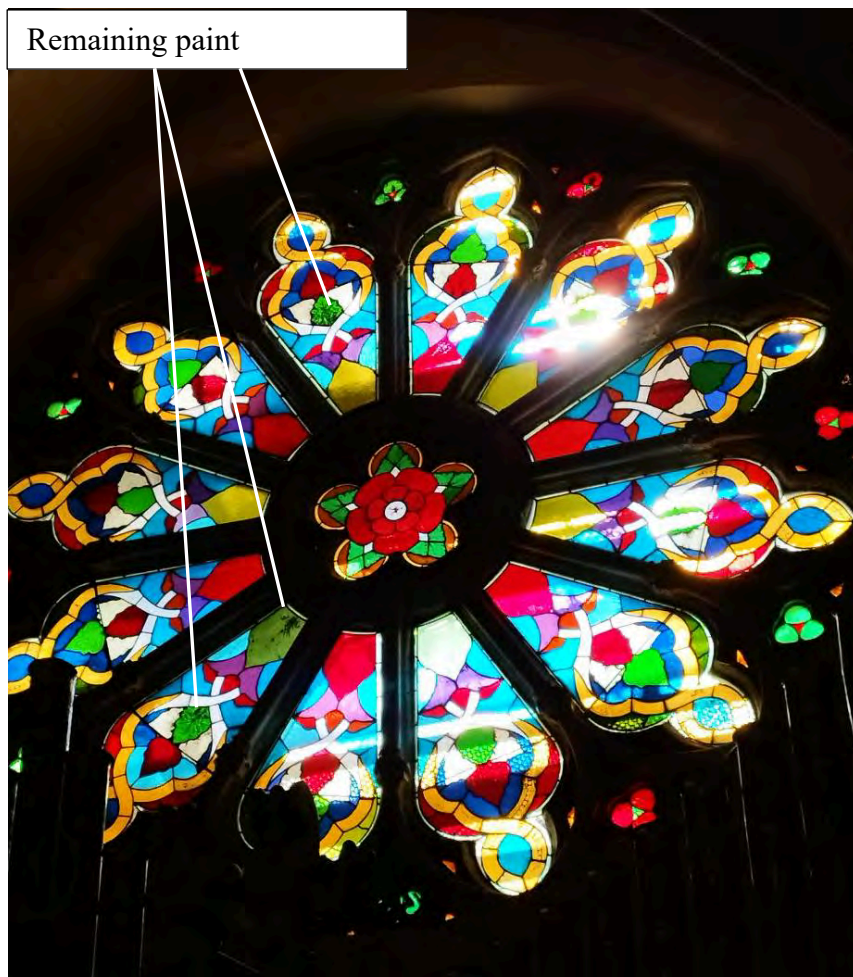
Figure 45. The south rose window of Oscar Fredrik's church with paint loss visible from distance. Photo: Eisfeldt, 2022

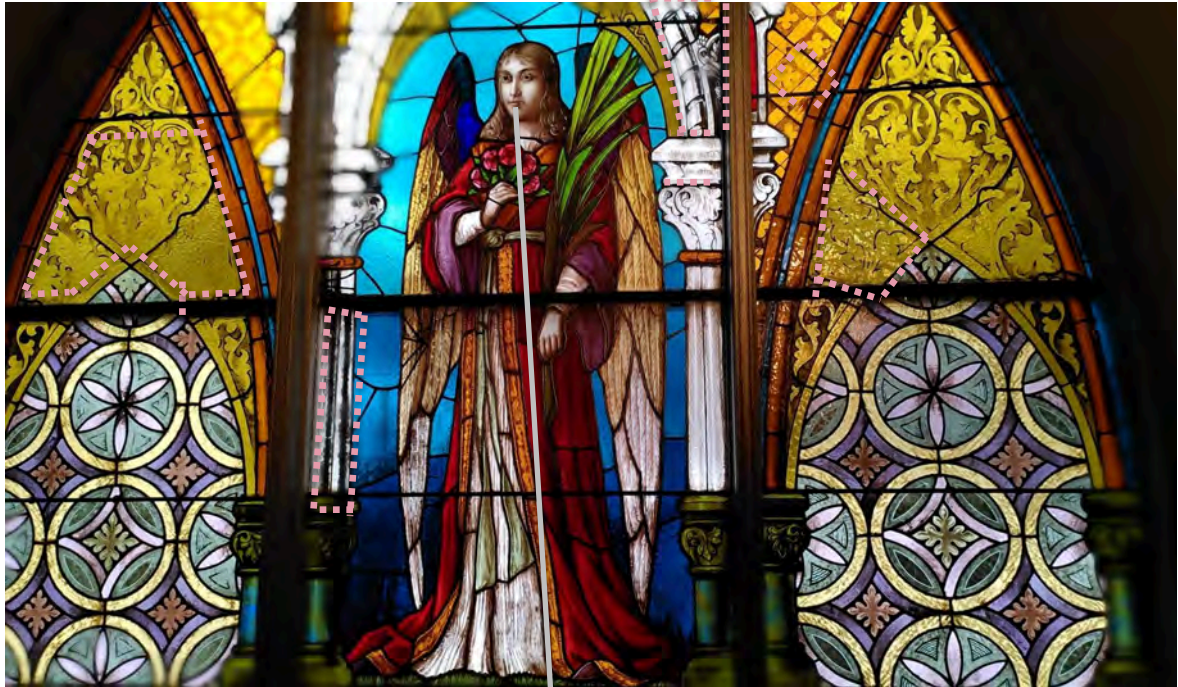
Figure 49. The right window in the choir of Jonsered church. Areas of paint loss are marked with dotted pink lines. Photo: Eisfeldt, 2022

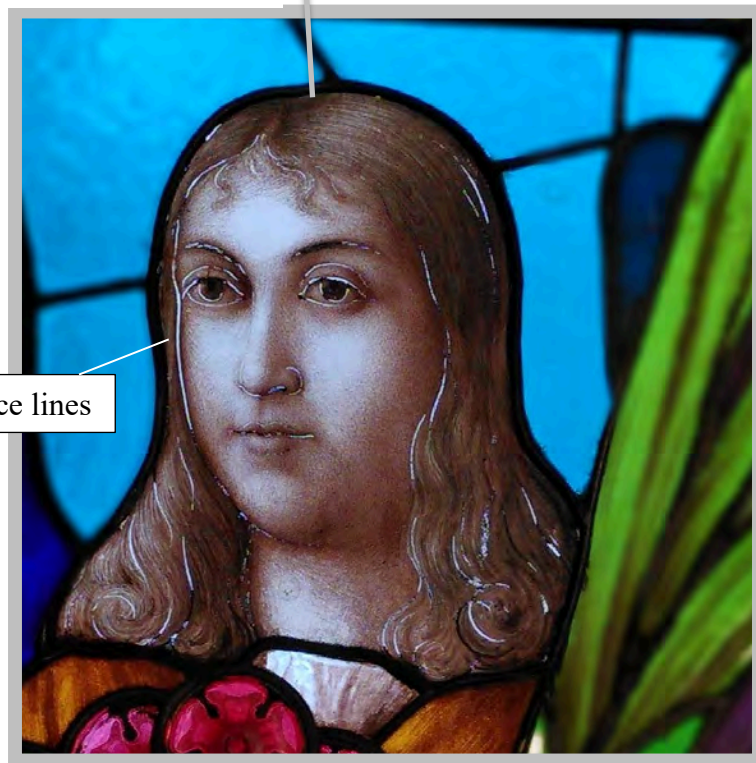
Paint loss of trace lines

Figure 50. The middle window in the choir of Jonsered church. Close-up on the face. Photo: Eisfeldt, 2022

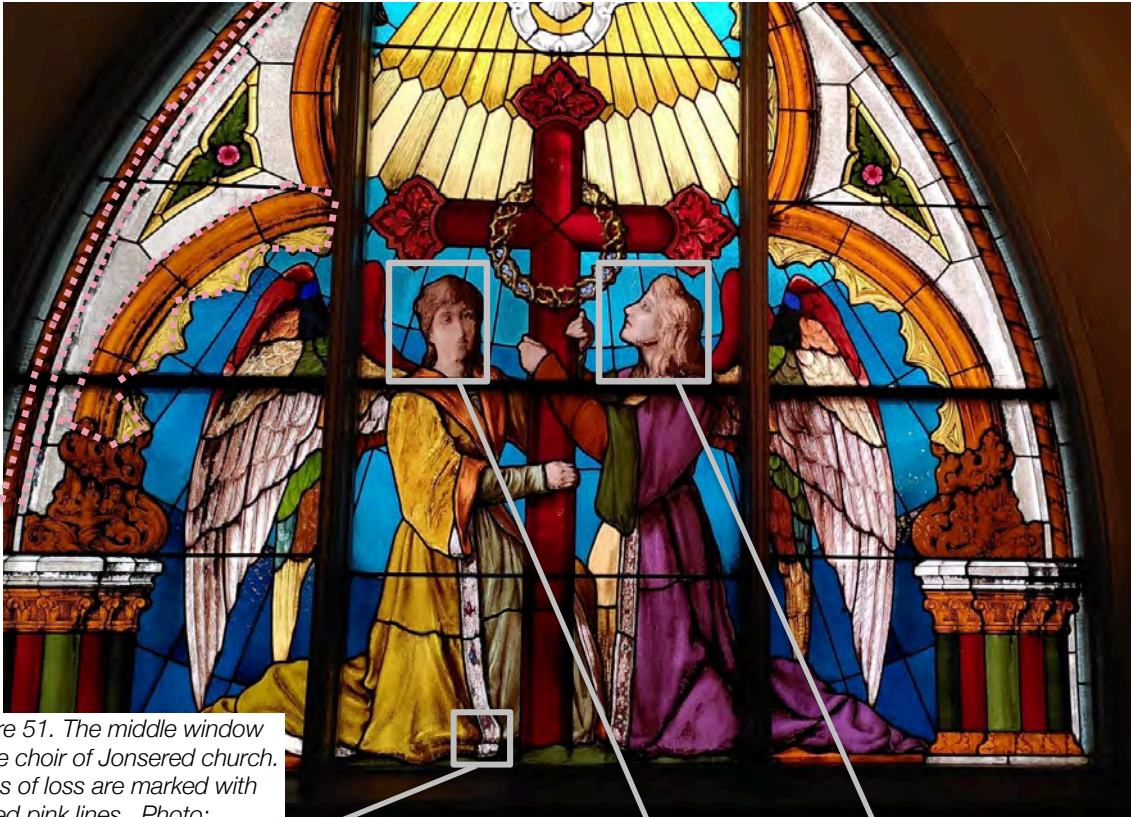
Figure 51. The middle window in the choir of Jonsæred church. Areas of loss are marked with dotted pink lines. Photo: Eisfeldt, 2022

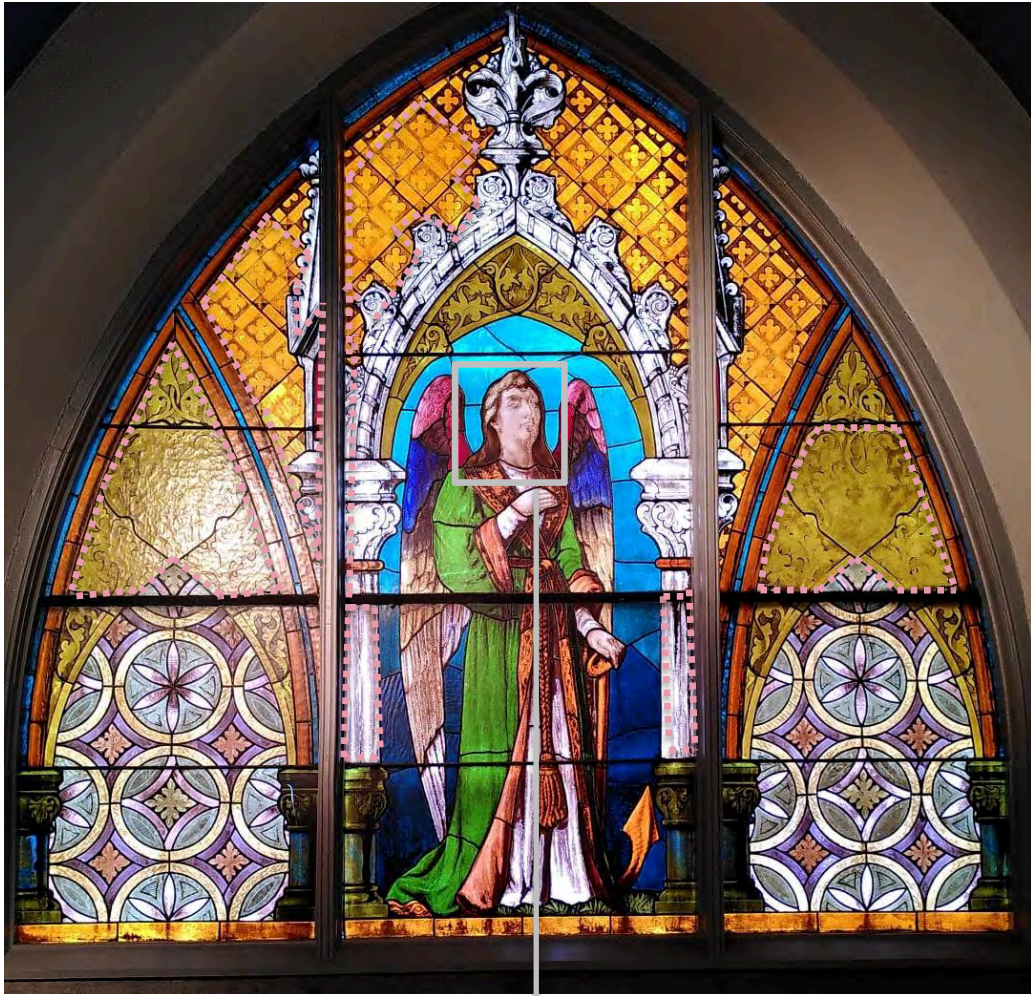
Figure 55. The left window in the choir of Jonsered church. Areas of loss are marked with dotted pink lines. Photo: Eisfeldt, 2022

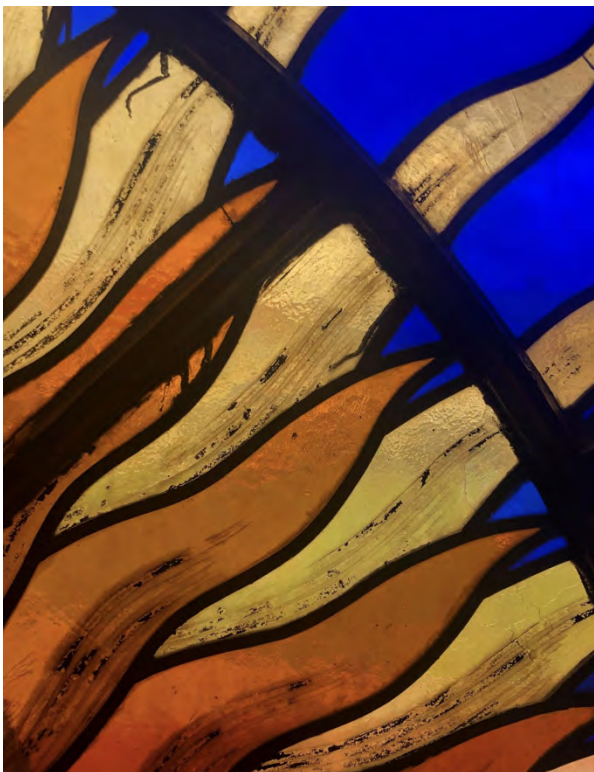
Figure 63. Paint-loss of Callmänder's stained glass in Varberg's church. Photo: Eisfeldt, 2022

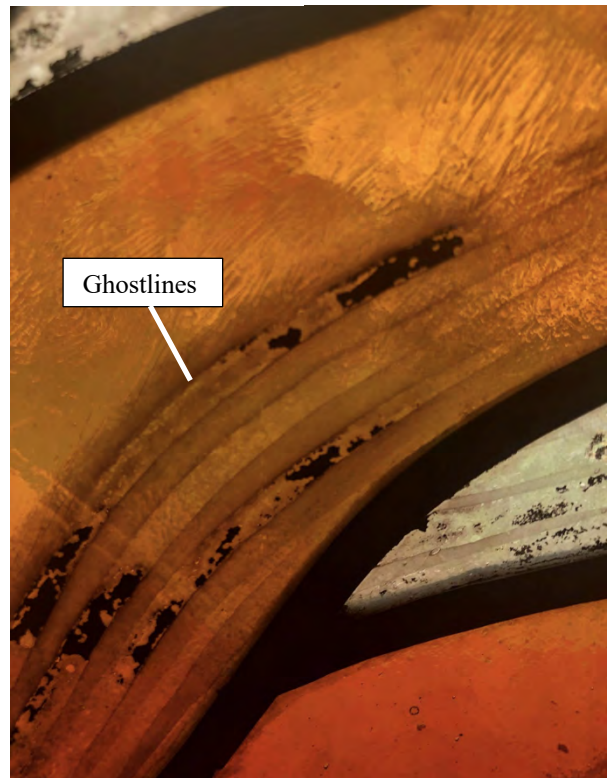
Figure 64. Paint loss and ghostlines of Callmänder's window in Varberg's church. Photo: Eisfeldt, 2022

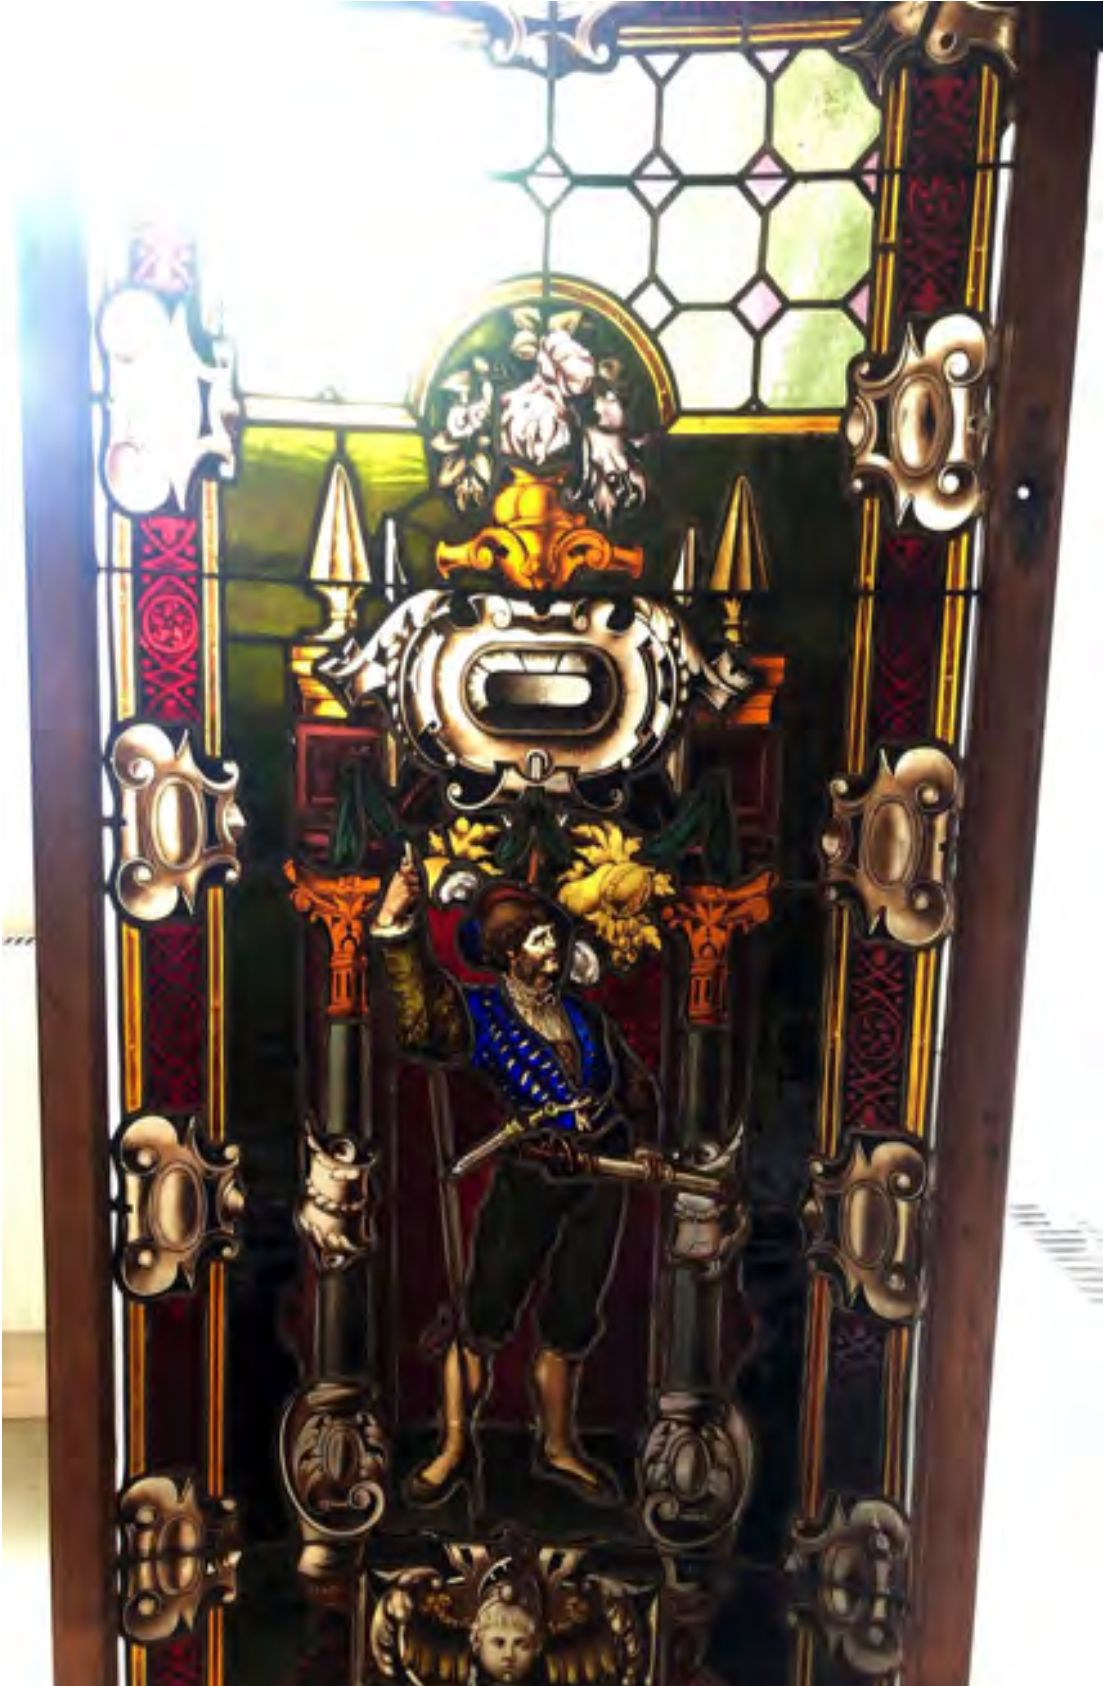
seen of the grisaille paint except small pinholes. The windows had been protected by exterior glass on their original site.

Figure 68. One of the windows from the Wernerska villan treated for bulging by Blyfönsteriet AB in Alingsås. Photo: Eisfeldt, 2022

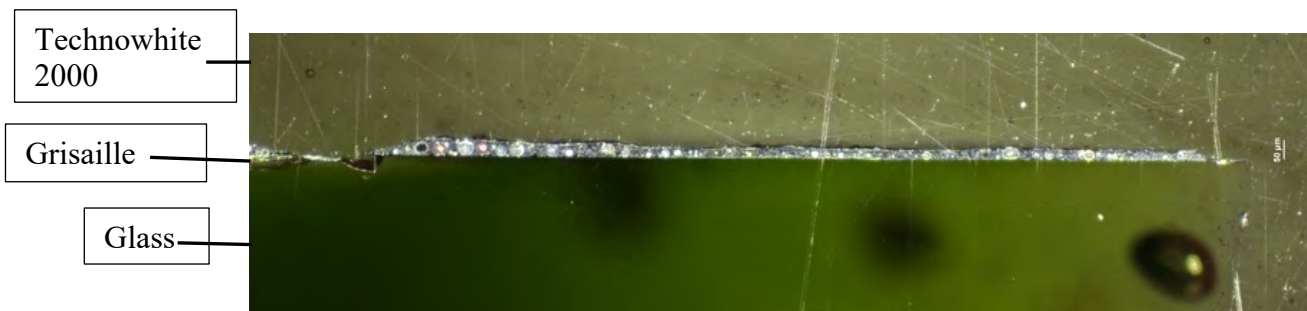
Figure 83. Microscope image of the cross section. The scale bar seen to the right is 50 μm.
Photo: Eisfeldt, 2022
