DEPARTMENT OF CONSERVATION

STATUS AND RISK ASSESSMENT AS DECISION SUPPORT FOR ENERGY EFFICIENCY MEASURES IN HISTORICAL BUILDINGS

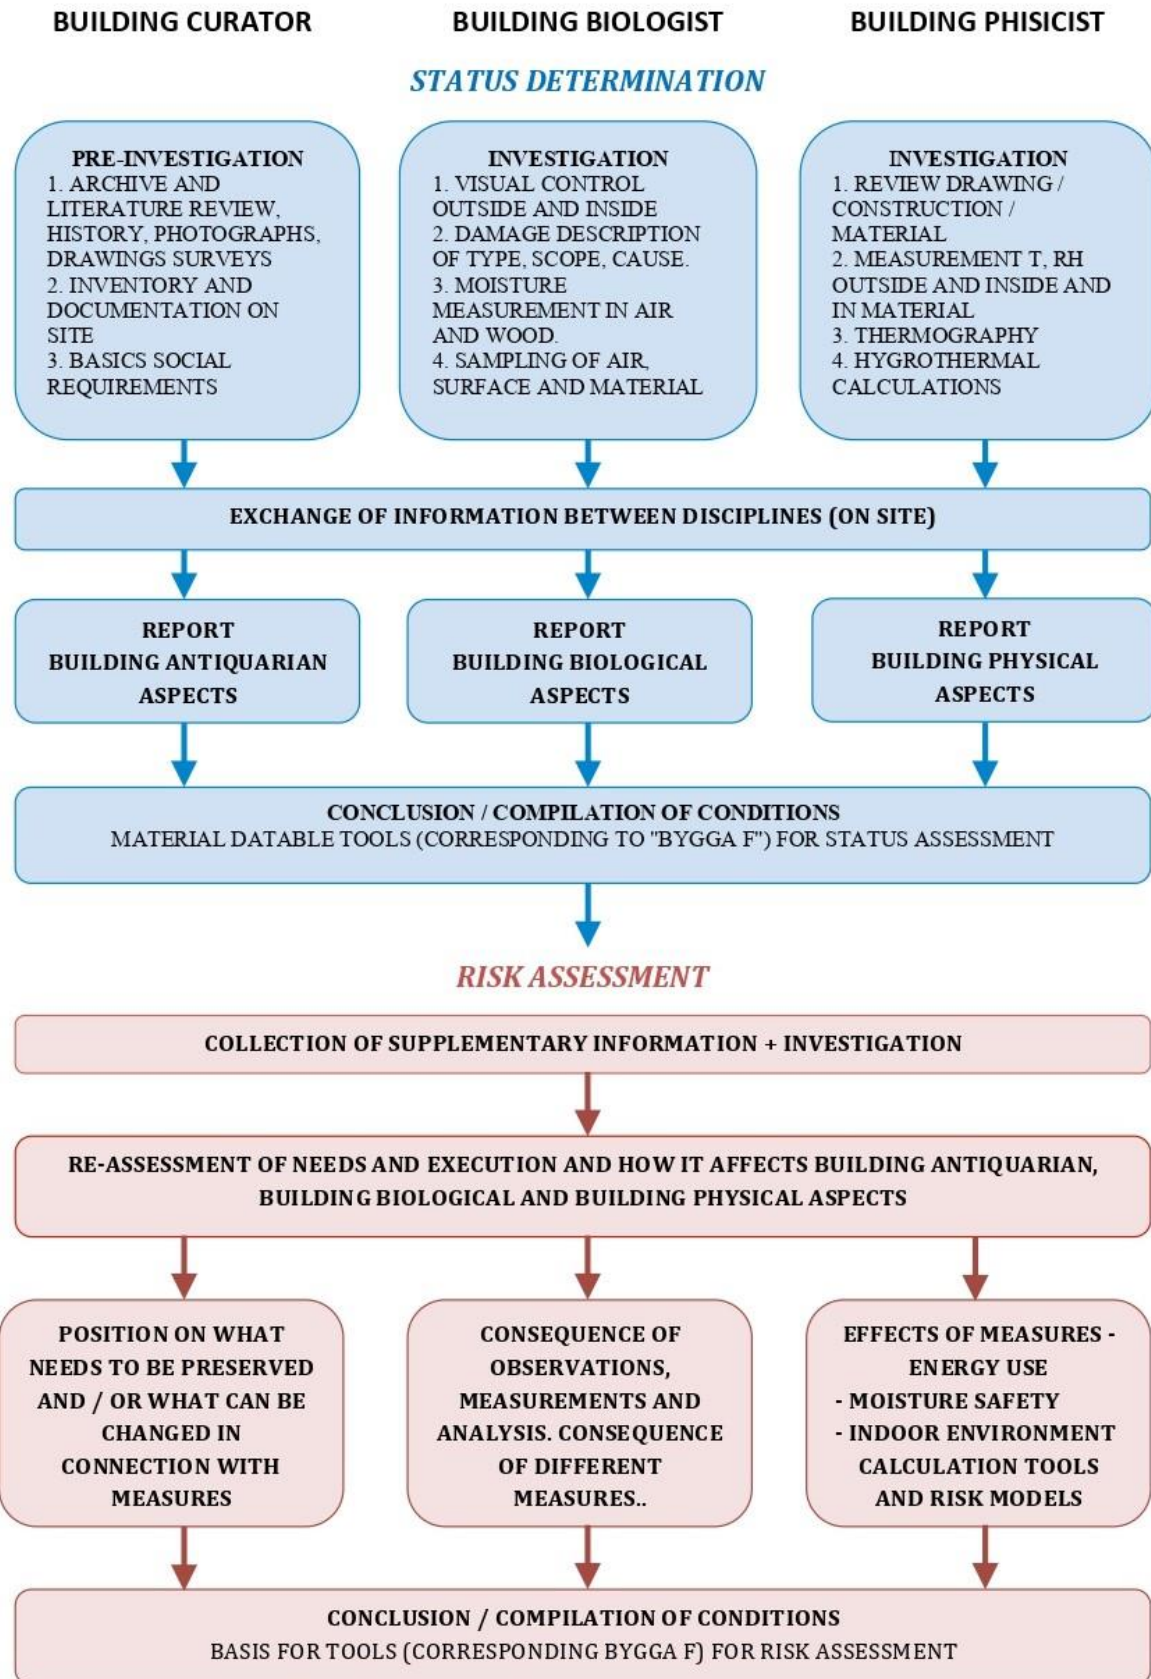
Figure 1. General scheme describing the working process within the method. Reprinted from *A method for status determination and risk assessment of energy measures in historic buildings* by Arfvidsson, Bjelke-Holtermann and Mattsson, 2021, p. 4 (<https://doi.org/10.1088/1755-1315/863/1/012043>). Copyright 2021 by Lund University.

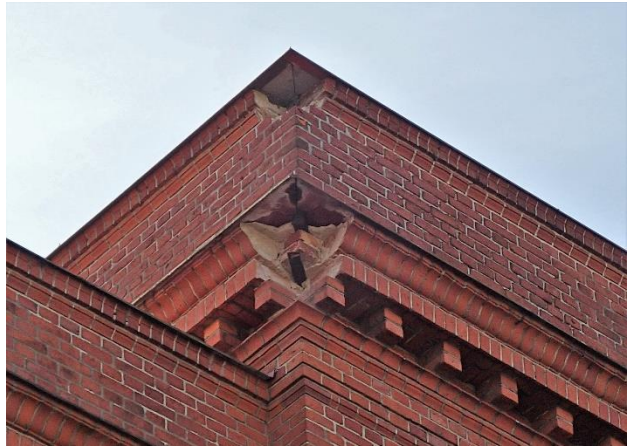
Figure 4. Damaged corner of the dentils frieze.

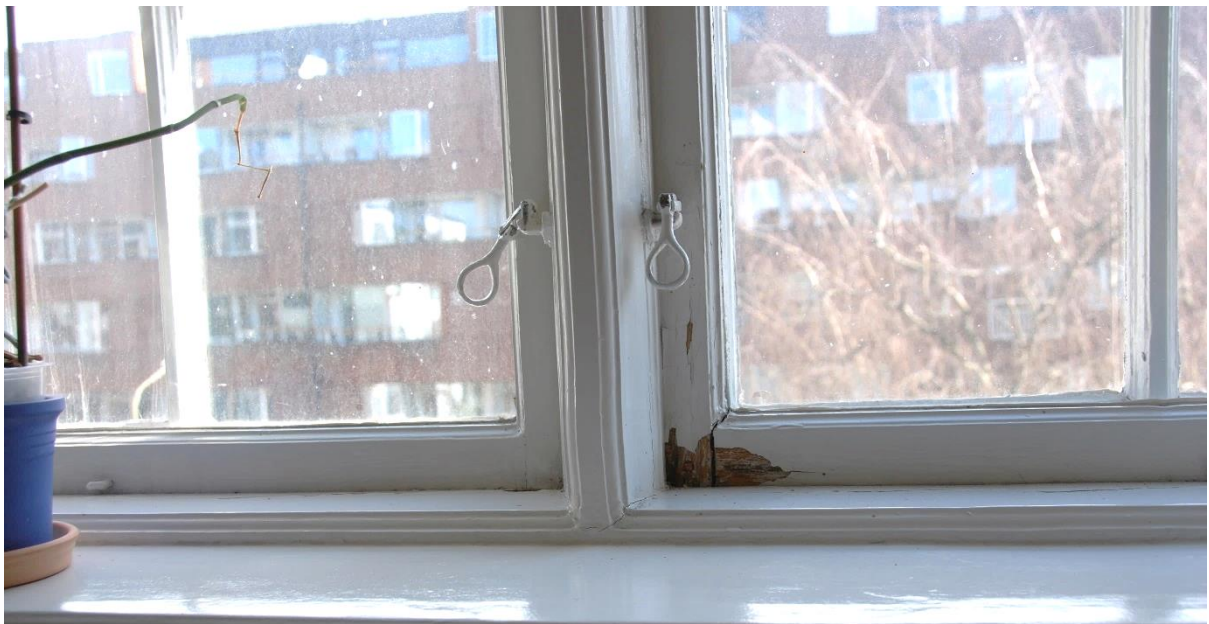
Figure 5. Flaking paint and potentially damaged wood in lower corner of window sash.

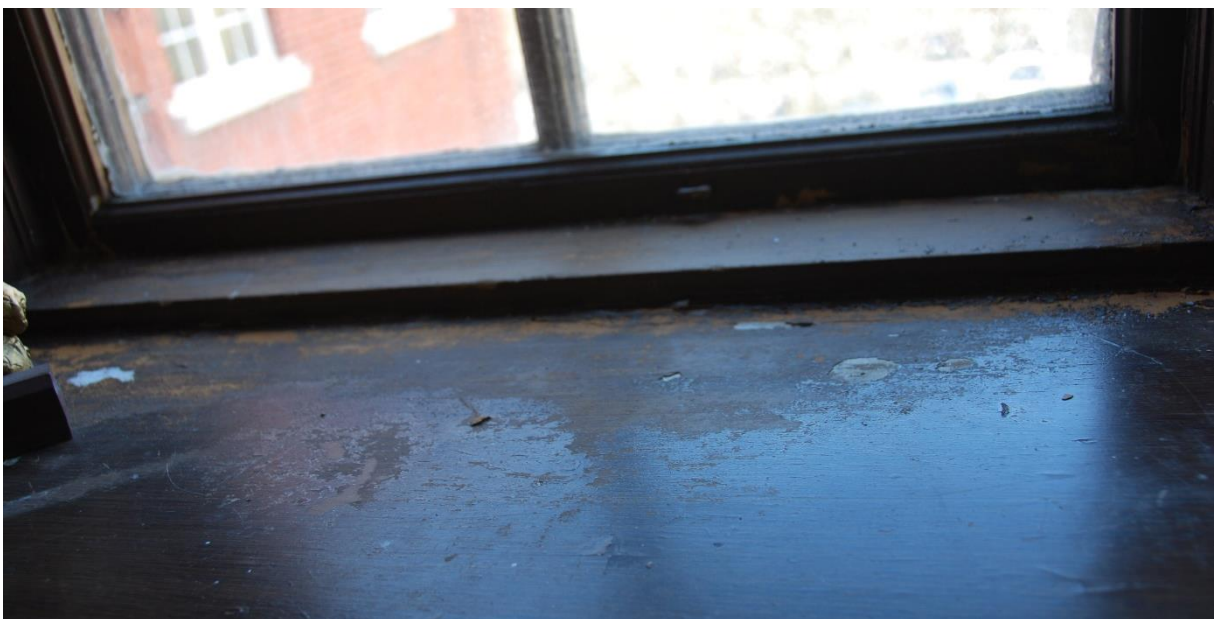
Figure 6. Flaking paint on interior window sill.

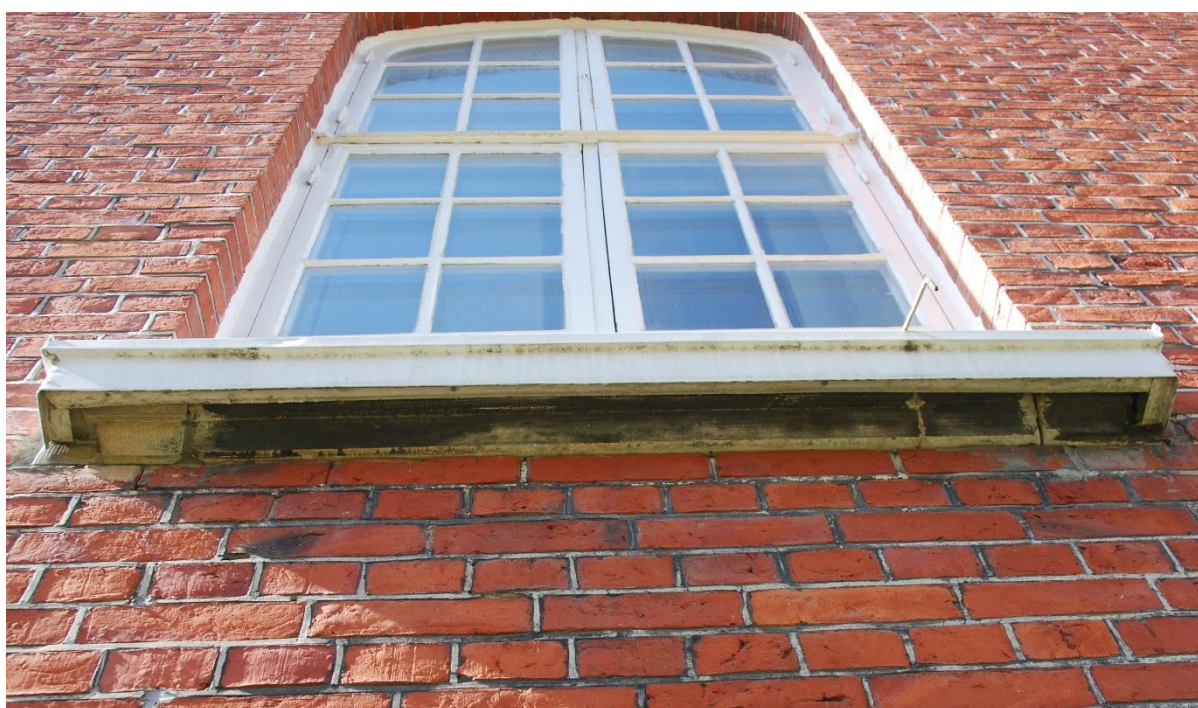
Figure 7. Exterior window sills blackened underneath.

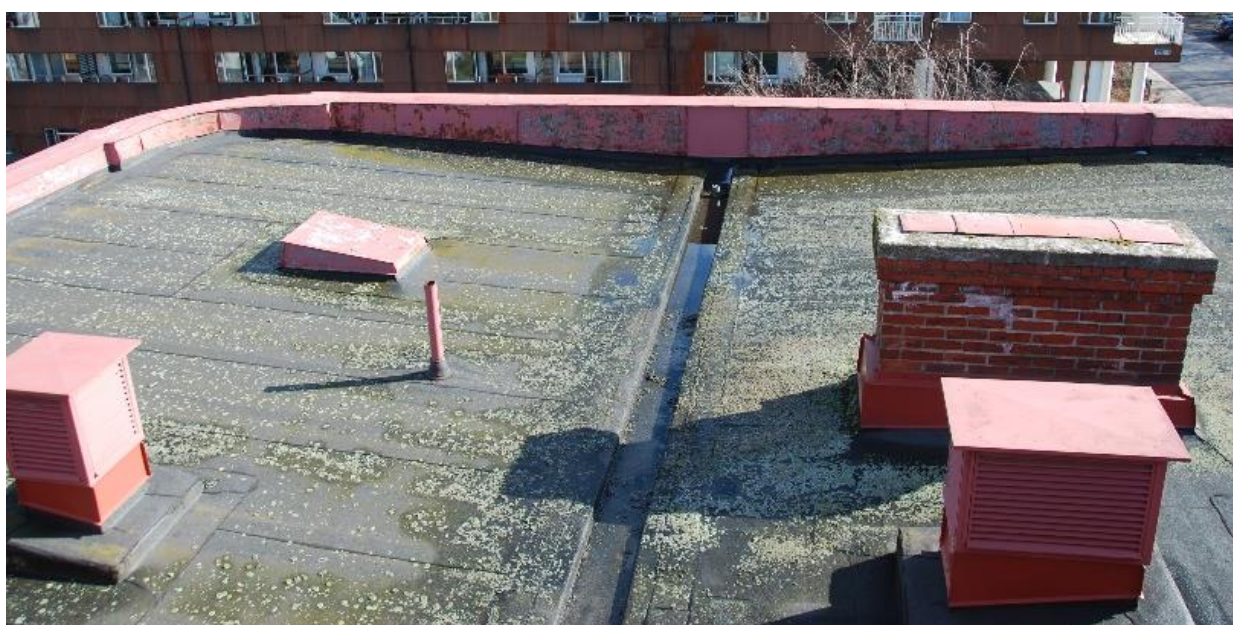
Figure 8. Stagnant water in roof valleys and roofing felt covered in lichen.

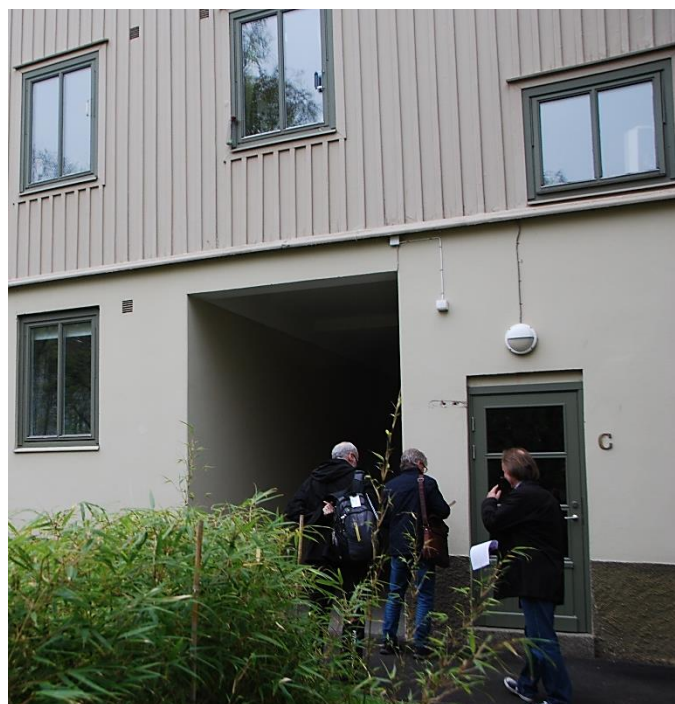
Figure 12. Arfvidsson, Mattsson and Bjelke-Holtermann examining the courtyard façades.

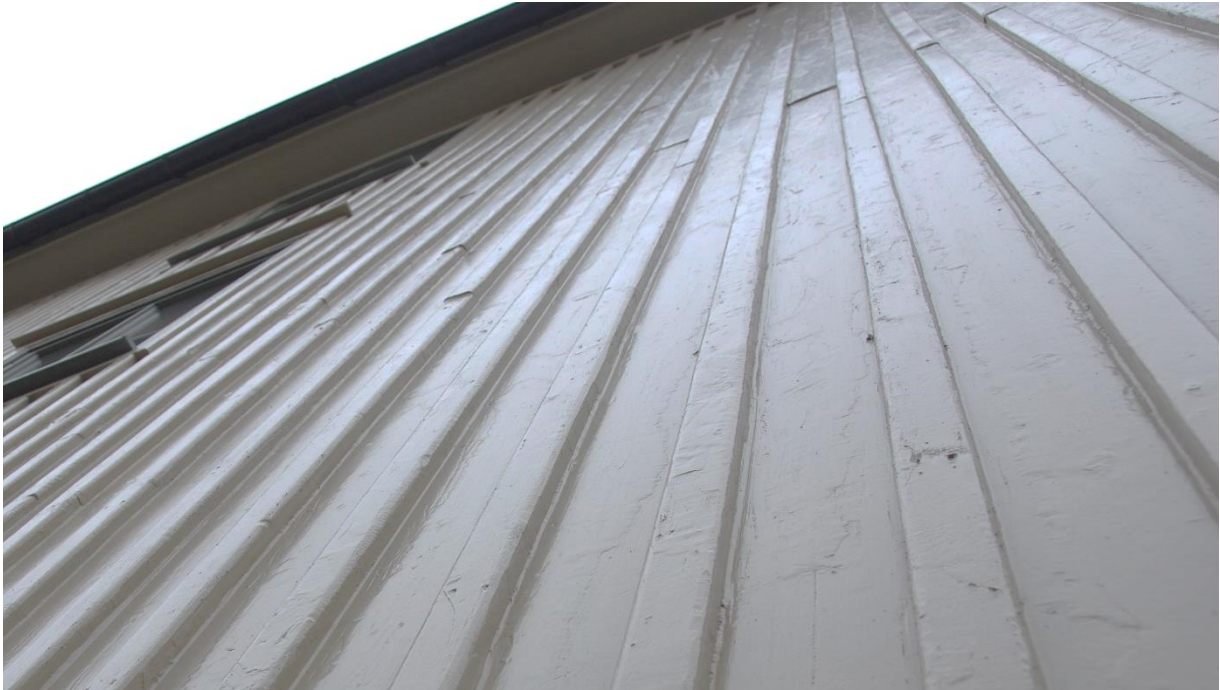
Figure 13. Vertical connections of the paneling.

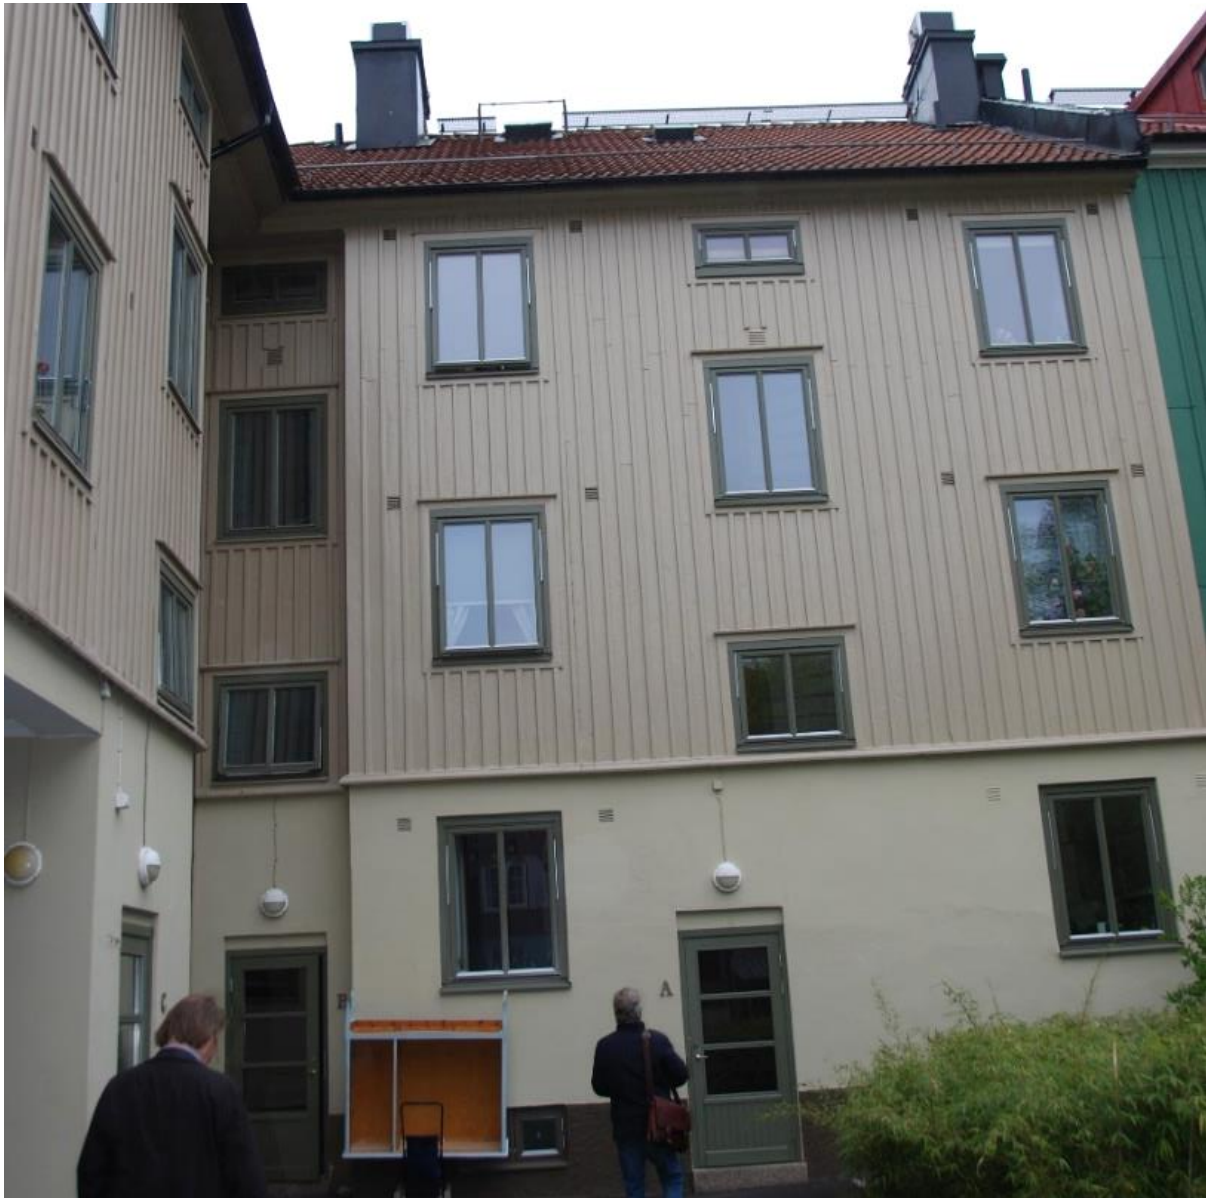
Figure 15. Appearance of the courtyard façades; connection between concrete base and upper wood construction

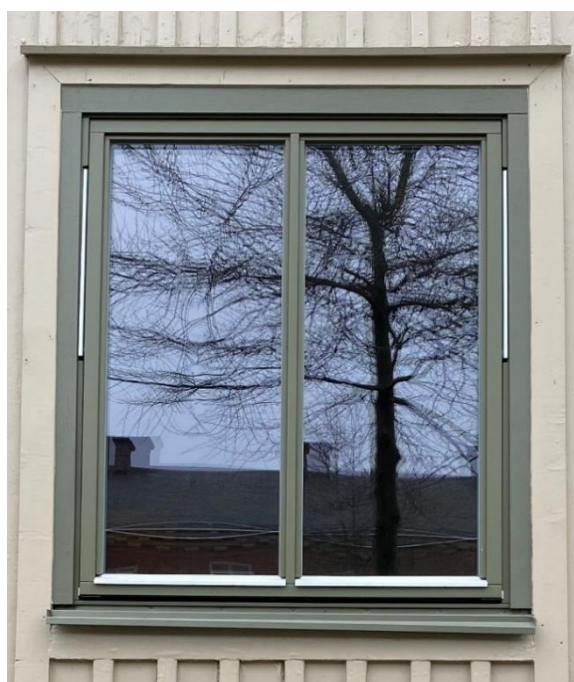
Figure 17. Close-up of window exterior.

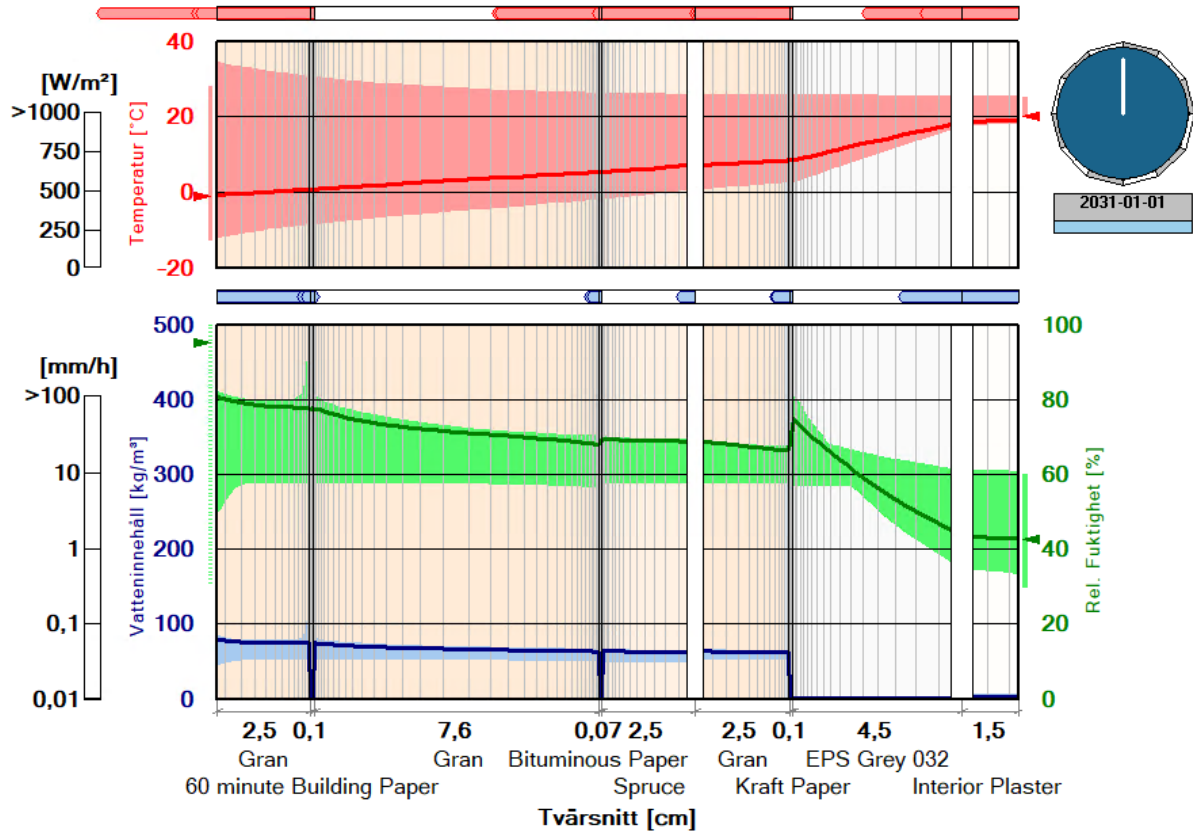
Figure 19. Simulation of 4,5 cm EPS insulation and 1,5 cm interior plaster added on the inside of exterior wall construction, by Abdul Hamid, Assistant senior lecturer, Building physics, Lund University, 2022. The upper graph shows the heat transfer and temperature gradient through the wall. The lower graphs show the moisture transfer through the wall; relative humidity (%) (green) and water content (kg/m^3) (blue).

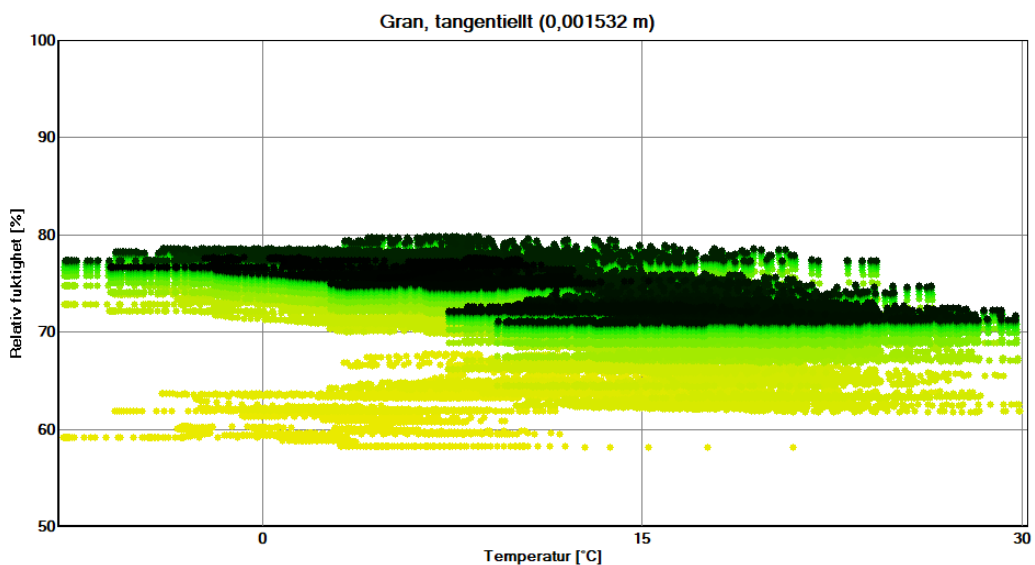
Figure 20. Isopleth showing acceptable risk level of mold growth between added EPS insulation and existing wall, by Abdul Hamid, Assistant senior lecturer, Building physics, Lund University, 2022.

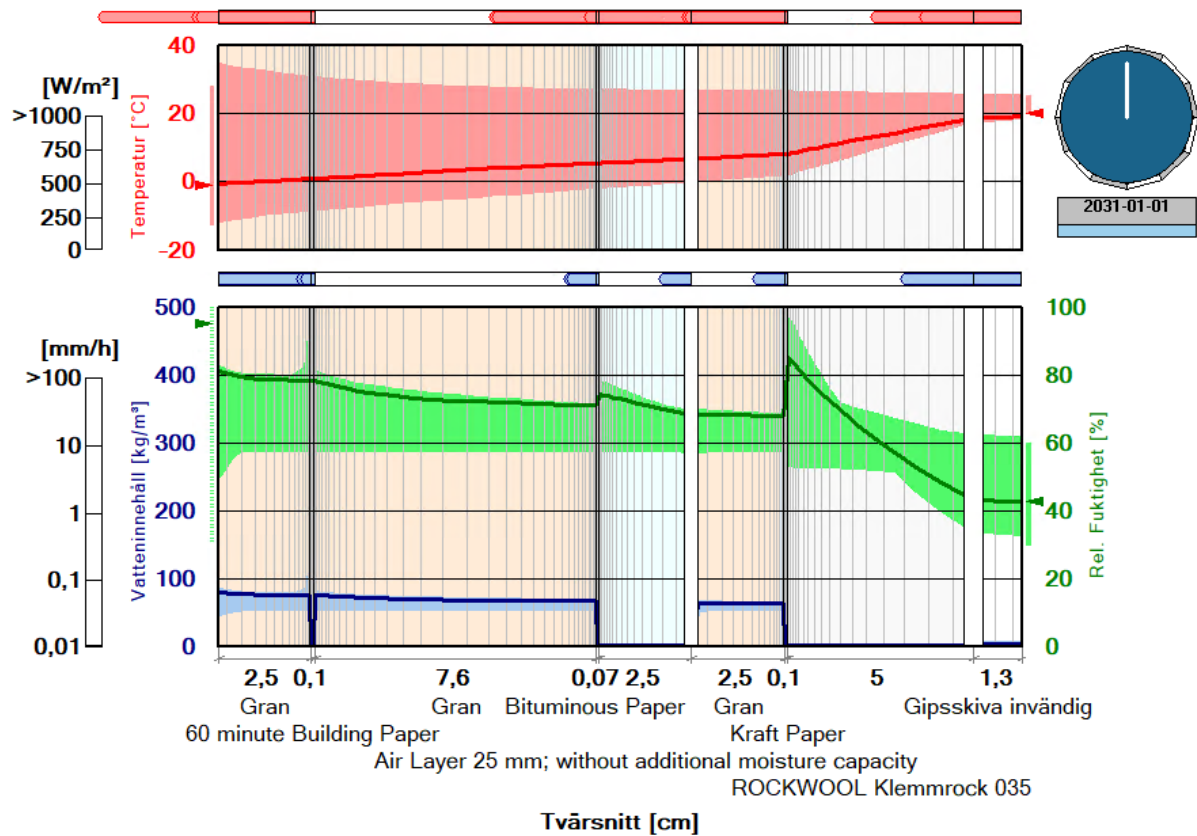
Figure 21. Simulation of 5 cm mineral wool and 1,3 cm gypsum board added on the inside of exterior wall construction, by Abdul Hamid, Assistant senior lecturer, Building physics, Lund University, 2022. The upper graph shows the heat transfer and temperature gradient through the wall. The lower graphs show the moisture transfer through the wall; relative humidity (%) (green) and water content (kg/m^3) (blue).

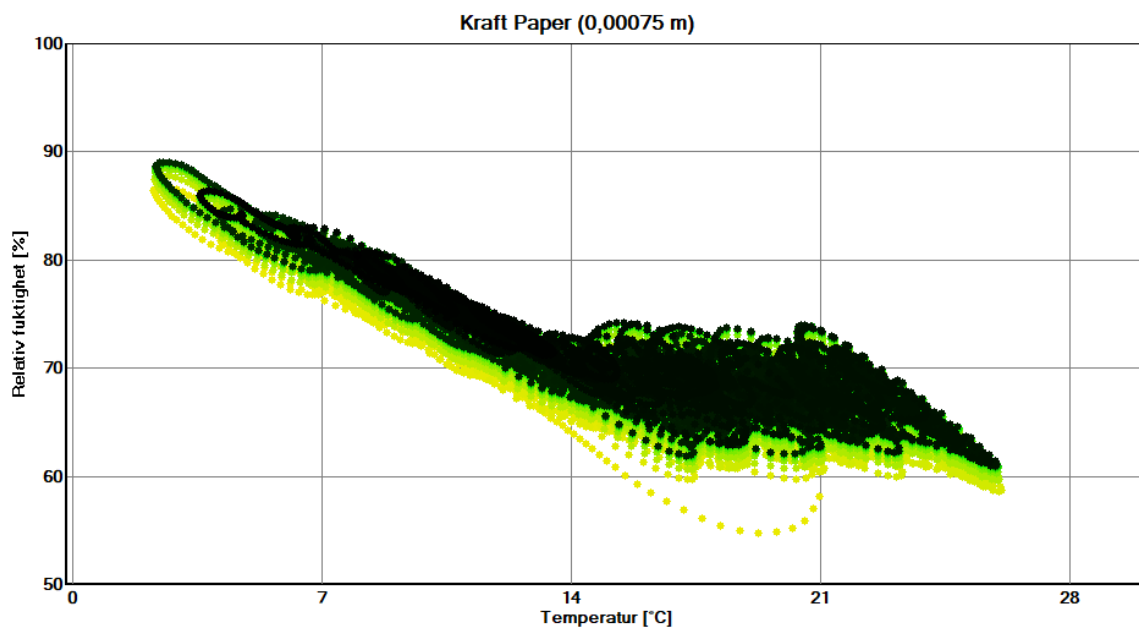
Figure 22. Isopleth showing heightened risk of mold growth between added mineral wool insulation and existing wall at low temperatures, by Abdul Hamid, Assistant senior lecturer, Building physics, Lund University, 2022

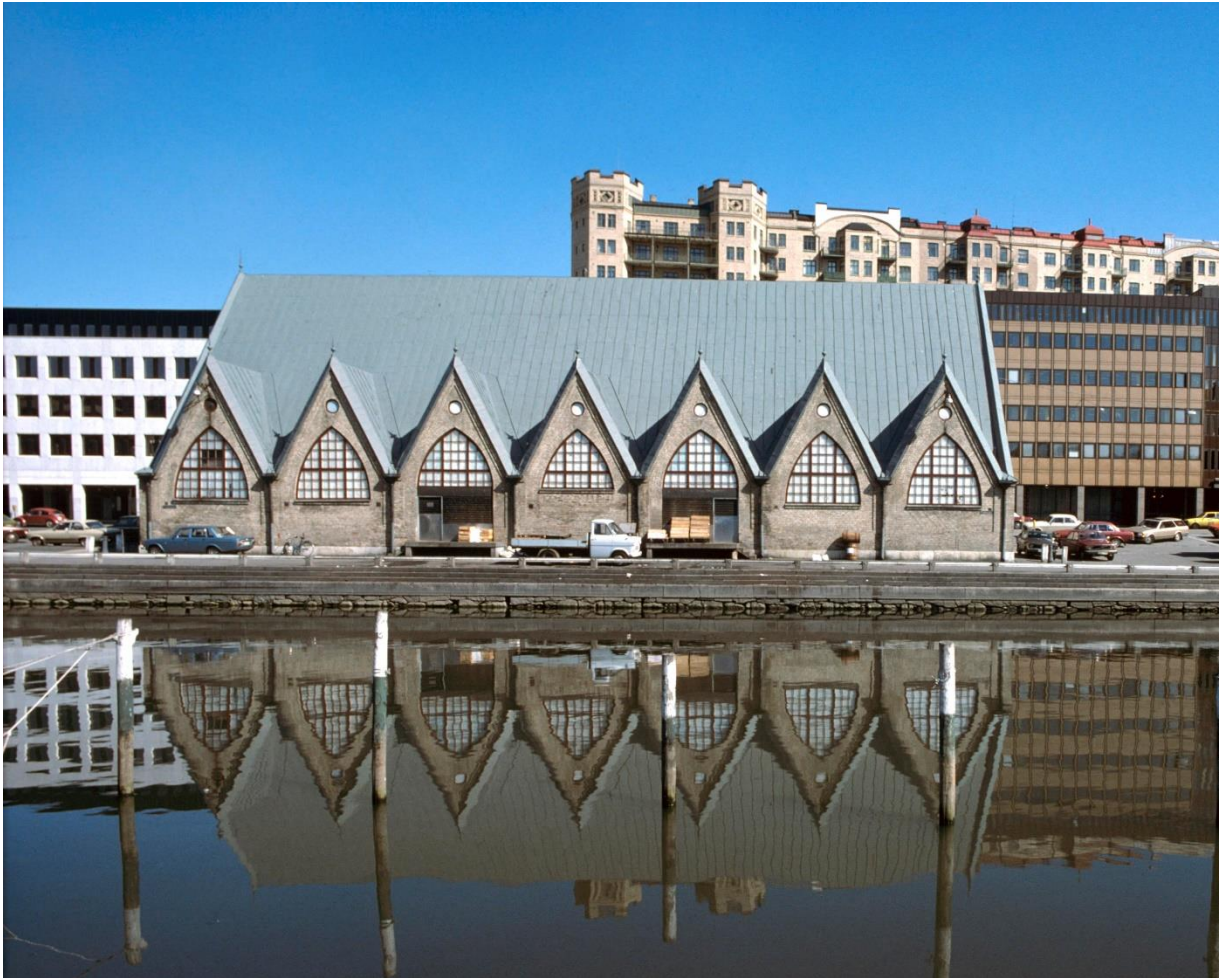
Figure 24. South façade. By Nilsson, P.N., 1977. Swedish National Heritage Board.

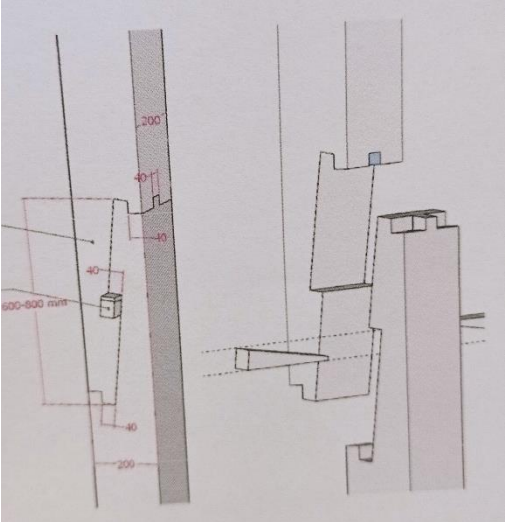
Figure 25. Carpentry joint used for visible parts of the structure. Advanced form of stop-splayed and tabled scarf joint with key (Karolak et al., 2020).

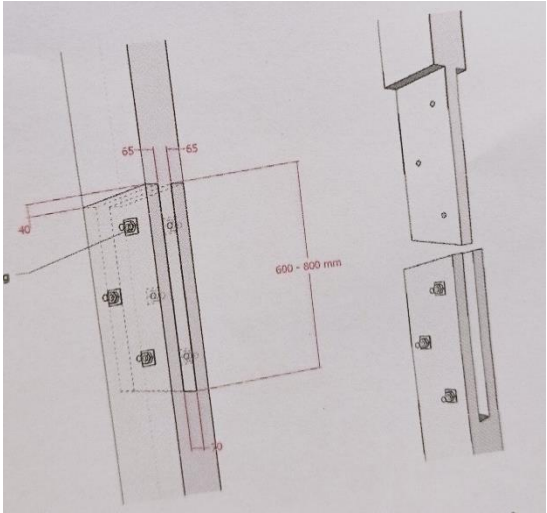
Figure 26. Carpentry joint used for hidden parts of the structure.

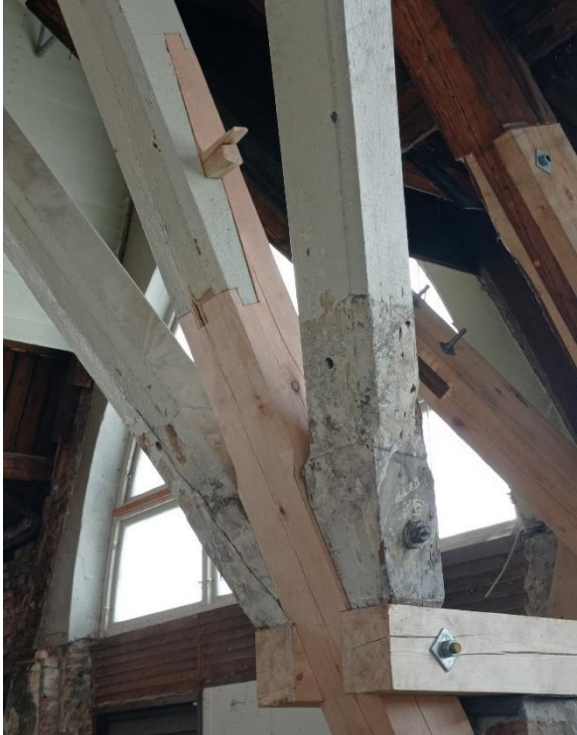
Figure 27. Repair on visible part of structure.

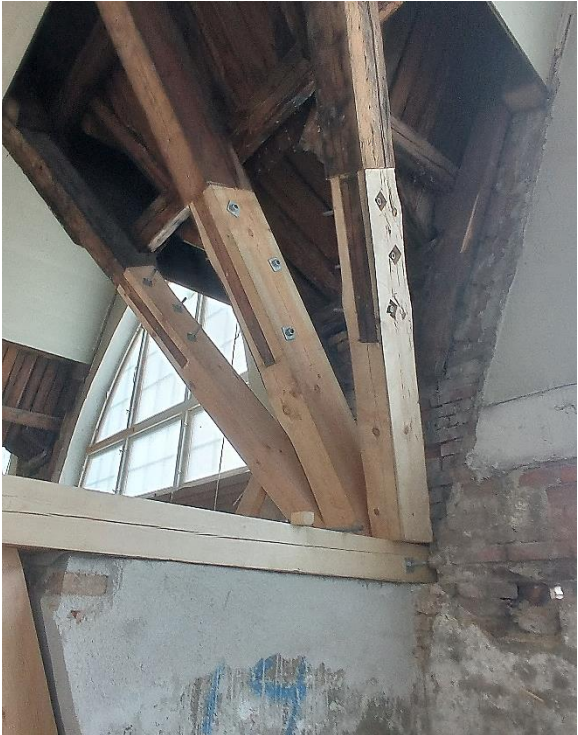
Figure 28. Repair on hidden part of structure.

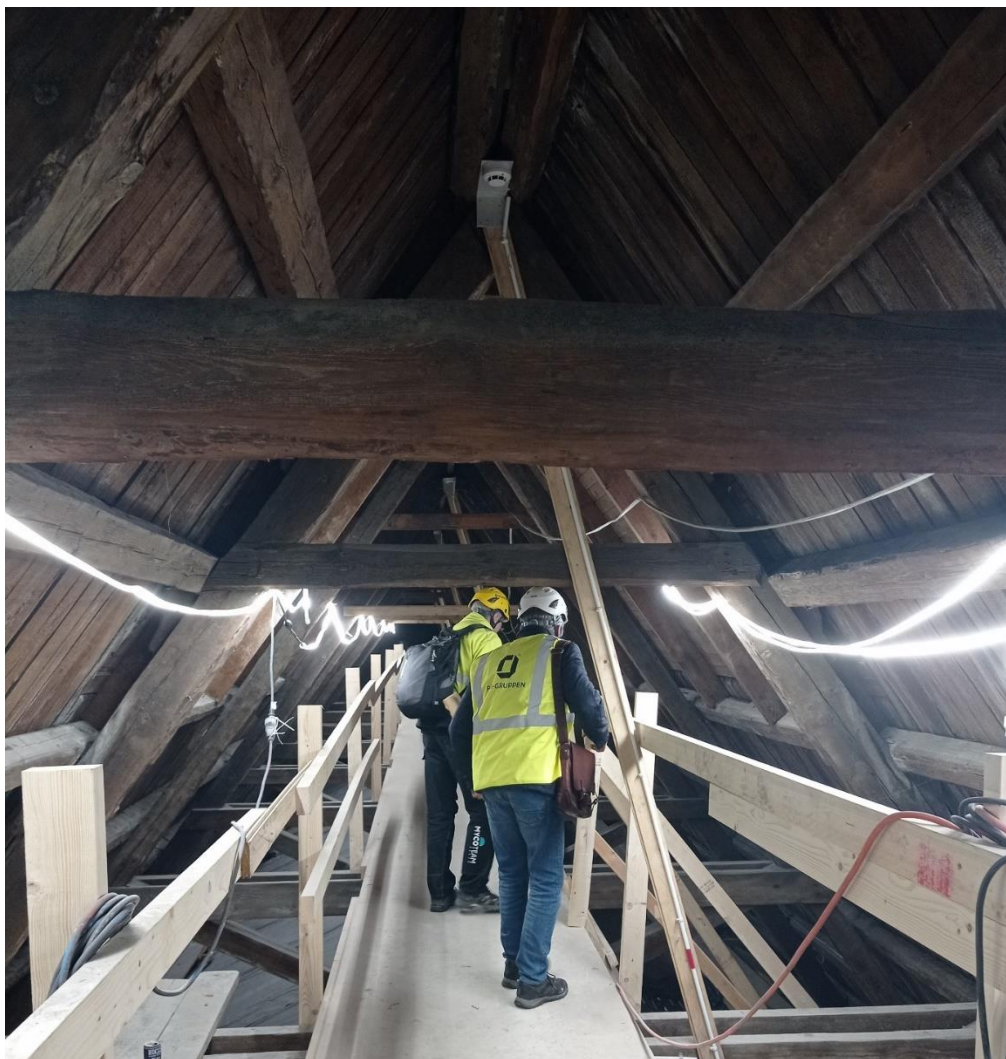
Figure 29. Bjelke-Holtermann and Mattsson in the attic.

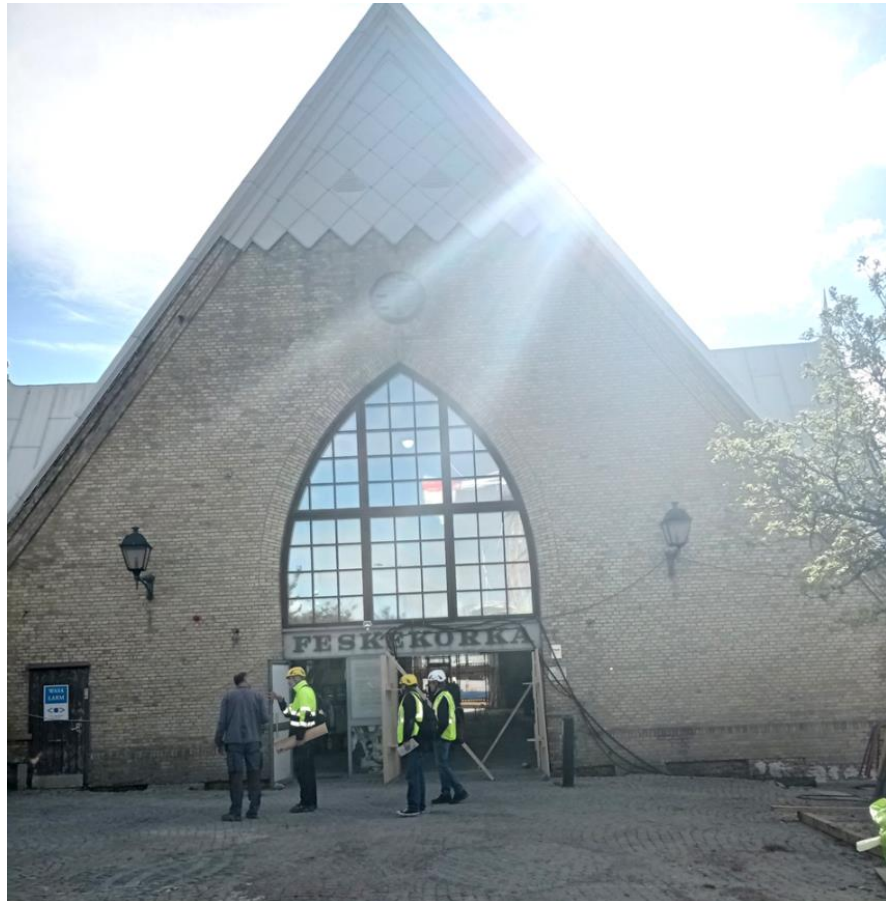
Figure 30. Arfvidsson, Bjelke-Holtermann, Mattson and a timber craftsman outside the west façade.

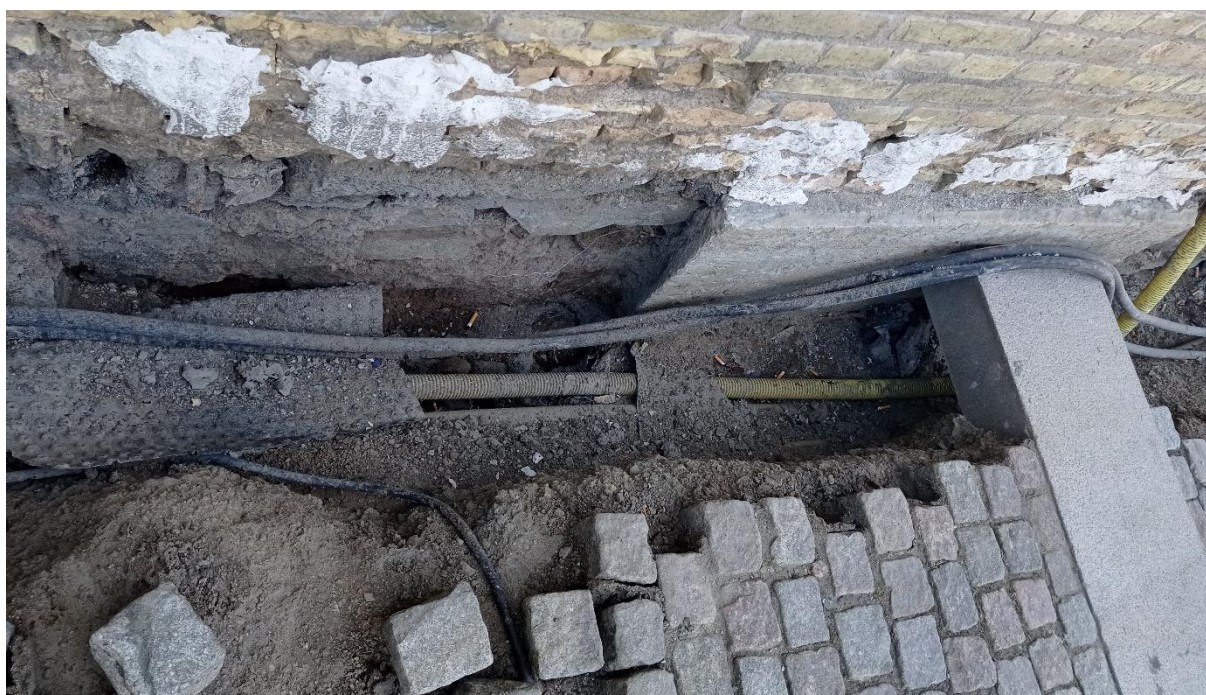
Figure 31. The lime stone base is partially submerged under-ground due to elevation of the ground level.

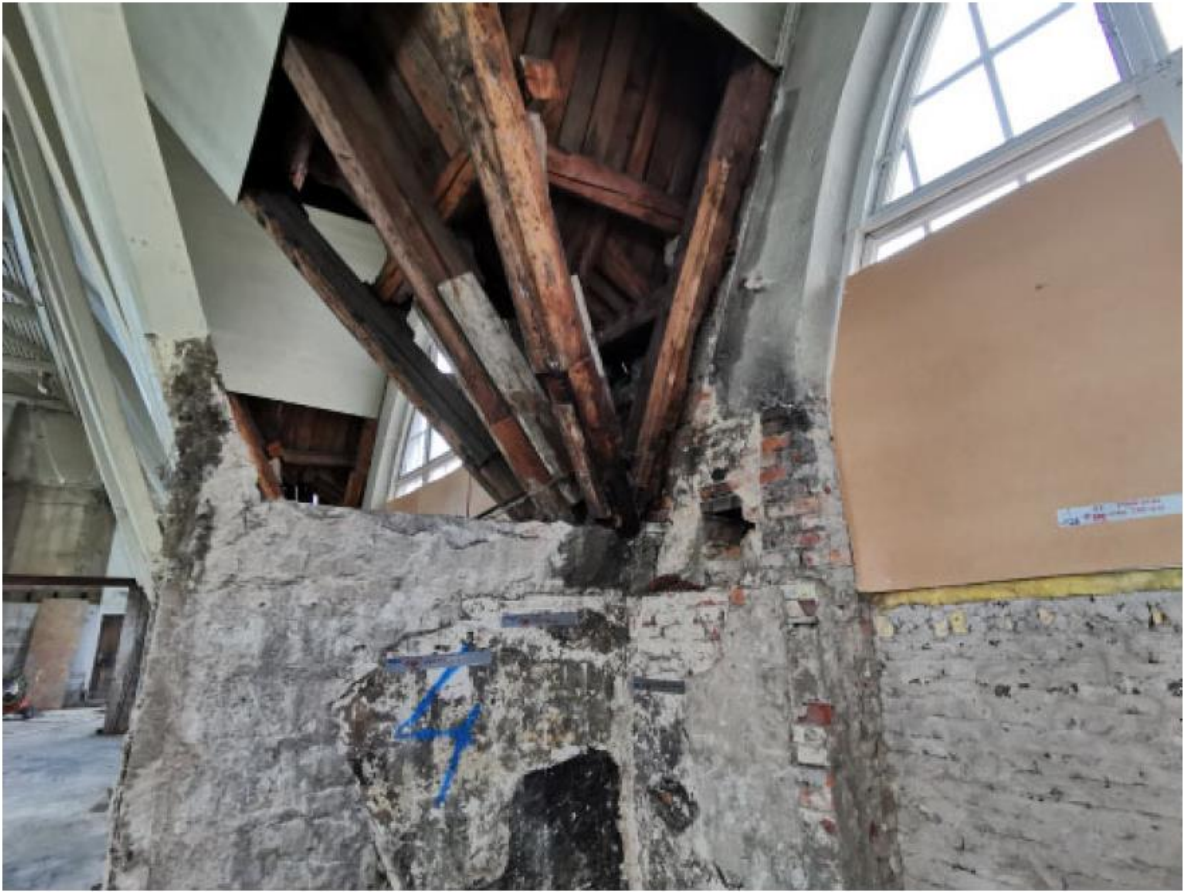
Figure 32. Damage to the roof truss in the connection points to the counterforts, especially near the exterior wall. By Mattson, 2022.

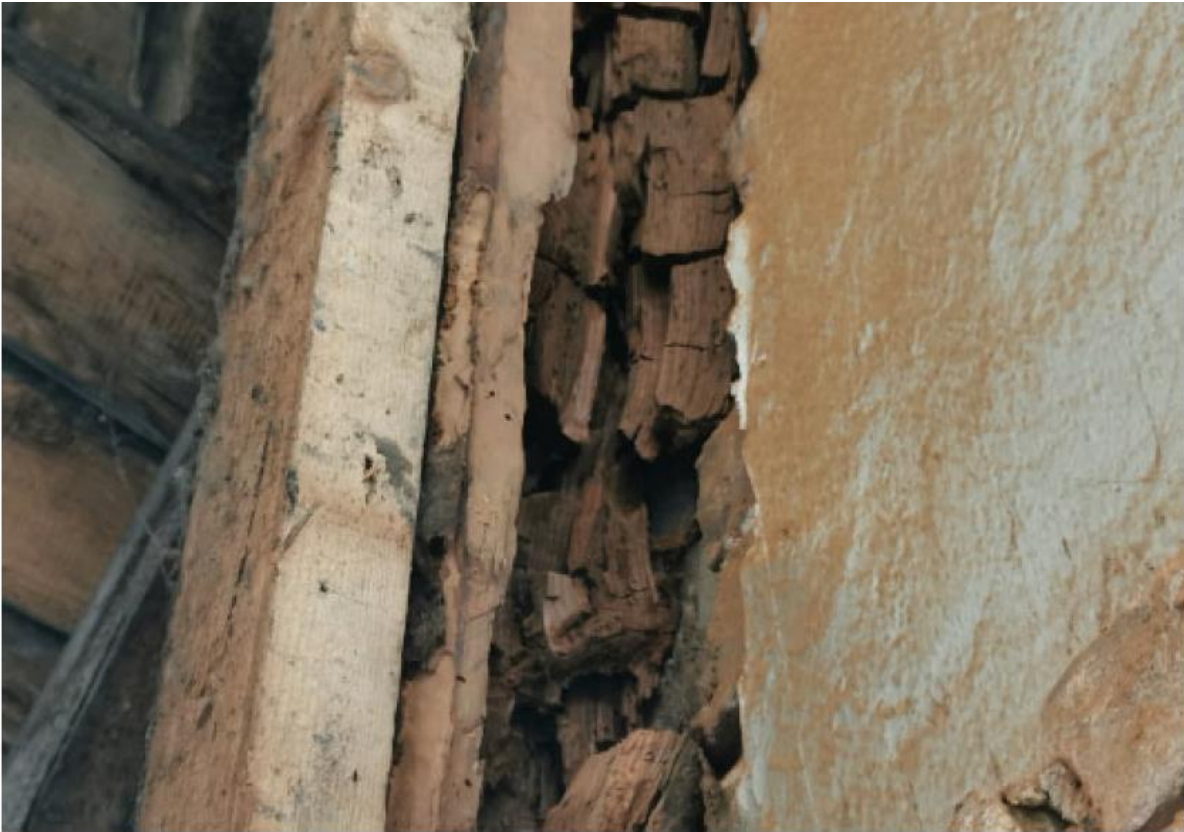
Figure 33. Close-up of the damage in one of the connection points. By Mattson, 2022.

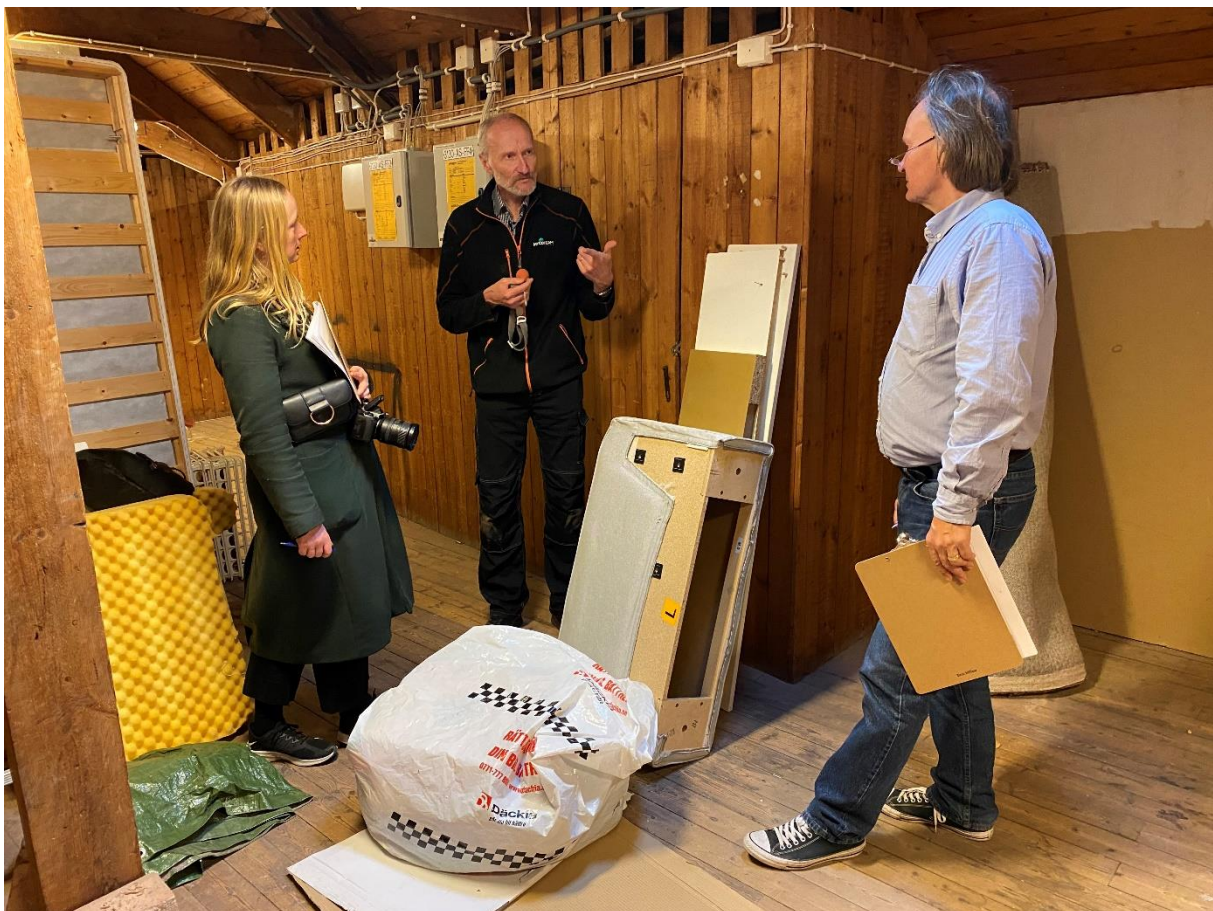
Figure 34. Arfvidsson, Mattson and the author in the attic of the governor's house. By Bjelke-Holtermann, 2022.
