Microbial degradation of wooden foundation piles in urban context – causes and concerns

Johanna Elam

Doctoral thesis

UNIVERSITY OF GOTHENBURG

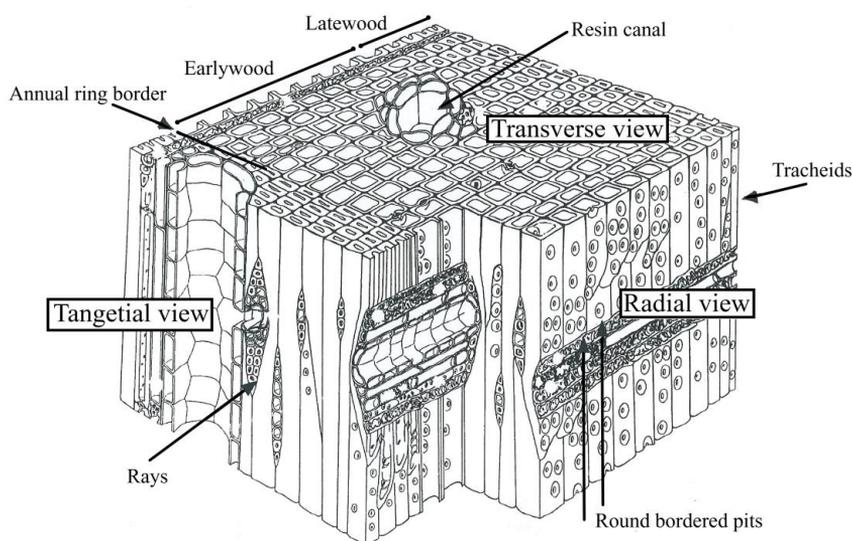
Figure 2 Anatomy of softwood material. The three directions in which cuts can be oriented are labelled: transverse view, cut laterally in a plane across the tree trunk; radial view, cut vertically in a plane from bark to core; and tangential view, cut vertically in a plane along the annual ring direction. Earlywood and latewood are shown as well as the annual ring border. Resin canals, rays, tracheids and bordered pits are marked with arrows. (Modified from (Siau, 1984))

Wood, the tissue of trees, is a strong organic polymer which consists mainly of cellulose, lignin and hemicelluloses. Anatomically, wood is made up of different types of cells that serve different functions in the living tree (Wiedenhoeft and Miller, 2005). Composition and distribution vary between wood species, so that species identification is possible by observing the anatomy (Wheeler, 2011). Spruce and pine which are commonly used as piling material are so called softwoods that have a simple structure compared to hardwood and is mostly made up of tracheids (around 95%) and rays. Tracheids, also called fibres, transport water and nutrients vertically upwards in the tree trunk, whereas rays store and transport horizontally from the bark to the core (fig. 2).

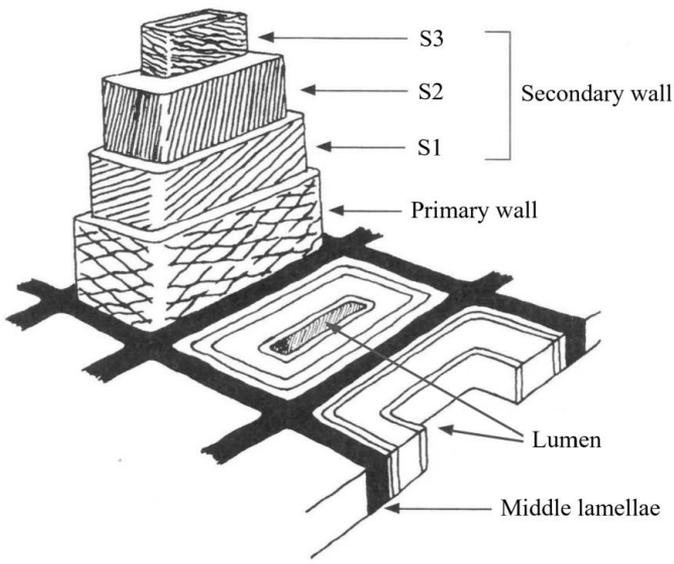
Figure 3. Cell wall structure. (Modified from (Eaton and Hale, 1993))

Each fibre is made up of a layered cell wall surrounding an empty hollow at the cell centre known as the lumen (fig. 3). It is within the lumen that water and nutrients are transported. The cells have anatomical openings known as pits in the cell walls, allowing exchange between neighbouring cells. The cell wall consists of a primary and secondary cell wall, where the secondary wall is separated in three layers. The cell wall consists mainly of cellulose and hemicelluloses, where the polymers are arranged in bunches called microfibrils which are oriented in different angles in the different layers of the cell wall to provide both flexibility and stability/strength. Between the cells, there is a lattice framework of middle lamellae which serves as a gluing layer holding the cells together. The middle lamellae consist mainly of lignin (Butterfield, 2003).

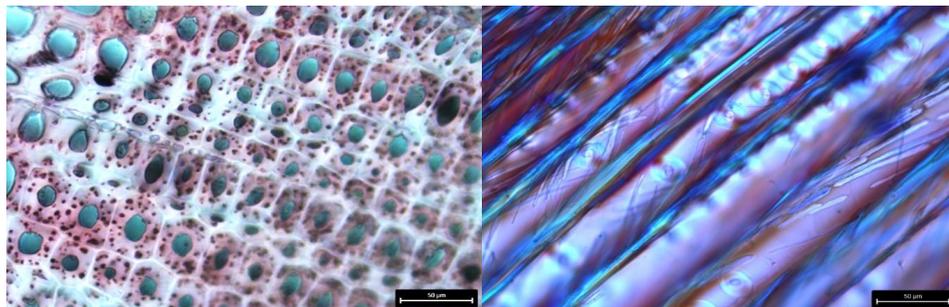
Figure 4: Soft rot cavities in transverse cut (left) and radial cut (right). The round holes in the cell wall and the spiral pattern following the microfibril angle are very distinctive.

In aerated topsoil and ground contact wood is degraded relatively fast by wood rotting fungi, which can be divided in three main types named according to the appearance of the wood after severe degradation: brown rot, white rot and soft rot (Goodell and Jellison, 2008). The type can be identified in light microscopy due to the differences in degradation pattern, for example soft rot hyphae creates visible round holes in the transverse cut, and in the radial cut they leave a typical spiral pattern of arrow-ended

cavities where the hyphae follow the microfibril angle in the S2 layer of the cell wall (fig. 4).

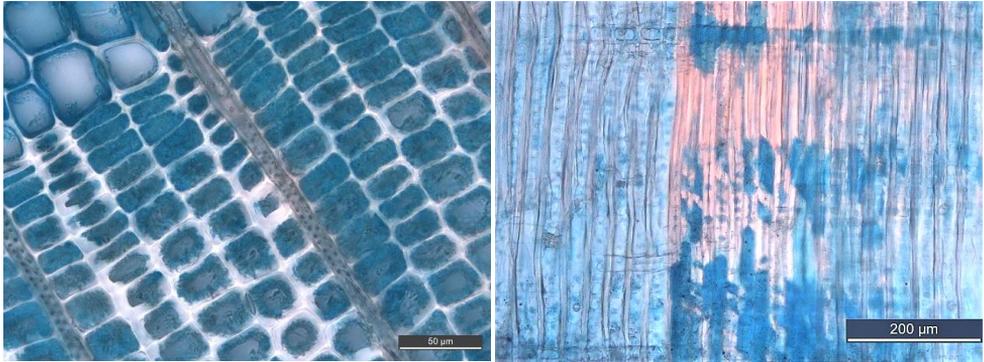
Figure 5: Degradation by erosion bacteria in the transverse cut (left) and radial cut (right) of a historic pile sample, examined for paper II. The decay progresses from the lumen outwards, seen here as blue areas in contrast to the undegraded white areas. The degradation can be seen as a sharp rhombic pattern in the radial cut.

The main degrader of wood in waterlogged environments are rod shaped so-called erosion bacteria, which are the only known organism able to degrade wood under waterlogged and near-anaerobic conditions (Björdal, 2012; Kim and Singh, 2000). The decay process can take several centuries, as the decay is continuous but extremely slow (Björdal, 2012). Decay by erosion bacteria starts from the exposed wood surface, proceeding inwards via the anatomical openings present in wood. The preferential decay of erosion bacteria breaks down the cellulose-rich cell wall but leaves the lignin-rich middle lamellae, leaving behind a honeycomb-like pattern that is easily identifiable under light microscopy (fig. 5).

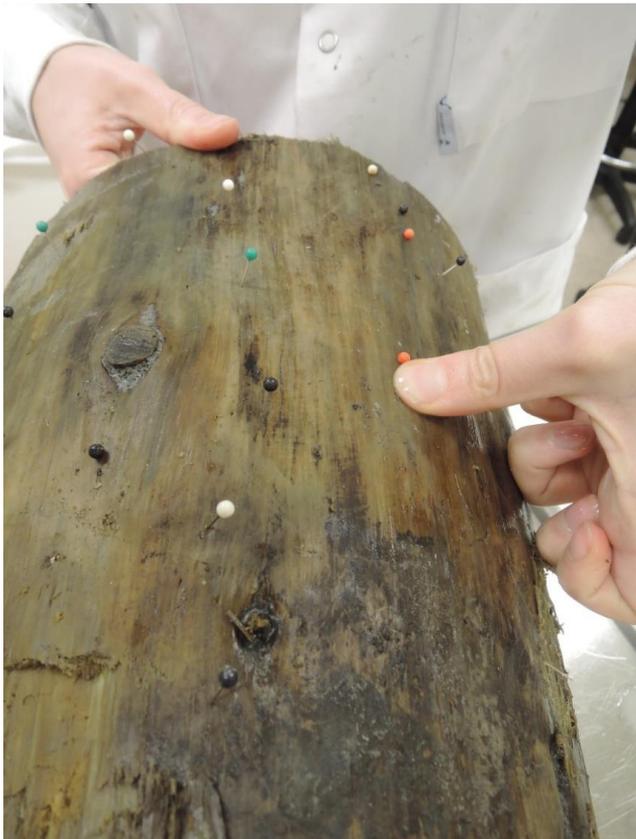
Figure 6: Wood foundation pile that has been degraded by erosion bacteria, appearing normal but soft enough that a pin can easily be pushed into the wood by hand. The wood material is spongy and even pressing with a finger can make an indentation.

Since this framework of middle lamellae remain, the wood can outwardly appear quite unaffected (fig. 6), but the mechanical properties are altered by the decay as the strength and hardness both depend on the cellulose content (Capretti et al., 2008).

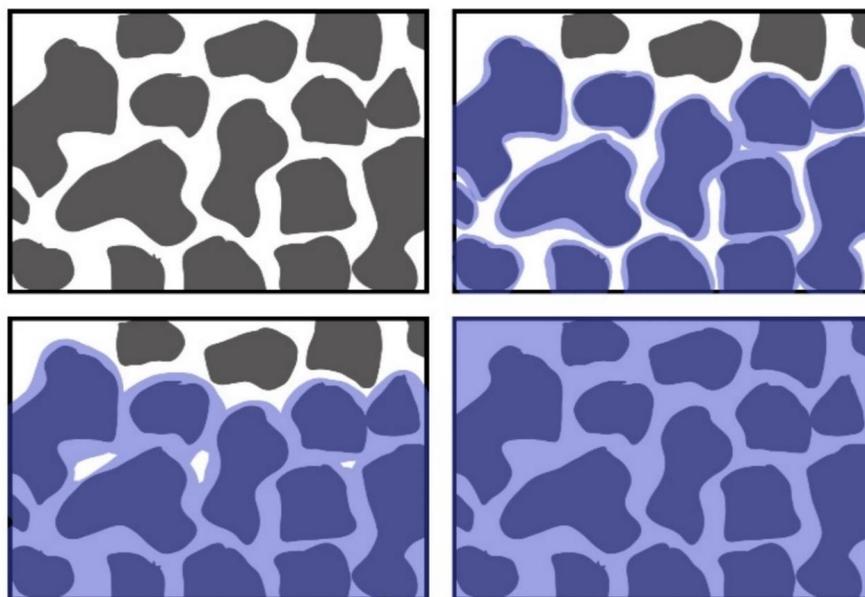
Figure 7: How increased moisture content in soil reduces oxygen availability by excluding air. Soil particles in grey, moisture in blue, air in white. Top left: no moisture. Each soil particle is in contact with air in the soil pore spaces. Top right: Presence of soil moisture. Due to surface tension, moisture adheres to the soil particles while air is still present in pore spaces. Bottom left: near saturation. Air is present above water level and in few remaining pockets. Bottom right: fully saturated. The water has filled all pore spaces, excluding air from the soil.

Previous studies have tried to find a correlation between wood degradation and environmental parameters (Huisman et al., 2008a; Klaassen, 2005; Kretschmar et al., 2008a; Kretschmar et al., 2008b; Zborowska et al., 2020; Zborowska et al., 2007), but so far, no clear correlation has been found. Building on these results and experiences, the experiments in this thesis focus on lowered groundwater level, high oxygen content and high redox potential. The three parameters are strongly interconnected, commonly measured in field, and each is connected to wood degradation as wood degrading organisms need moisture and oxygen to actively degrade wood (Goodell and Jellison, 2008). Groundwater level determines soil and wood moisture content, and as previously stated wood degrading organisms are only able to actively degrade wood within specific moisture optima. Too much moisture can inhibit fungal growth, and while soft rot fungi can be active also at full saturation like in aquatic environments (Eaton and Hale, 1993), erosion bacteria are the only degrader known to be active in fully saturated and anoxic conditions. Groundwater level also directly relates to soil oxygen content, as each pore space in the soil which is filled with water reduces the contact with air (fig. 7). In waterlogged conditions, i.e., soils which are fully saturated by water, gaseous oxygen is depleted rapidly.

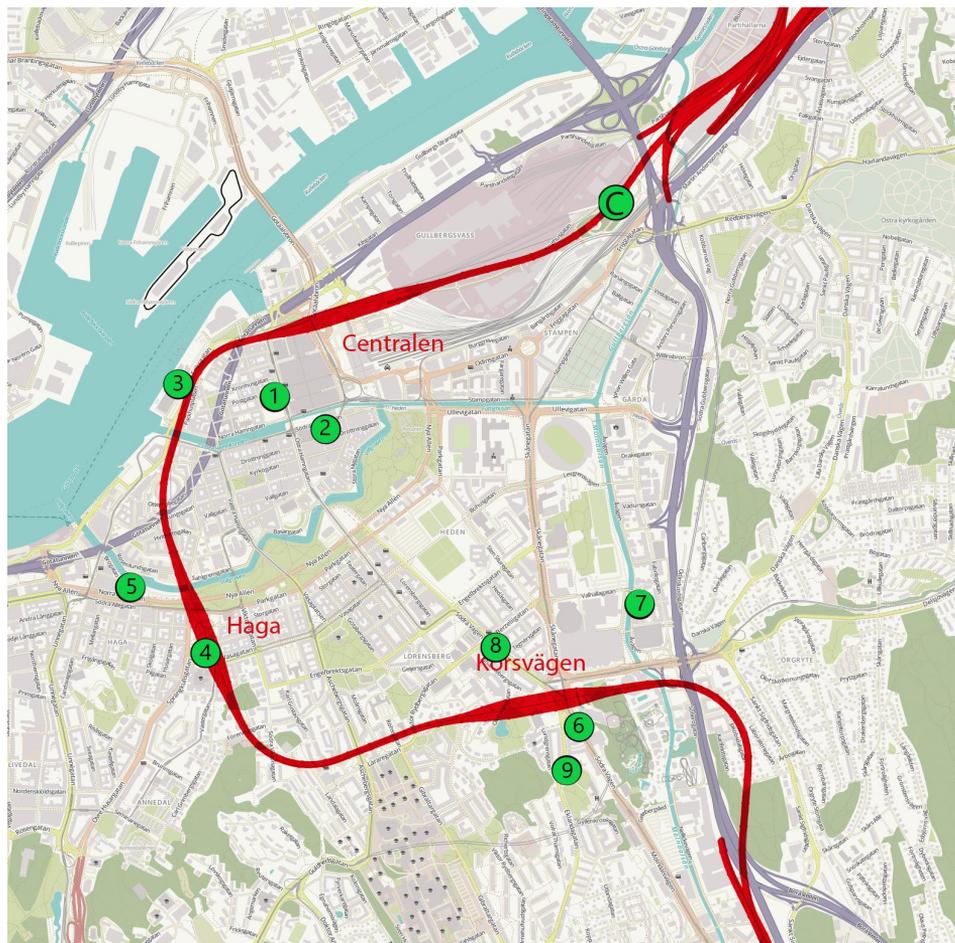
Figure 8. Map of central Gothenburg where field sites with historic foundations are shown (1-9), as well as ongoing construction for the West Link tunnel project (marked in red) and site for clay sampling for laboratory study (C).

Via the Swedish Transport Administration, access was granted to nine sites with historic foundations in central Gothenburg, as well as to a site of clay sampling for laboratory experiments (fig. 8).

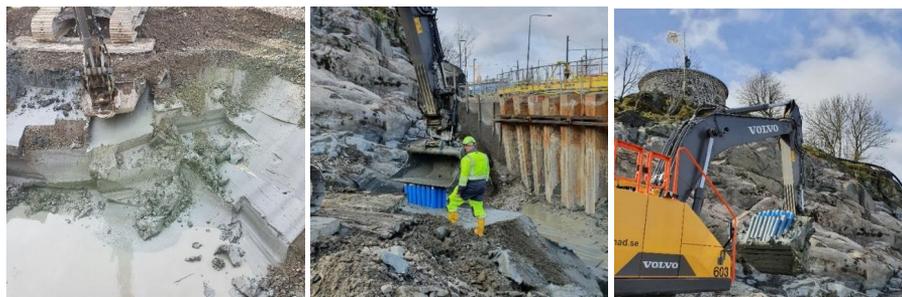
Figure 10. Left: Preparing the clay shelf. Middle: Pressing the experimental tubes into the clay. Right: Clay and tubes removed en bloc.

The site for clay sampling was accessed in April 2020. A horizontal clay shelf was prepared at the edge of the dig site pit and the experimental tubes pressed vertically into the soil to preserve the natural layering and structure in the clay soil (fig. 10).

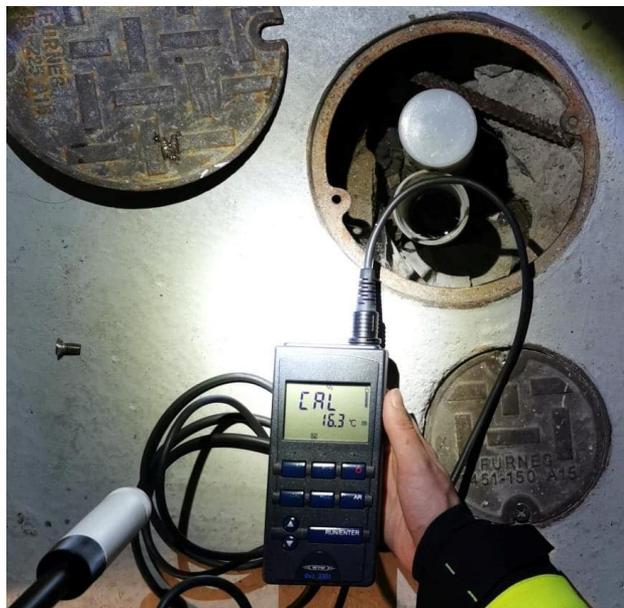
Figure 11: Size and accessibility of two monitoring dipwells through the concrete floor in the basement of field site Södra Vägen 65 (white plastic tubes, top right corner of photograph). The top dipwell is covered with a lid as it contains the exposed wood samples, the lower dipwell is temporarily opened for active monitoring of oxygen. Hand and calibrating instrument are shown for scale.

Each field site was thoroughly examined in terms of soil and pore water parameters by accredited laboratories prior to start of the long-term field study. Based on these data (for details see Paper II) and which parameters were proved most useful in environmental monitoring at archaeological sites (Caple, 1994, 2004; Caple et al., 1996; de Beer et al., 2012; Gregory, 2002; Gregory et al., 2008; Gregory and Matthiesen, 2012; Hollesen and Matthiesen, 2015; Huisman et al., 2008a; Huisman et al., 2008b; Klaassen, 2005; Matthiesen, 2007; Matthiesen, 2008; Matthiesen et al., 2008; Matthiesen et al., 2004; Matthiesen and Hollesen, 2012a; Matthiesen et al., 2016) according to the literature review (Paper I), the focus lay on groundwater level, redox potential and oxygen content for the long-term monitoring of the field sites and laboratory setups. The same hand-held instrument was used for monitoring redox potential in both field and lab settings (Mettler Toledo Seven2Go pH meter S2) equipped with redox probes using platinum ring indicators (Mettler Toledo InLab ORP Redox combined electrode and PaleoTerra custom Pt. redox probes respectively).

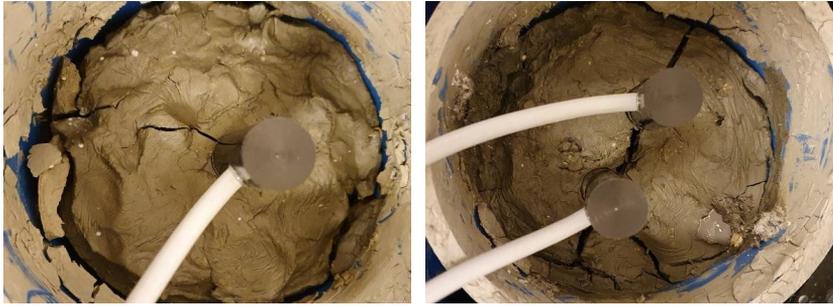
Figure 12. Redox probes installed in experimental tubes for regular monitoring throughout the experiment, one per treatment (left) and with a duplicate in T2 (right).

Oxygen measurements proved to be somewhat unreliable in the field experiment (Paper III) and obtaining instrumentation that would work in the designed laboratory setting was problematic: installing large oxygen optodes without disturbing the natural layering of the clay, creating air pockets or harming the sensitive instrument seemed unnecessarily difficult. Thus, one special redox probe designed for long-term use in natural soils was installed in one separate tube per container to limit disruptions in the soil due to measurements, and in one tube duplicates were inserted to check accuracy (fig. 12).
