END-OF-LIFE FOR A QUARRY, WHAT IS THE ENVIRONMENTAL IMPACT?

Kimia Golamian Yosaf Abadi

Degree project for Master of Science (120 hcr) with a major in Environmental Science

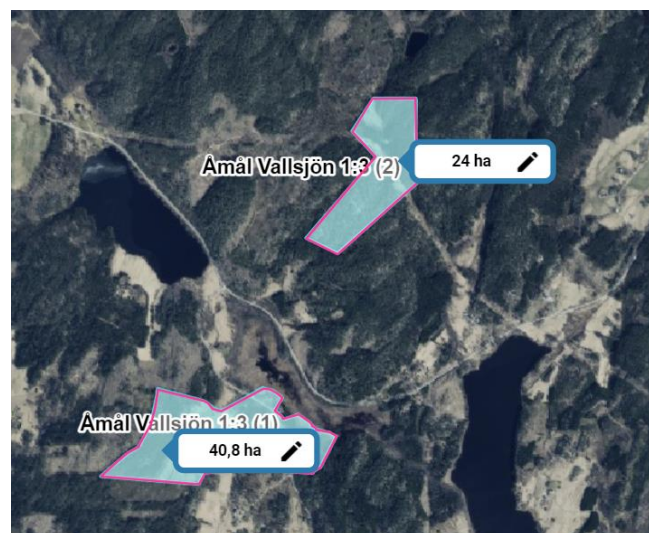
For measurement, first, the whole area of each polygon was measured with the measurement tool provided in Lantmäteriet to get the size of the total area. These total areas were divided into several classifications of land use to be measured. After that, the total size of the restoration outcome was calculated by summing each category in the land cover classification. The reason was to assess variance of the total size of polygon area and total restoration outcome to estimate the margin of error. For estimating the margin of error, the t-test data analysis was done in the Excel sheet to check the significant differences between the two items. The data relating to the measurement of total area and total outcome is shown in Table 5 in the Appendix section. The example of measurement related to total area was revealed in Figure 2.

Figure 2- A measured polygon of quarry closure located in Åmål (Vallsjön 1:3)

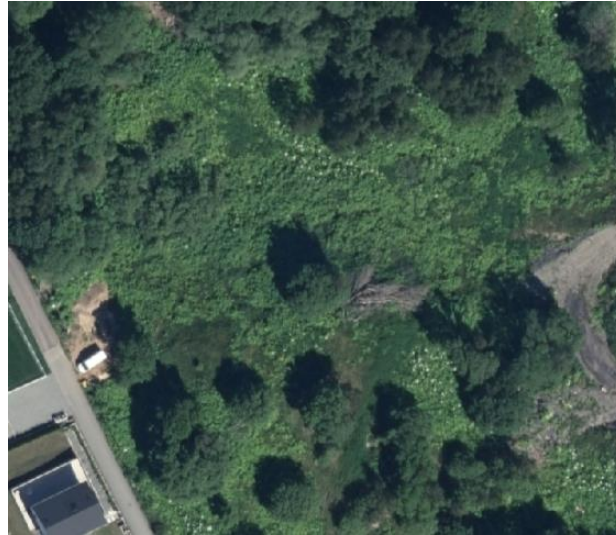
Figure 3- The mixed vegetation category, Polygon: *Angered 2:22*

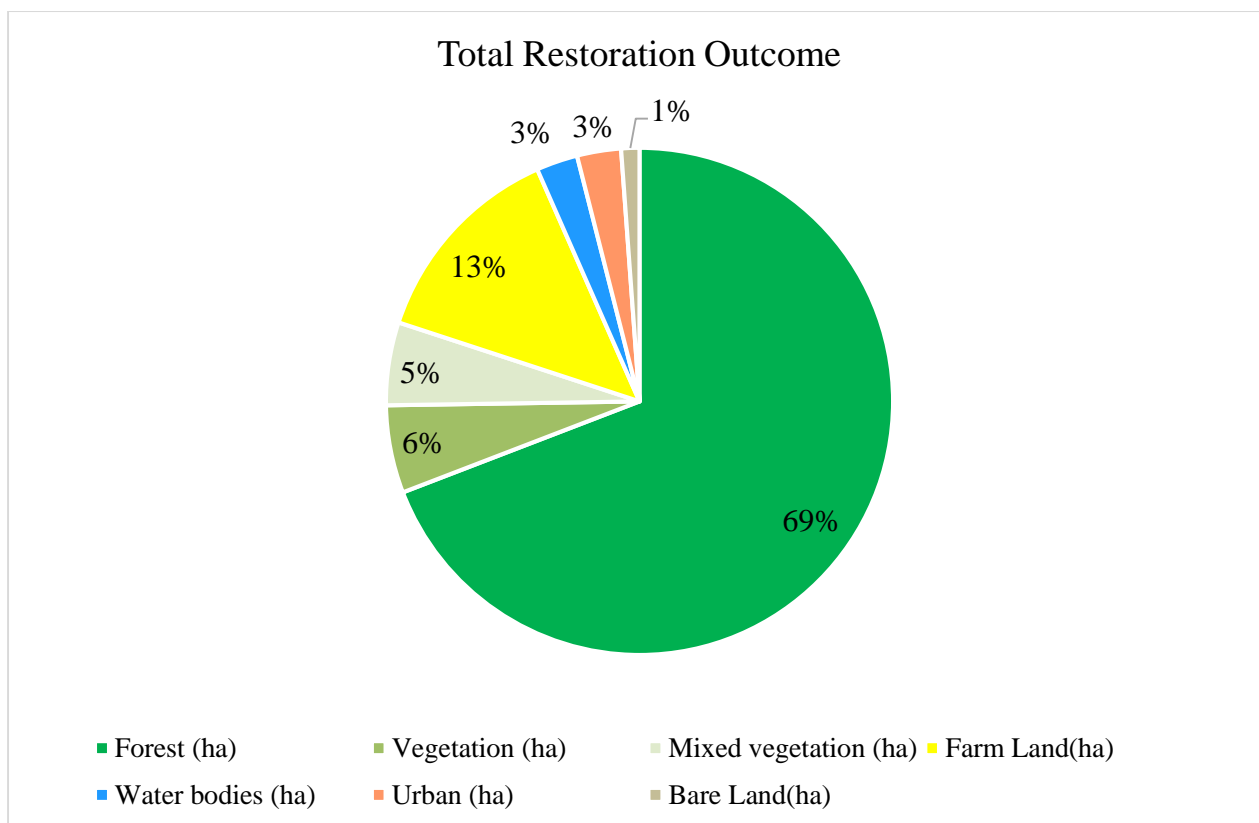
The measurement of restoration related to old quarries in the classification was investigated. The result of the total restoration outcome illustrates in Figure 6. A high proportion is allocated to the forest category, in which 69 percent of the land area was converted to forest amongst 129 closed quarries. The farmland possesses the second rank occupying 13 percent of the pie chart; moreover, the vegetation and mixed vegetation are 6 and 5 percent respectively. Obviously, the lowest percentage of the figure (7%) is composed of barren ground, metropolitan areas, and aquatic bodies.

Figure 6- The result of total restoration outcome in nine municipalities

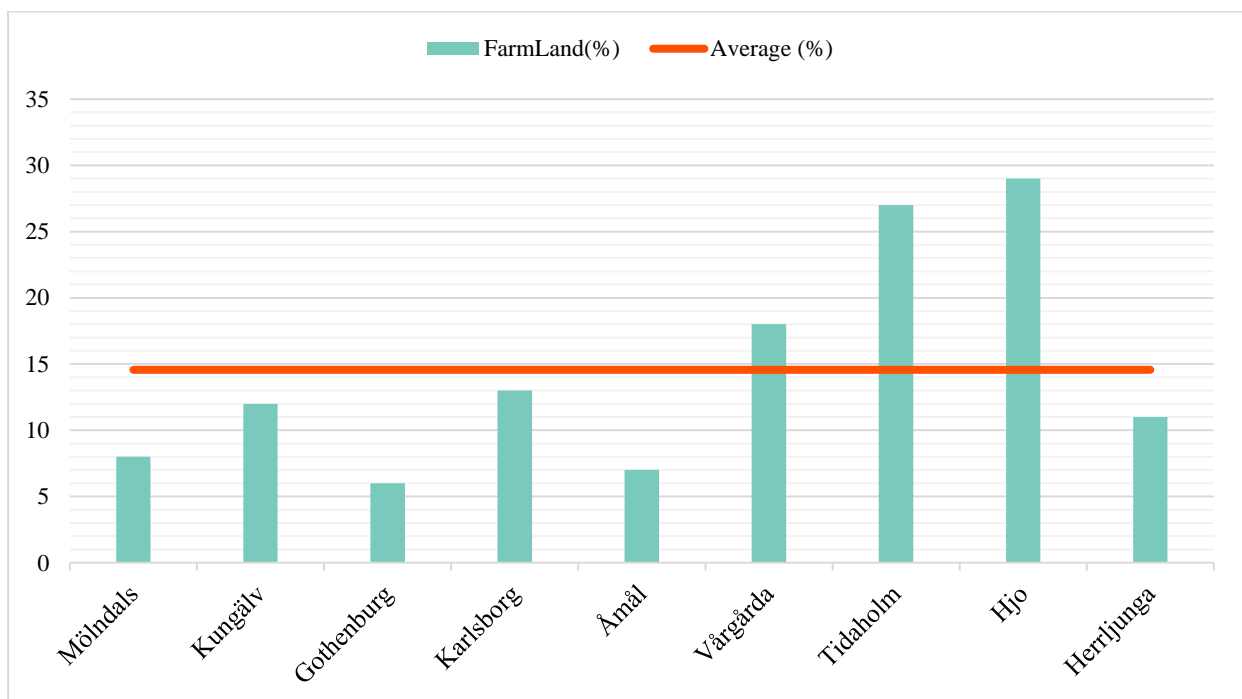
The information on the results of farmland restoration is depicted in the following Figure (10). It is apparent that Hjo has the highest percentage among the others, close to 30%, and Tidaholm is in second place with 29%. Other municipality's measurement results, with the exception of Vårgårda, are below average with a varying trend.

Figure 10- The Farmland restoration outcome in nine municipalities

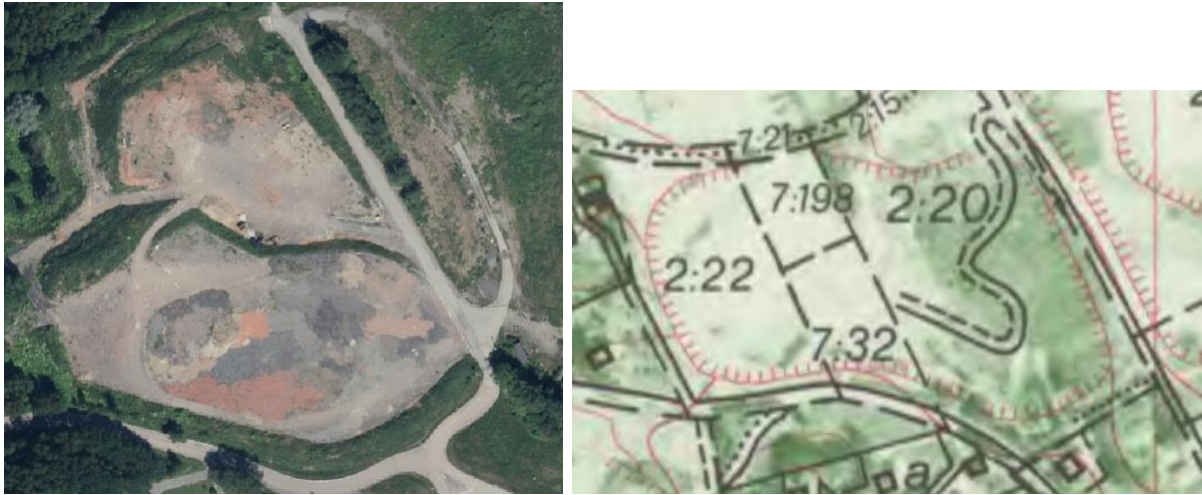
In addition, obtaining the permits of the evaluated quarries from the County Administrative Board was sought after data categorization analysis in order to assess the restoration outcomes and compare them to the actual restoration mentioned in the permit. Despite the existence of the permits, they are not currently available. Only four permits related to the quarries Angered 2:20 (Gothenburg), Hjällbo 117:4 (Gothenburg), Ryr 1:1 (Kungälv), and Ålgårdsbacka 1:12 (Mölndals) were received. In addition, the years of completing the closure of the quarries Kockhed 1:5, Maggered 1:3, Angered 7:195, and Angered 7:187 (Gothenburg) were also given by the County Administrative Board. The previous permits were investigated, except Angered 2:20, the restoration plan was not described in the document. In the permits of Angered 2:20 which it was expired in 1978, according to the forest protection organization, this area was suitable for the forest. However, in the current situation restoring the forest was not observed. Figure 14 shows the location of these abandoned quarries.

Figure 14- Quarry closure - *Angered 2:20* (current- 1976)

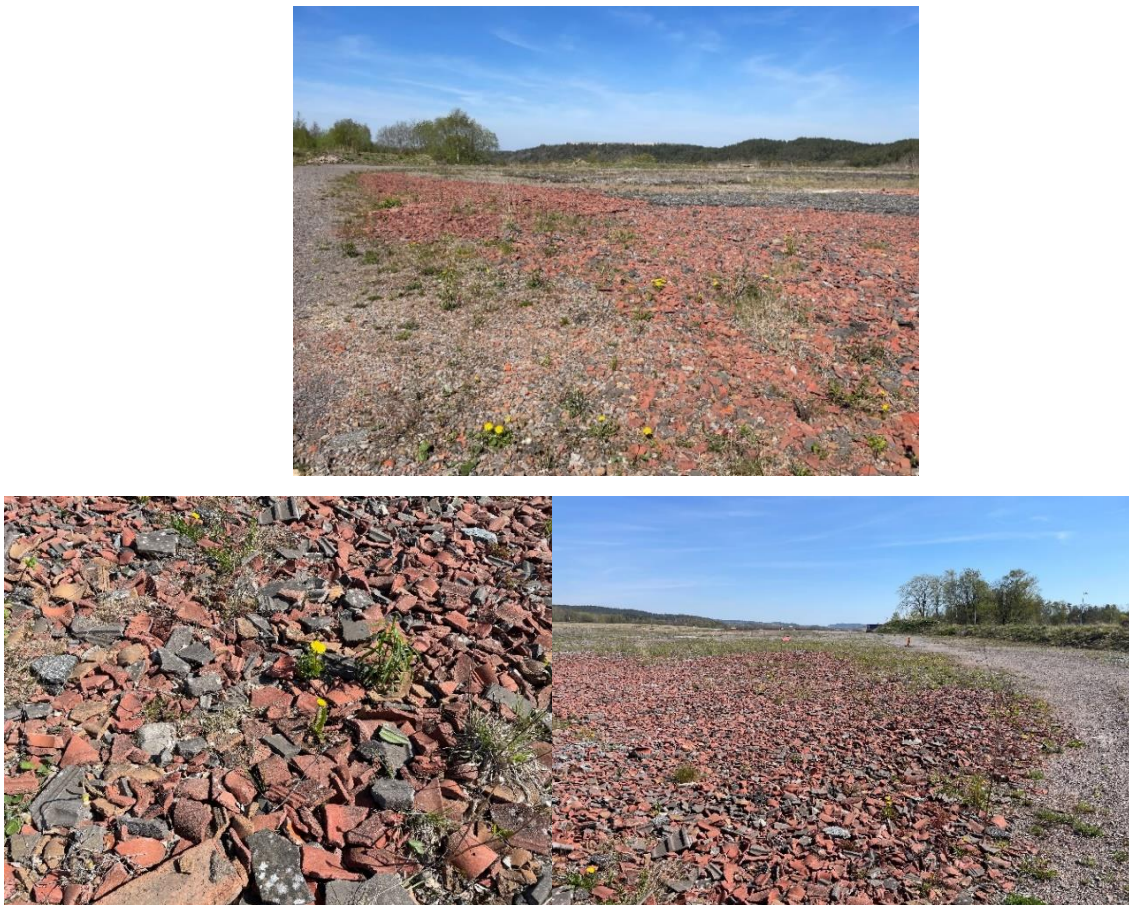
Therefore, the closed quarry located in Angered 2:20 was visited to check the current situation of this location. There were no differences between the satellite image and the actual land area. Forest, vegetation, residential area, and roads were observed in the neighborhood. The quarry was surrounded by vegetation, trees, and roads. Two butterflies were observed flying around the location and some plants were grown in the gravel land sparsely. Some parts of this quarry seem to be used as a road and discarded the building materials which Figure 15 was shown the location of this quarry.

Figure 15- The current land situation of Angered 2:20

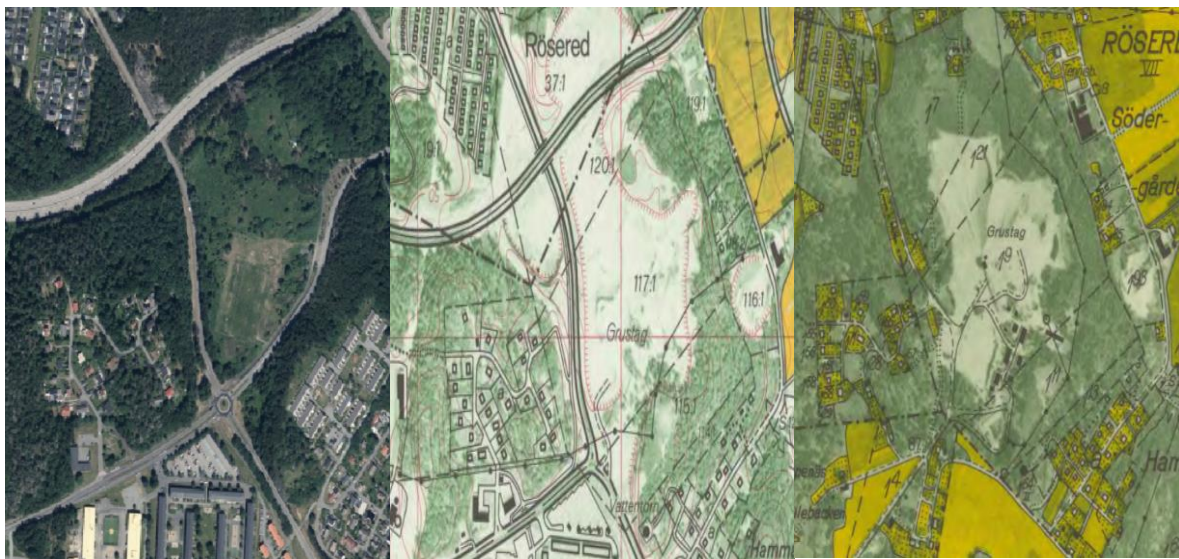
On the other hand, the historical maps were reviewed to analyze the previous condition of the land before starting the quarries and the current condition after restoration (Kockhed 1:5, Maggered 1:3, Angered 7:195, Angered 2:20, Ryr 1:1, Ålgårdsbacka 1:12). The historical maps of Lantmäteriet regarding the versions of 1950, 1964 and 1976 were observed. The maps related to 1950 were not readable, since there were not any keys or information in the maps to distinguish the classification in the map. Since Kockhed 1:5, and Maggered 1:3, were completed before 1964, the former condition was not obvious in the historical map. According to the maps, for other closed quarries, it seems that there are not great differences between the two circumstances. Only in some cases, the road and urban area have increased and this situation means that current areas are close to the original nature and land use. Hjällbo 117:4 in both maps was in the progress of aggregate quarries.

Figure 16- Hjällbo 117:4 in the three different periods (current- 1976- 1964)

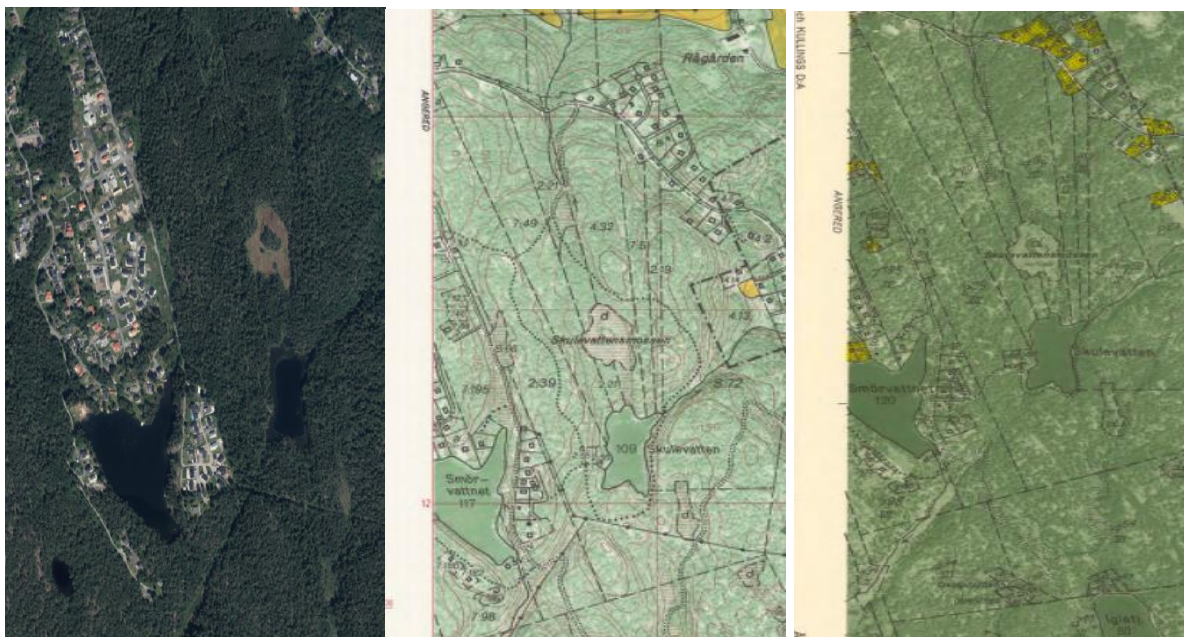
Figure 17- Angered 7:195 in the three different periods (current- 1976- 1964)

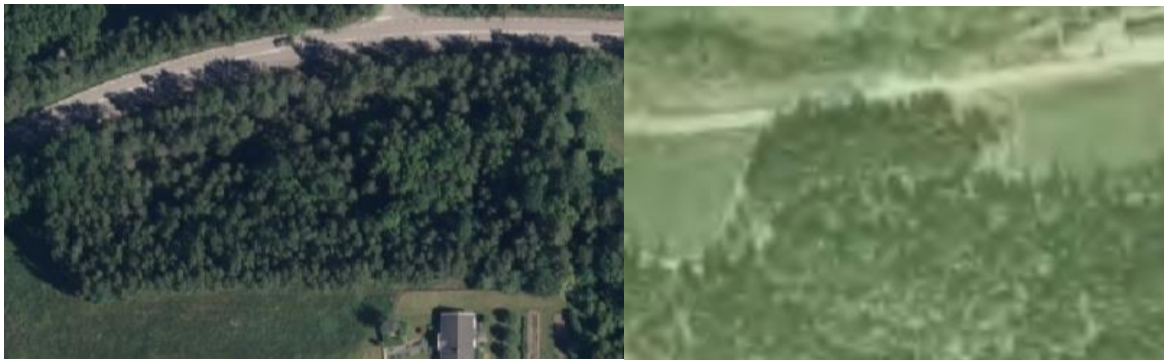
Figure 19- Ålgårdsbacka 1:12 in the two different periods (current – 1963)

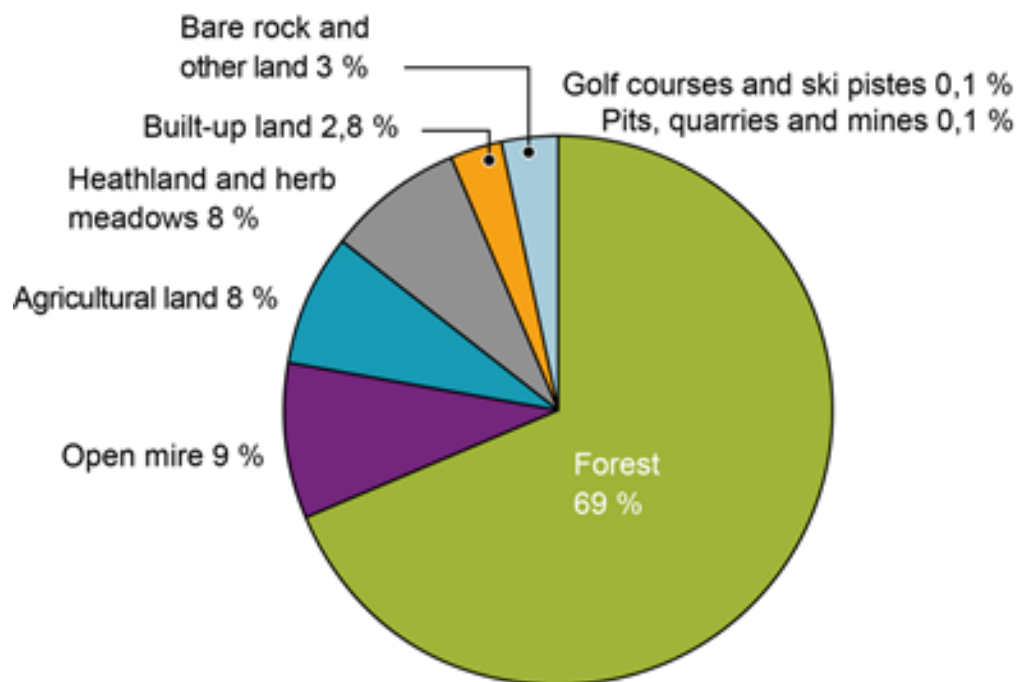
Figure 20- Total Landuse Classification in Sweden in 2010 (SCB,2013)
