MASS MOVEMENTS IN SVALBARD: A STUDY OF IMPACT ON INFRASTRUCTURE IN THE LONGYEAR VALLEY

Degree project for Bachelor of Science with a major in Geography
2023, 180 HEC
First Cycle
B1276

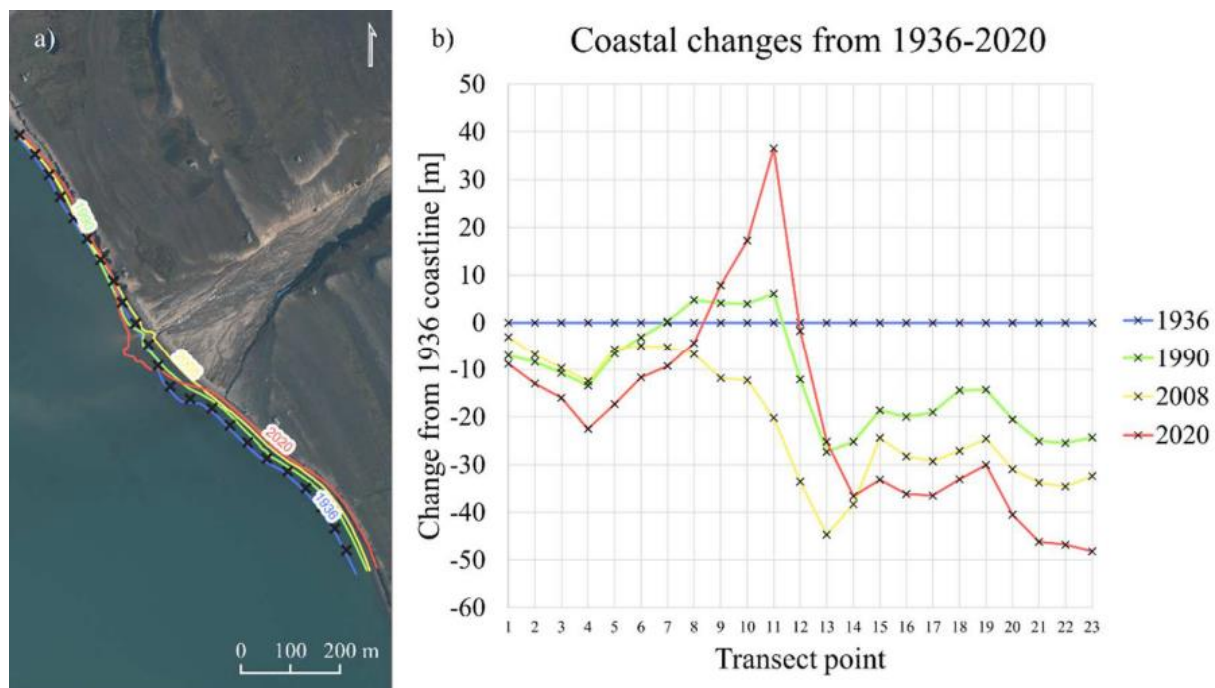
Figure 2: a), an orthophoto (2013) of Hanaskogdalen's coast and the mapped coastlines with the respective year as a label. b), coastal propagation and retreat [m] at one transect point (x-axis) by 1990, 2008, and 2020 with respect to the coastline of 1936. Point 1 marks the northernmost transect and point 23 is the southernmost transect point. Cited from source: Ellermann (2023).

The coastline can also be compared to Hanaskogdalen due to the geomorphological similarities between the two areas. It can be observed that the coastline in Hanaskogdalen shows stronger signs of retreat compared to the Longyear Valley. However, the human activity in Longyearbyen extends to the harbour area and the effect this has on the coastline could influence how it shapes and where sedimentation spreads alongside the coast.

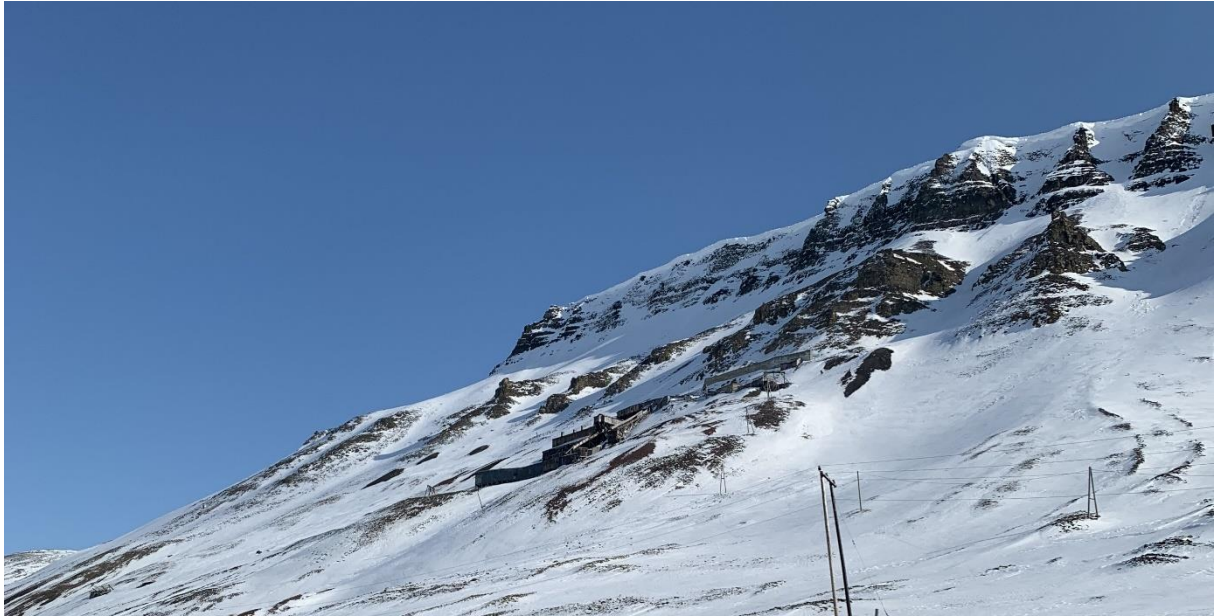
Figure 3. Accumulation of cornices on the eastern side of the Longyear Valley. Photographed 02.05.2023.
Source: Authors' own (2023).

Another concern that has been a known occurrence is cornice fall avalanches, as they are known to erode the plateau edge that has been weathered by ice segregation. Either this allows the rock to be brought down with the snow, by collapsing cornices or cornice fall avalanches, as the weathered sediment is mechanically plucked from the ridge. This counts as a type of avalanche sedimentation, where the rock debris is being deposited onto and forming avalanche plains. The formation process is important to understand as certain houses in Nybyen, located further into the Longyear Valley, are located on an avalanche plain. Cornices form on the lee side of the eastern side of the valley due to the southeasterly winds and heavy precipitation in the form of snow, as can be seen in Figure 3. With climate change, which may bring changes to wind, melting, and precipitation patterns, the direction of avalanche sedimentation will also change. This may lead to changes not only in how it is deposited in the areas already affected by this kind of sedimentation, but also in where they may occur overall (Eckerstorfer et al., 2013).

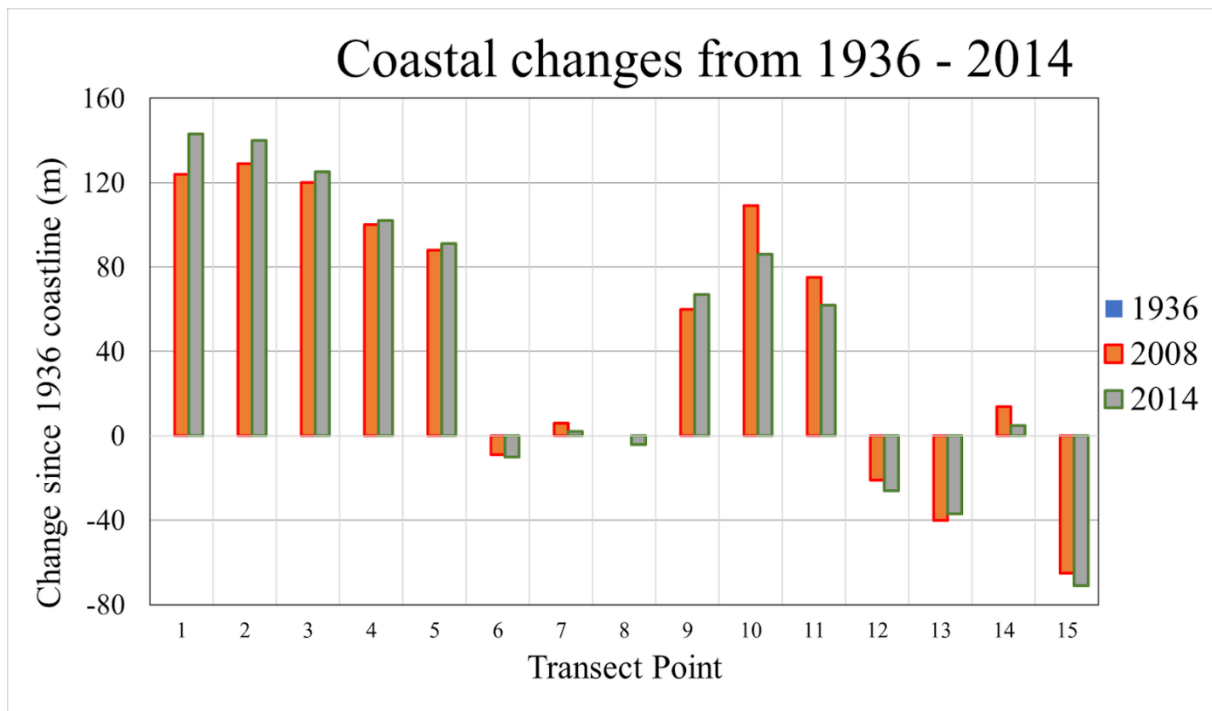
Figure 8. An orthophoto on Longyearbyen in 2014 and its coast, mapped out with respective years as a label, along with the results of each transect point and the coastal propagation and retreat (m) in 2008 and 2014, with 1936 as a baseline. Source: Authors' own (2023.) Data source: Geyman et al. (2021), NPI, Hauber et al. (2011).

Regarding the coastline, there are clear variations from 1936 up to 2014. For a large portion of the coastline, starting from the western side, a clear and pronounced transgression into Adventfjorden can be observed in Figure 8.

Beginning from *Transect 1*, going from left to right, where the strongest positive trend can be observed in both 2008 and 2014, the positive trend becomes less pronounced until *Transects 6-8*, which is located where the Longyear River connects to Adventfjorden. As *Transects 1-5* are located where most of the harbour activity takes place in Longyearbyen, the noticeable increase which appears to be a positive trend between the recorded years can be attributed to a combination of sediment transportation and accumulation, in combination with further harbour activity.

This positive trend continues between *Transects 9-11*, but there are signs of erosion between 2008 and 2014 as the positive values decrease between the timespan, along with a general negative trend forming between *Transects 12-15*, suggesting that sediment accumulation largely travels alongside the western side of the Longyear Valley while erosion has a stronger effect on the eastern coastline. This is consistent with the stronger harbour activity as noted before.

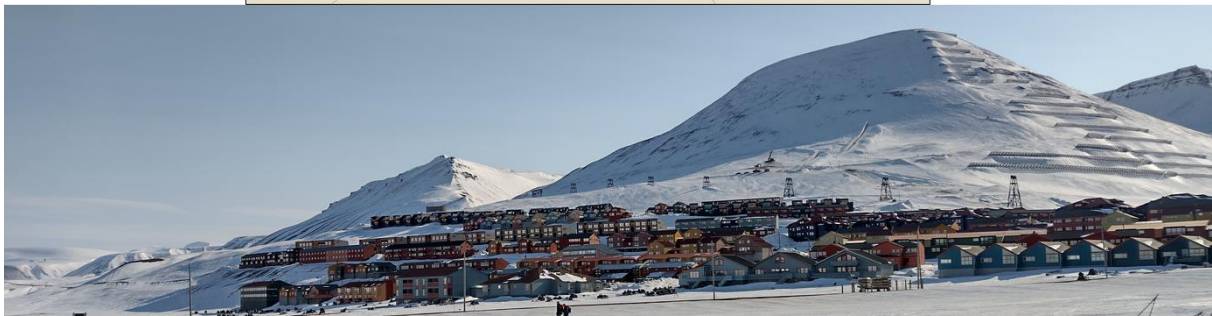
Figure 11. Ground truth image taken of the northeastern region of Longyearbyen. Data: Authors' own (2023).
Data source: NPI, own data (2023).

To further investigate areas of interest, ground truth pictures were taken at areas of interest to produce an accurate understanding of Longyearbyen today. Figure 11 details Gruvedalen where a large portion of the town's residents live today.

Buildings and structures appear to be largely intact and plots for further densification could be observed. Construction work was also apparent in the centre of town, where residential areas for research students and tourists are heavily located, as shown in Figure 12. Further town densification appeared to be located and scheduled within this portion of Longyearbyen, which has a lower risk of being affected by geological activity.

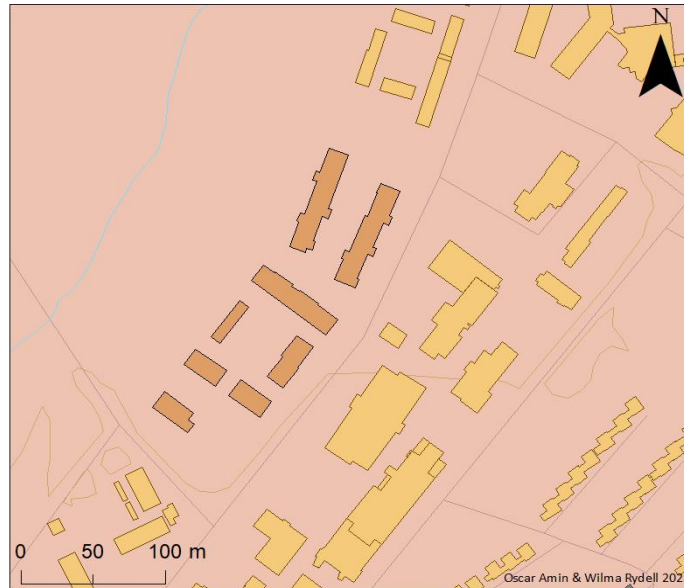
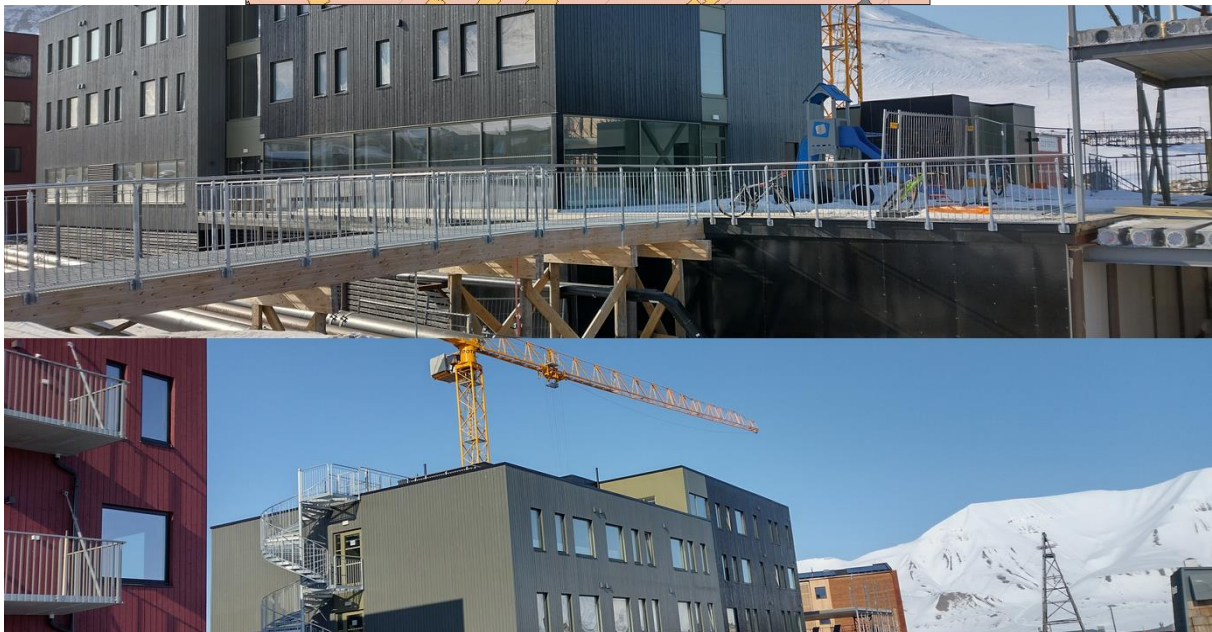
Figure 12. Ground truth image taken of the construction work in the centre of Longyearbyen. Data: Authors' own (2023). Data source: NPI, own data (2023).

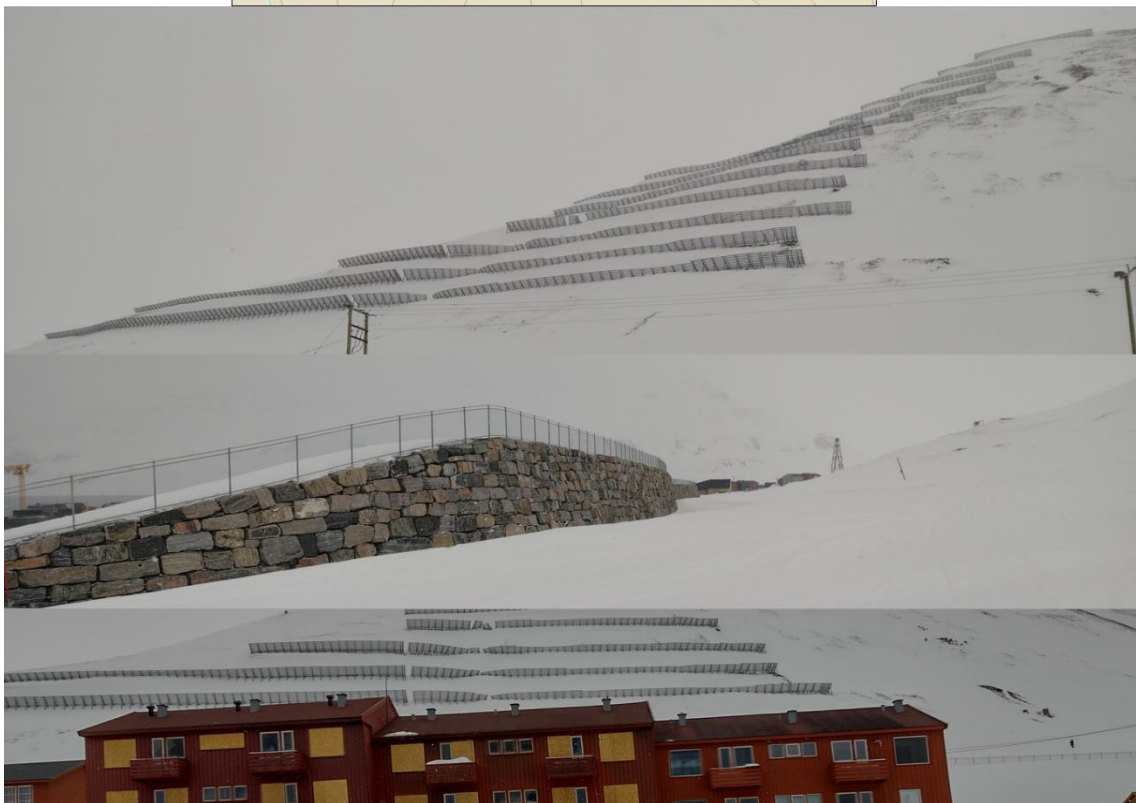
Figure 13. Ground truth image taken of the abandoned buildings and avalanche protection structures in the eastern part of Longyearbyen. Data: Authors' own (2023). Data source: NPI, own data (2023).

The section of Longyearbyen where previous avalanches have taken place was observed to have demolished buildings, and appeared abandoned in some way, shown in Figure 13. In addition, multiple rows of fences had been placed across the hill in sets of rows, with observed collections of snow having formed on each row. These are a continuous project set to hinder snow avalanches, as each row slows down the accumulation of snow and hinders the ability for avalanches to drag down enough material to present a danger.

In case these fail or in the case of a slush or debris flow, a stone wall up to 5 meters high and 200 meters wide has been constructed, running across the residential buildings closest to the existing area previously affected in 2015 and 2017.
