Change Analysis of the Stenungsund Landslide Using UAV and Airborne LiDAR Data

Degree project for Bachelor of Science with a major in Earth Sciences

2024, 180 HEC

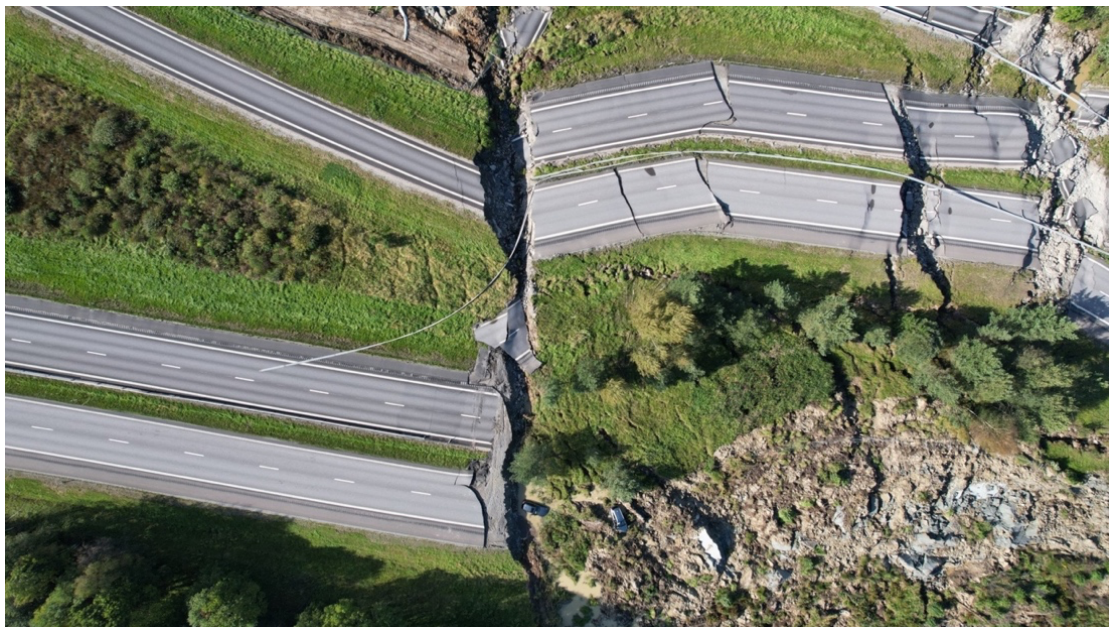
Figure 1 An UAV-image showing how the landslides has dislocated the highway E6 from its original place (Länsstyrelsen, n.d).

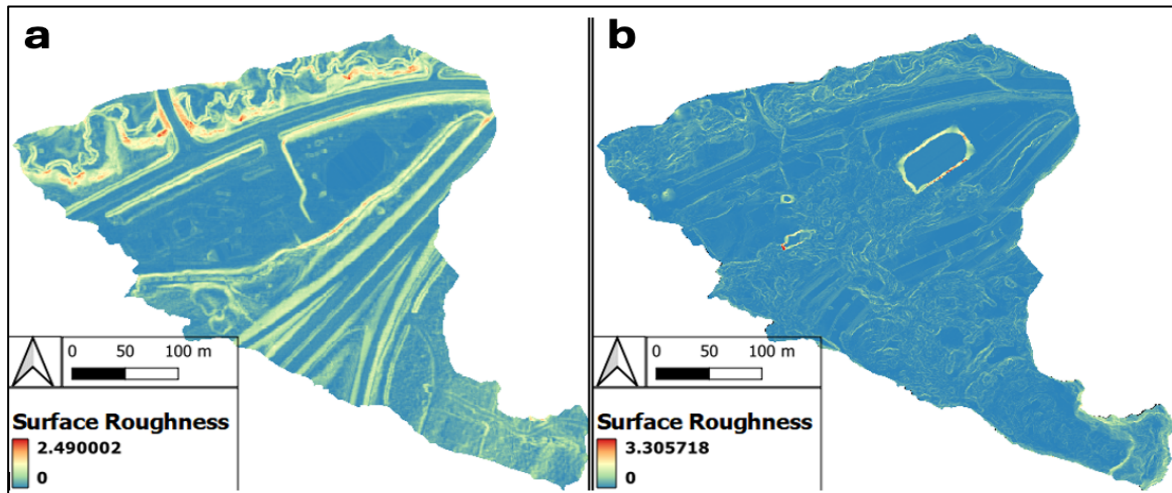
Figure 10 Degree of irregularity on the surface (roughness). a) pre-data. b) Post-data. The pre-data has overall higher values compared to the post-data, but the post-data has the highest max value.

There is no significant difference of the surface roughness between the pre- and post-data (figure 9) indicated by the surface roughness values. The pre-data (figure 10.a) has however values that fluctuate more compared to the post-data (figure 9.b), and in the northwestern part it has also significant higher values. The post-data has more even values, but it is still clear where the surface is either disturbed or intact, with yellow and red areas indicating higher surface roughness (figure 10.b)

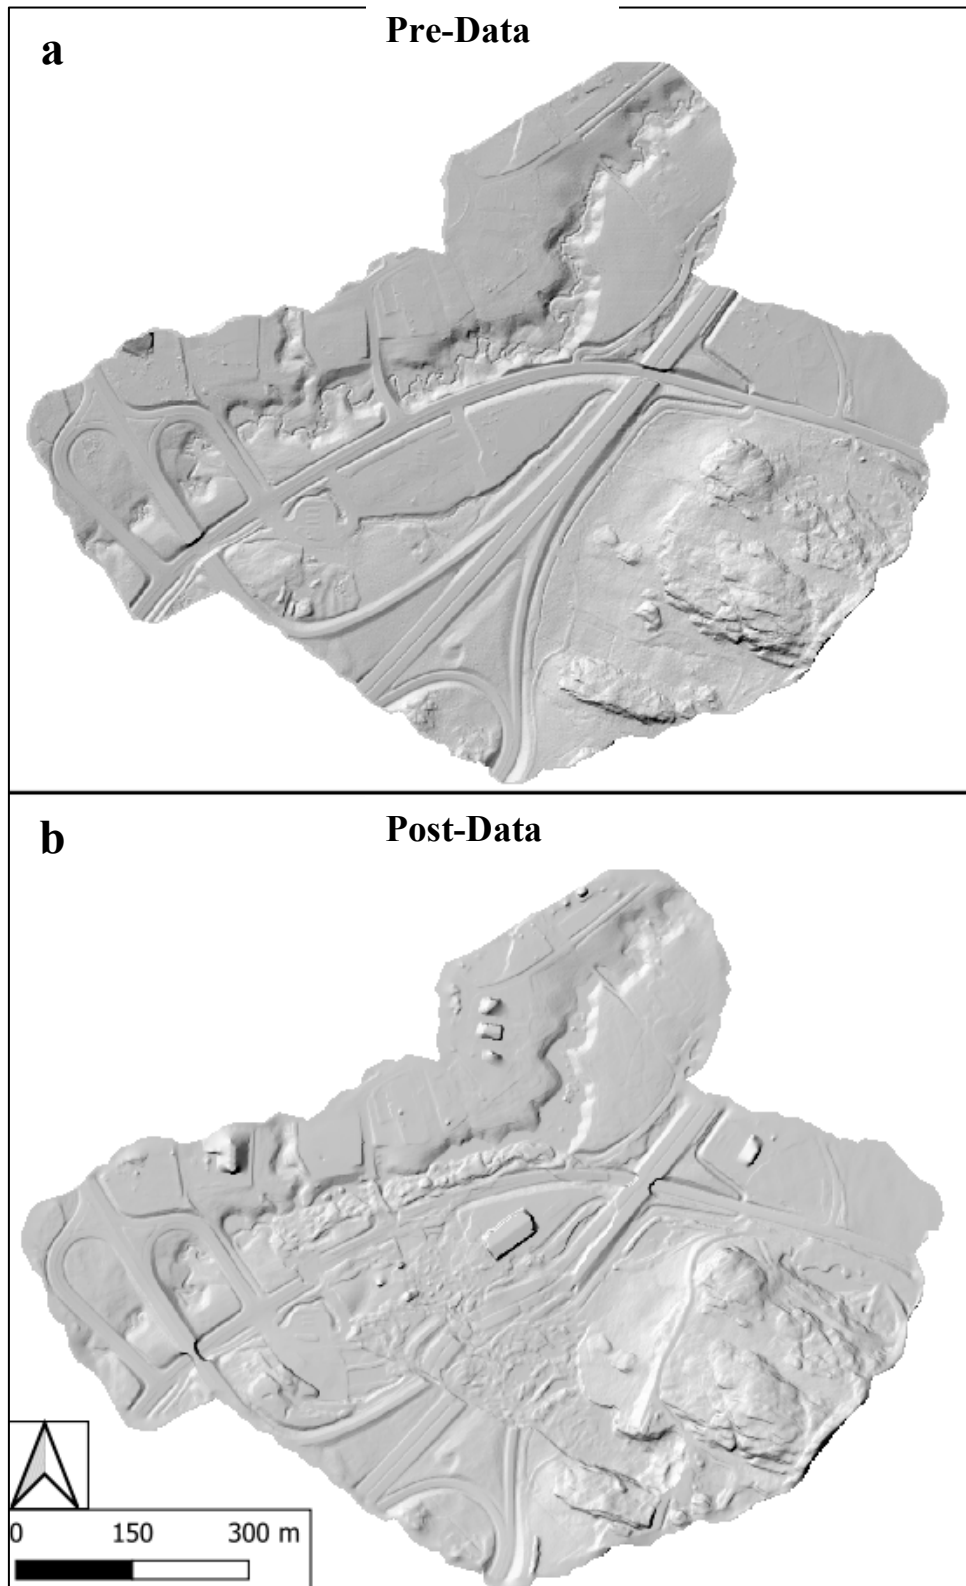
Figure 12 DTM-derived 1m resolution hillshades. a) Pre-data that shows the intact highway and its direction. b) Post-data that shows the scar of the landslide and how it has dislocated the highway and effected the area

The hillshades (figure 12) indicate how the landslides have massively changed the surface and have caused great damage, not only the highway in the center but also the small river that has been clogged from the accumulated material (figure 12.b). The scar also shows the extent of the landslide having a southeast to northwest direction. in the upper part of the slope (southeast) the landslide has a bottle shaped scar that widens out down the slope towards the northwest.

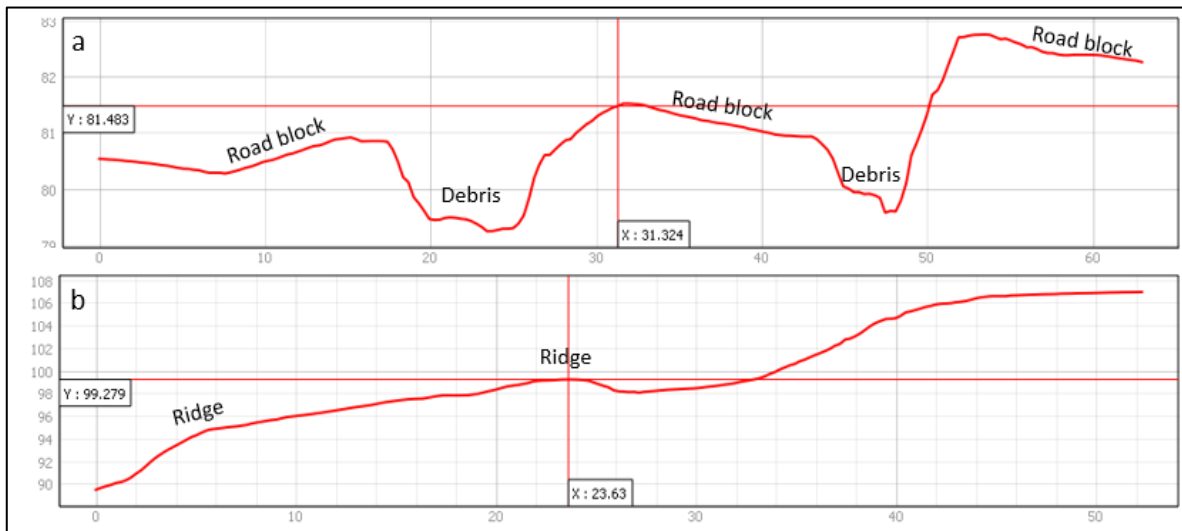
Figure 15 Graphs containing profiles from two sections. X-axis is distance (m) and y-axis is MASL a) Profile parallel to Highway which have great elevation change as a results from the cracks and dislocation of the highway. b) Profile of the upper part parallel to the landslide with two ridges that indicate a waveformed structure.

Figure 14 and 15 highlights two areas of the landslides: figure 14.a that shows how the vector displacement and cracks are distributed along the highway; and figure 14.b that shows the perpendicular ridges in the upper part of the landslide, close to the main scarp. These figures have a profile a and b that is illustrated in figure 15.

There is large number of cracks located on the highway and are parallel to the movement of the displacement (figure 14.a). As seen in profile a in figure 15.a, four cracks are significant bigger compared to the rest and there are the two main entrances where debris has dislocated and passed the highway. The cracks show elevation change of up to three meters (figure 15.a). As mentioned in figure 13, there is two main directions of the displacement indicated by the two vectors in the southern (figure 15.a). These directions correlate with the form of the scar which has a straight southern flank scarp but a bending northern flank scarp (figure 13).

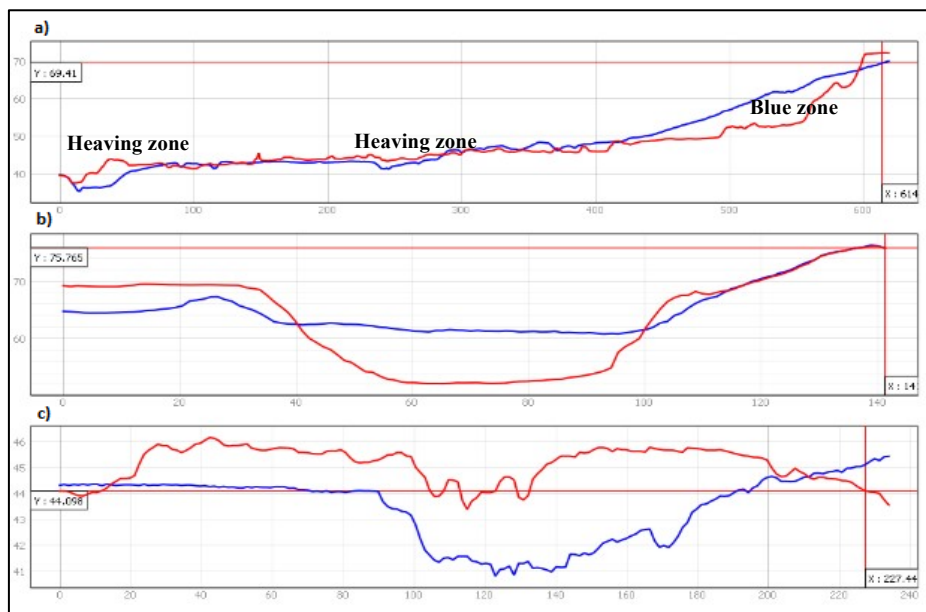
Figure 17 The graphs represent profiles of DoD (m) between pre-data (blue) and post-data (red). a) Profile parallel to the landslide movement b) Profile perpendicular to the landslide movement and is located in the zone of decrease elevation, similar location to Figure 15.b. c) Profile perpendicular to the landslide movement and is located in the zone of increase elevation, similar location to figure 15.a.

When comparing the profiles between the pre- and post-data (figure 17) with the types of sensitive clay landslides illustrated by L'heureux (2012) (figure 5), it was however not as clear to interpretate. This was due to the different characteristics that were found in the results.

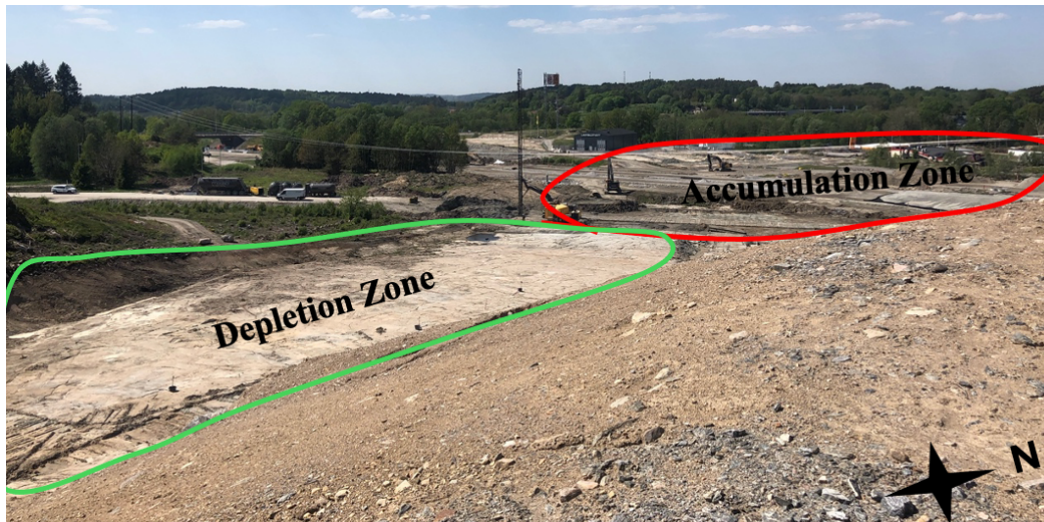
Figure 18 Photograph taken from the Northeastern part of the study area which provides a good overview.

Some of the features that were observed from the remote sensing studies were also identified in field. For example, Figure 18 which displays the two zones could be compared with the DoD change analysis (section 3.3). It is clearly visible that material has been added and compressed to the right in the upper part of the image (marked as accumulation zone). To the left of the image is a flat area that is at a lower level compared to the surrounding terrain and this is where material has been removed (marked as depletion zone) (figure 18). Figure 19 shows where the main scarp is placed but it is difficult to know if the appearance have changed since the post-data was produced. It is bottle shaped similar as the LiDAR data and it consists of loose sediments. The bedrock is however highly linked to the scarps shape as seen in the top right corner. The field observations also show the clear impact that the landslide has had on buildings, infrastructure and the nature in the study area (figure 20). The right part (figure 20) indicates how trees have been displaced and moved from its original position. This is also the case for the buildings that have been displaced in an angle and some are even covered in debris. Heaving zones was identified and one of them is placed nearby the white-red building to the right in the image (figure 20). This heaving zone is perpendicular to the movement of the landslide as previously seen from the LiDAR data.

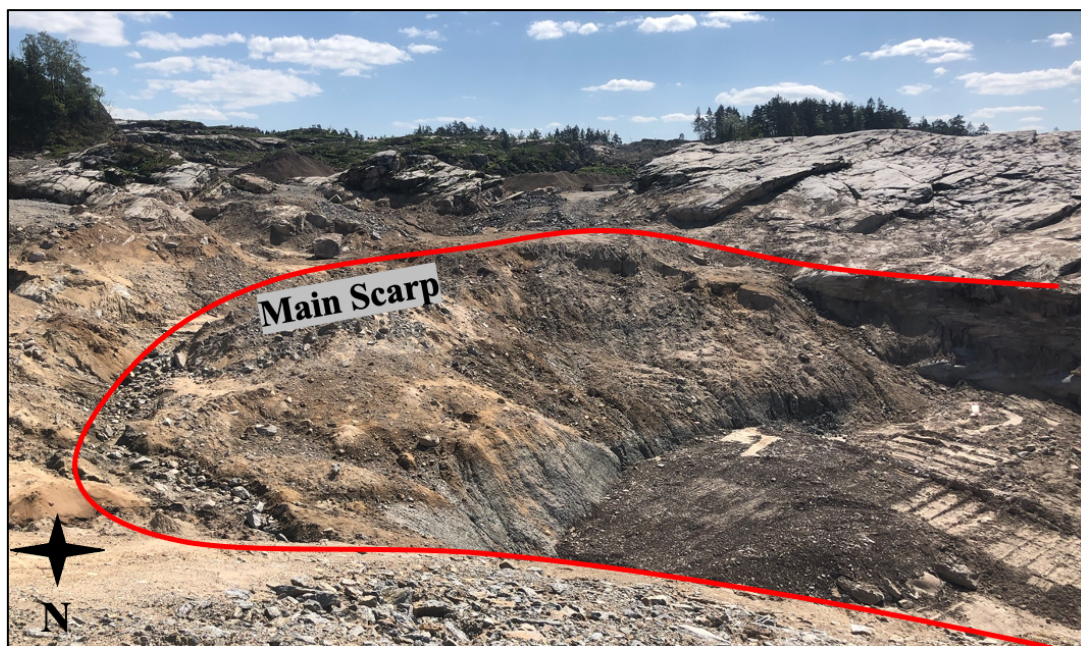
Figure 19 Photograph of the main scarp which shows that a large amount of material was removed when the landslide occurred. It also gives information about the influence that the bedrock had on the scars shape.

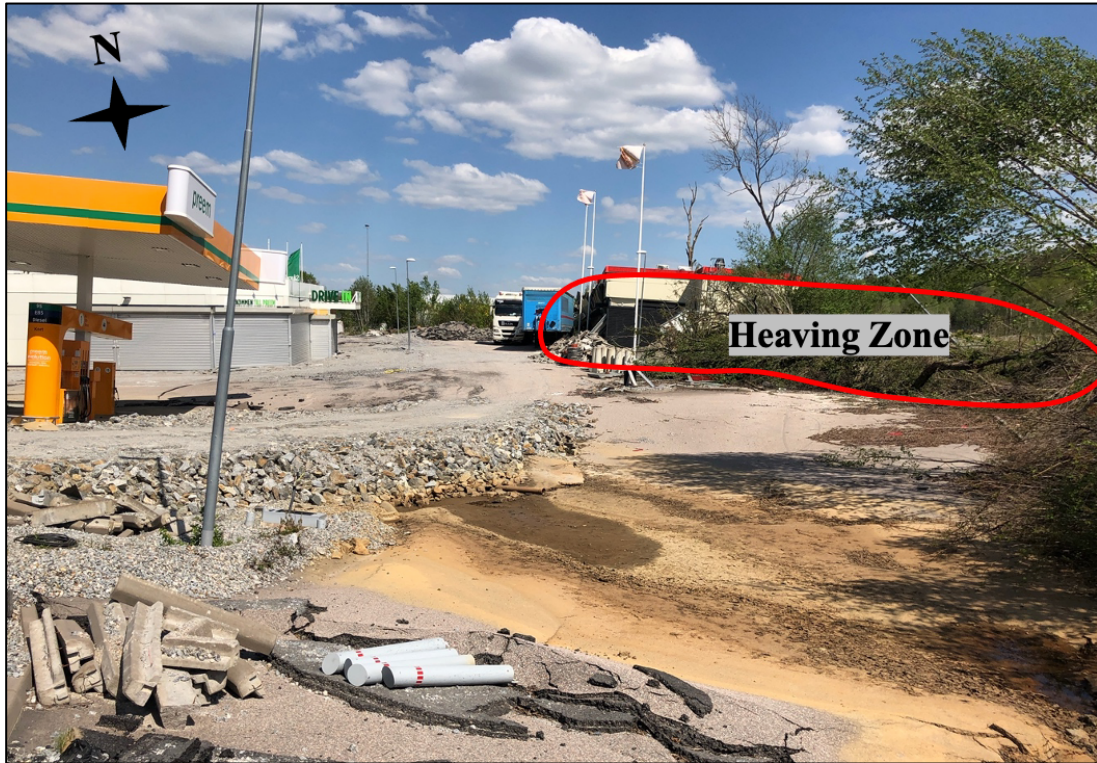
Figure 20 Photograph taken in the northwestern part of the landslide. This shows the impact that the landslide had on buildings and infrastructure. One of the heaving zones are also part of the image.

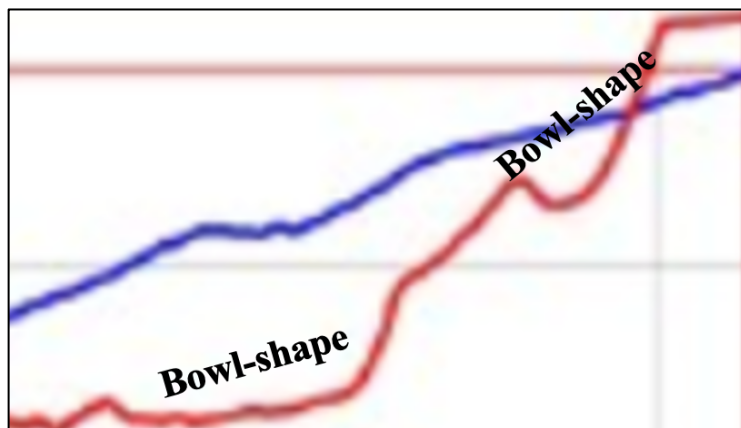
Figure 21 Bowl-shaped forms similar to rotational landslides. Zoomed in image of the parallel profile to the landslide

Firstly, the upper part of the landslide (figure 21) consisted of two repeated bowl-shaped forms with ridges indicating the boundary between them. The bowl-shaped form is normally associated with rotational landslides, the type which is not as common to be found in sensitive clays (Hungar et al., 2014). The repeated characteristics could also be scars of multiple slides which could also be an indication of a multiple retrogressive behaviour (L'heureux, 2012; Locat et al., 2011; Torrance, 2012). The accumulation zone is not completely homogeneous and has two specific areas where the heaving is more intense (figure 22). These two zones could potentially be linked to the retrogressive behaviour with multiple flows compressing the accumulation zone thus, from the interpretation, there might have been two major flows during the landslide. It should however be considered that the landslide did not likely start in the lower part of the slope which usually occurs in retrogressive conditions. Most material is transported and accumulated further down and past the slope in the accumulation zone (L'heureux, 2012; Locat et al., 2011). The ponds that were mapped gave no clear indication of the type of landslide or how it moved. But it does indicate that many pits have been created from landslide scars where water has been filled.

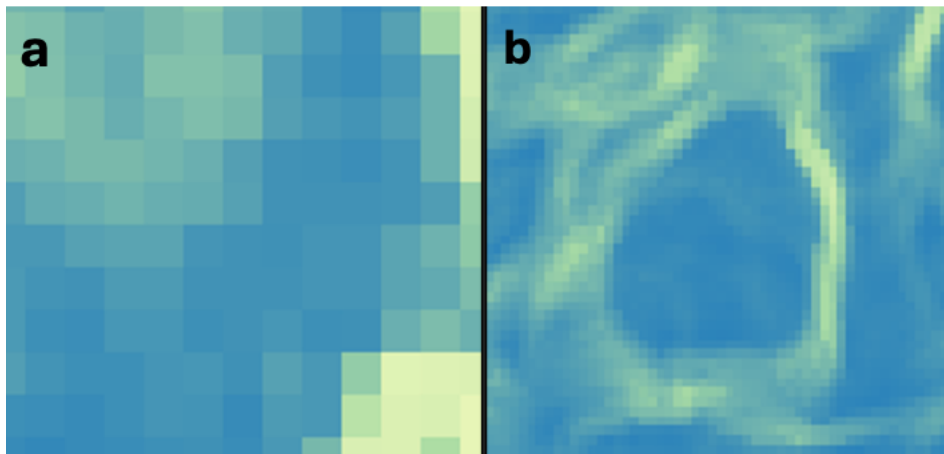
Figure 23 Comparison of resolution in the slope-model. a) Pre-data. b) Post-data.

The pre- and post-data were produced by different survey as previously mentioned, which resulted in differences in the accuracy and resolution between them. The post-data from Swedron that was captured from an UAV have considerable higher resolution of LiDAR-points compared to the aircraft survey from Lantmäteriet. The UAV-derived data was hence much more efficient to analyze which simplified the identification of morphological features (Figure 23 and 24) (Joon-Kyu et al., 2024; Zhuo et al., 2017). The DoD change analysis was first intended to use 0.25 m resolution, but due to the sparse density of the pre-data, it became distorted and less interpretable which meant that 1m resolution was used instead. From the Standard deviation between DTMs (table 3) there might however not be much of a difference in the values between the resolutions. Thus, the lower resolution has probably not affected the final result of the DoD change analysis.
