THE PAINT LOSS OF CALLMANDER'S STAINED GLASS WINDOWS

An investigation of the prevalence and causes
behind the paint loss on Callmander and Svenska
Glasmåleri AB's stained glass windows

Degree project for Master of Science with a major in Conservation
2023, 30 HEC
Second Cycle
2023/25

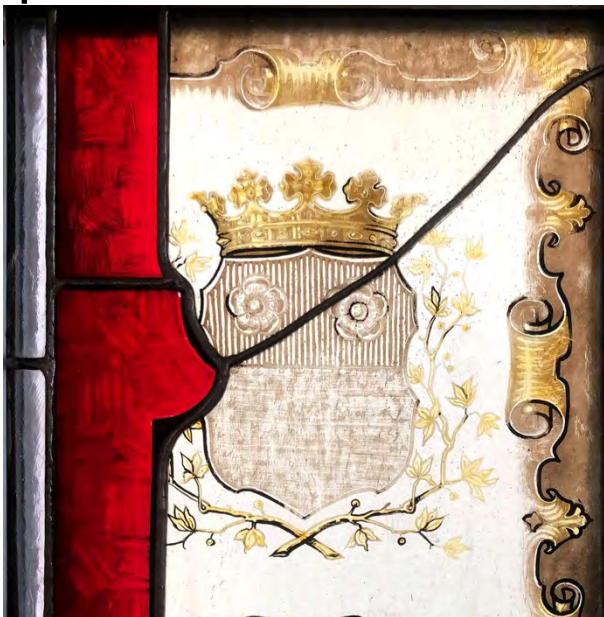
Figure 21. A panel of the red window in the church's choir with paint loss in the dark trace lines. Photo: Eisfeldt, 2022

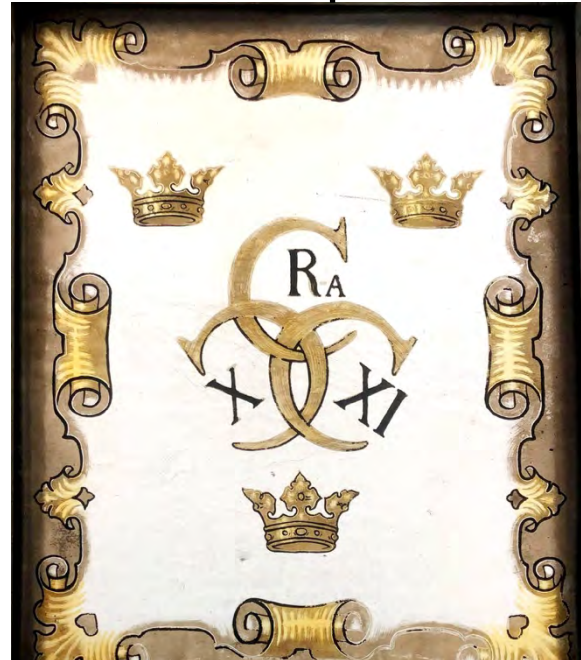
Figure 22. A panel of the red window in the church's choir. Paint loss of the dark trace line can be seen in the panel's bottom left and top right. Photo: Eisfeldt, 2022

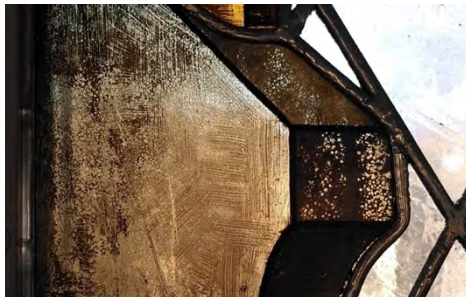
Figure 24. Photo of the window of St, Matheus showing paint loss. Photo: Eisfeldt, 2022

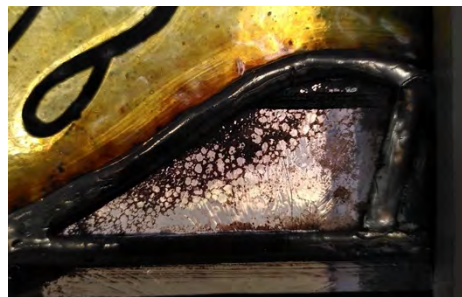
Figure 25. Photos on a second area of the window of St, Matheus showing paint loss. Photo: Eisfeldt, 2022

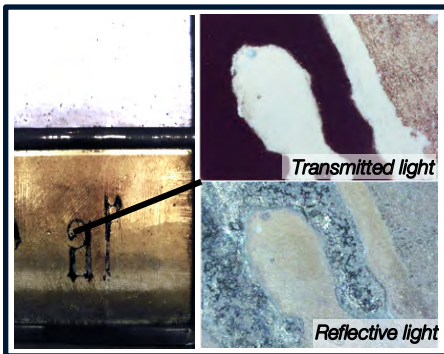
At first glance the grisaille paint appeared to be in good condition, perhaps because so many glass panels was replaced due to the explosion in year 1978. Especially for the windows near the choir, the condition was good. The bottom part of these window were situated in eye level, were only small areas of paint loss and pitting could be found, (fig 21 and 22) the upper part however could not be investigated up close. The windows in the nave showed greater signs of deterioration, possibly as they were further away from the explosion and therefore had more original glass left. For these windows especially the tracing had in places lost significant amount of paint, ranging from pinholes to entire areas of 5 x 5 cm. The characteristics of the loss was much like the paint loss of the windows in Uppsala cathedral of Callmander. With a circular pattern, possibly adhering from small pits (fig 24, 25). The loss was not uniform, and for example certain panels could have a deterioration on the upper part while the panel next to it only had deterioration on the lower. With the handheld microscope the paint appeared to be quite granular (fig 26 and 27).

Figure 26. Photos taken with hand-held microscope on Matheus showing paint loss on St Matheus. Photo: Eisfeldt, 2022

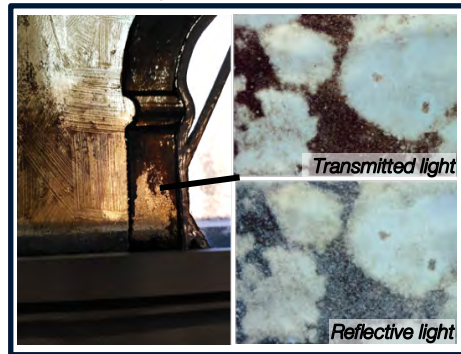
Figure 27. Photos taken with hand-held microscope on a second area of St, Matheus showing paint loss. Photo: Eisfeldt, 2022

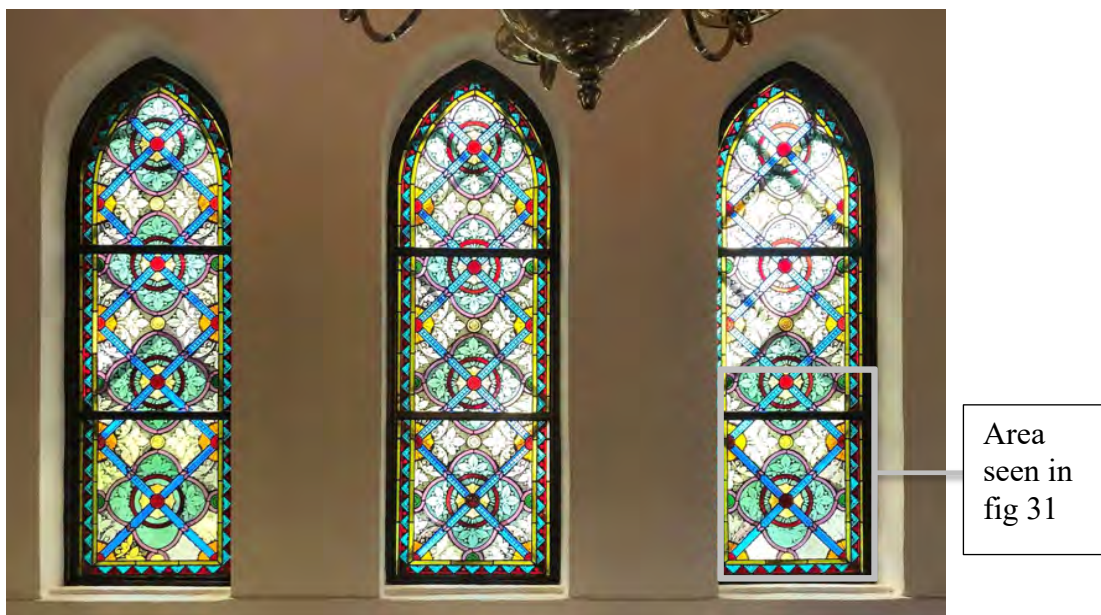
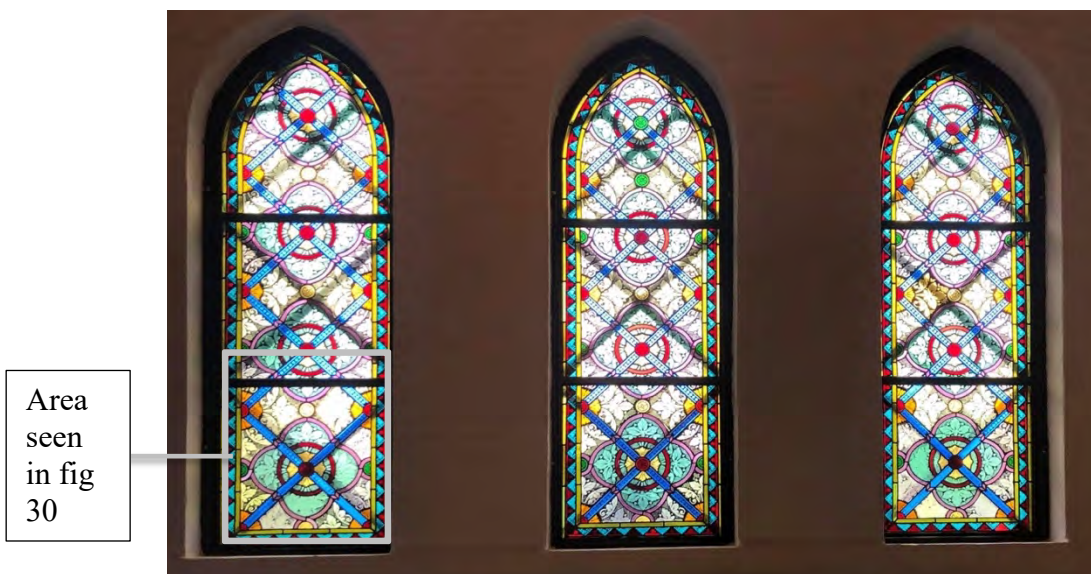
The church has three rose windows and six lancet windows. The six lancet windows are located three on each side in the nave. Where three are facing to west and three to the east. The lancet windows have an ornament pattern made of a dark trace lines (fig 28 and 29). On the lancet windows a lot of grisaille paint have vanished (fig 30 and 31). The paint loss is not uniform, and for each panel the grisaille has vanished on different locations of the glass. The paint is perceived as quite granular. Beside the paint, the windows are in fairly good condition. The glass condition is without remarks, and the lead is without cracks and only shows minor corrosion. No difference was noted between the windows of the west and the east wall.

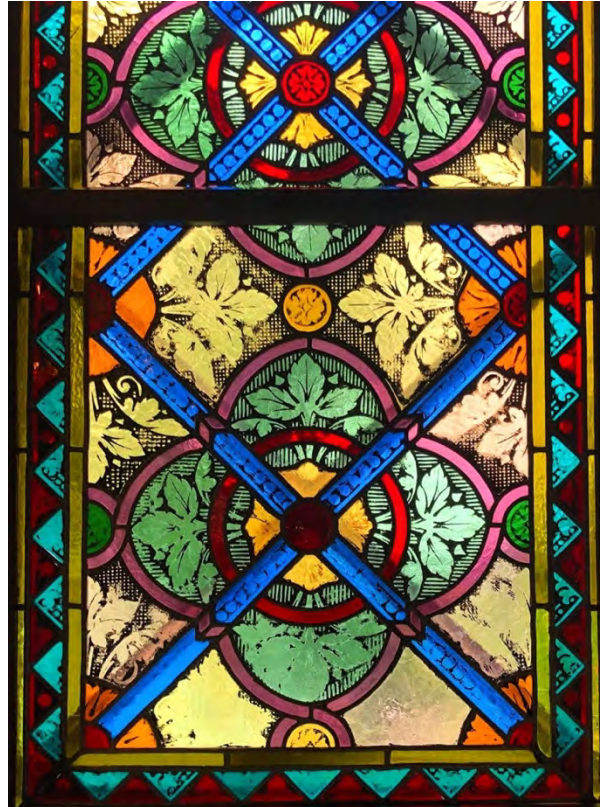
Figure 31. Photo of the bottom right window in figure 28. Photo: Eisfeldt, 2022

For the windows in the nave, the paint loss was perceived to appear quite randomly, this can be seen in figure 30 and 31, where some panels with the most paint loss are situated next to the ones in the best condition.

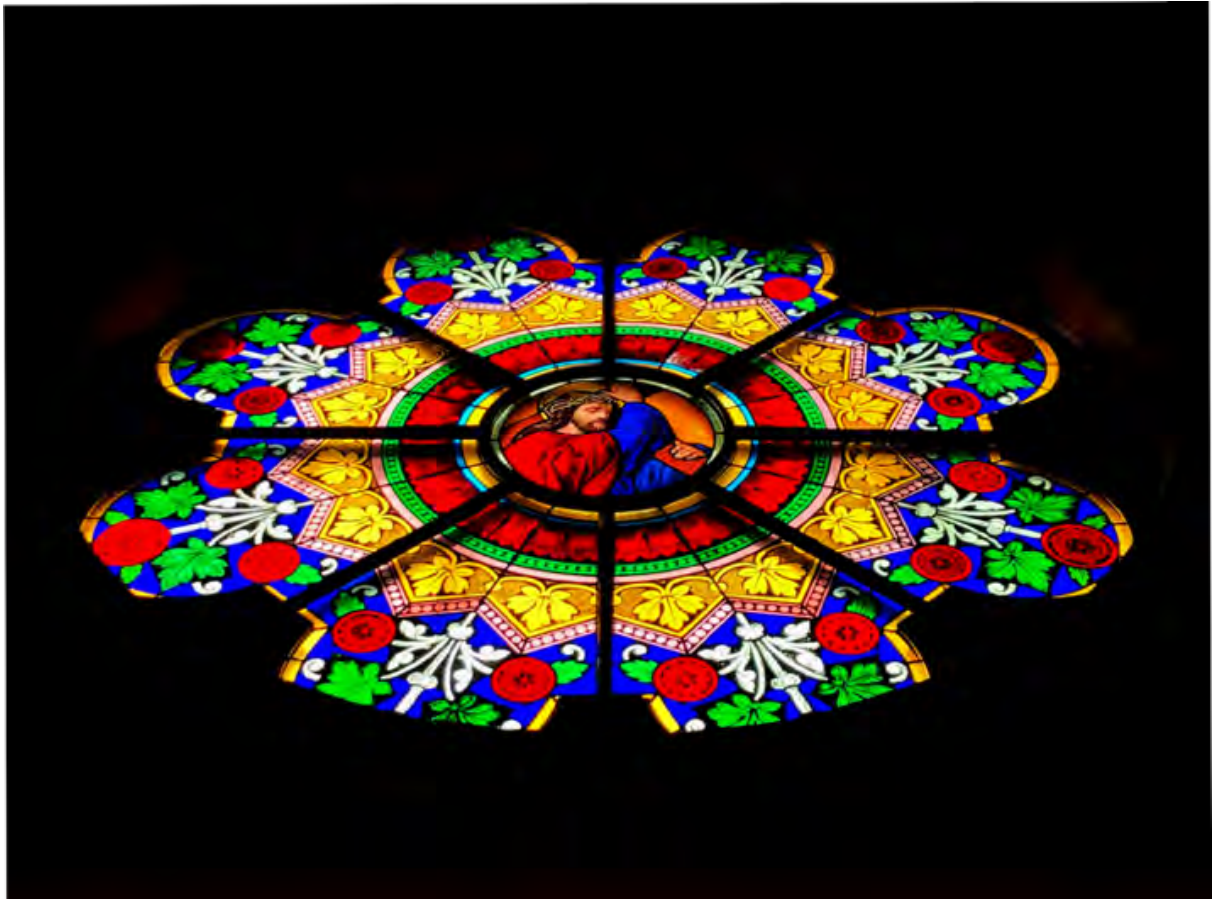
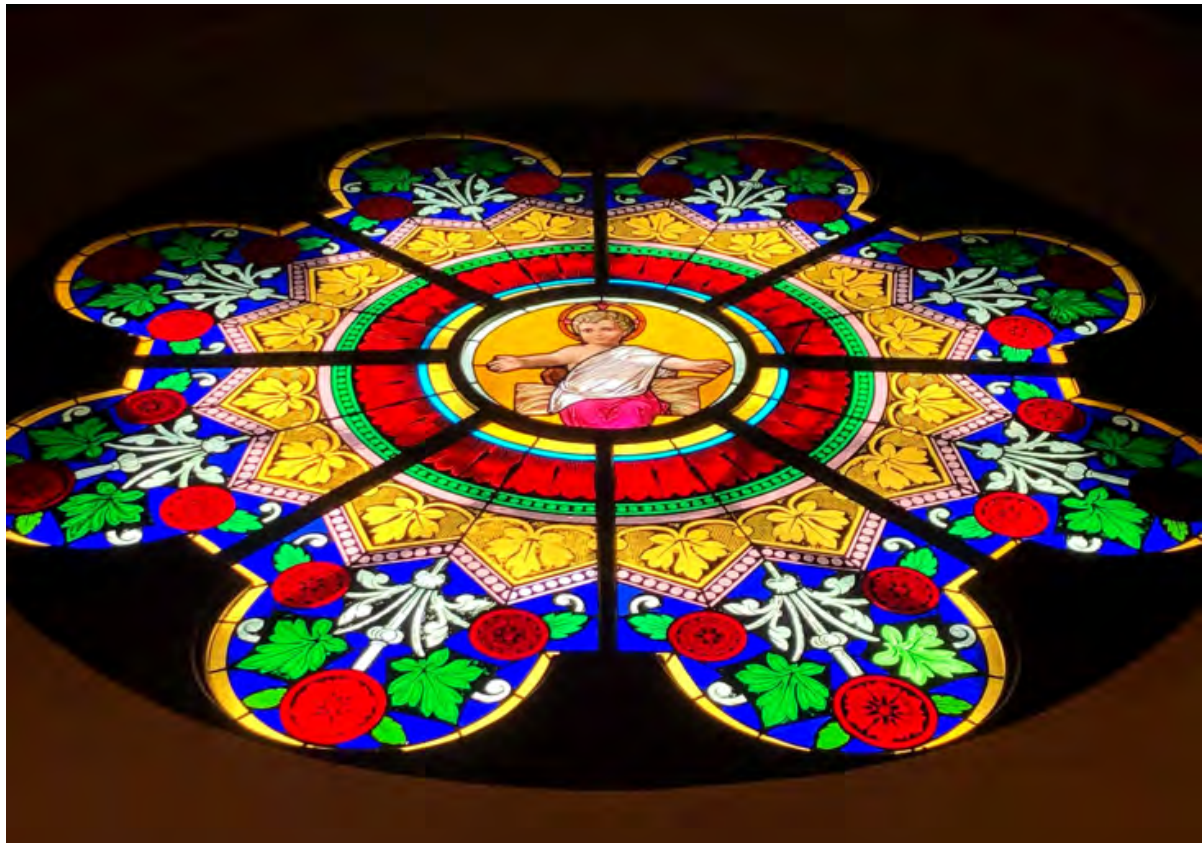
The grisaille paint on the three rose windows, located east, west and north, were more difficult to investigate, as their placement was high. However, it can be seen from afar that the grisaille has disappeared at several places (fig. 32 and 33). Perhaps, the panels with red substrate glass have slightly more paint loss, but it is difficult to anticipate. Reasons behind this could be that the red colour absorbs more heat from the sunlight causing them to flake more. It could also be that the red substrate glass had a too high melting point for the vitreous paint to fully fuse. It could also be that the red glass pieces were fired simultaneously and with a slightly low temperature. No difference in deterioration could be made whether the windows were located to the east, south or north.

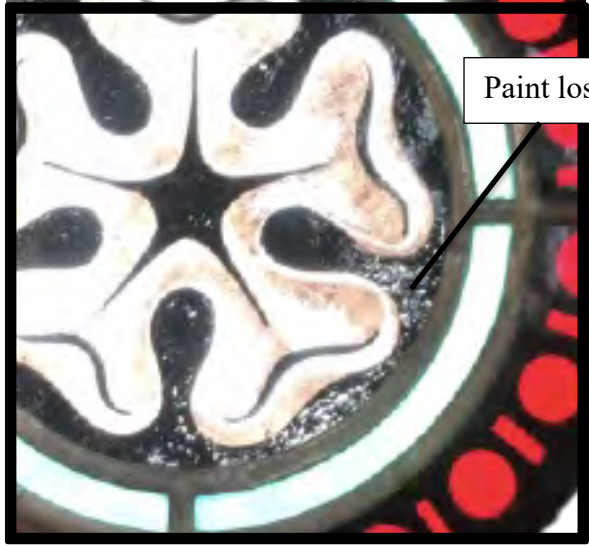
Figure 41. Example of one of the roundels with paint loss. Photo: Eisfeldt, 2022

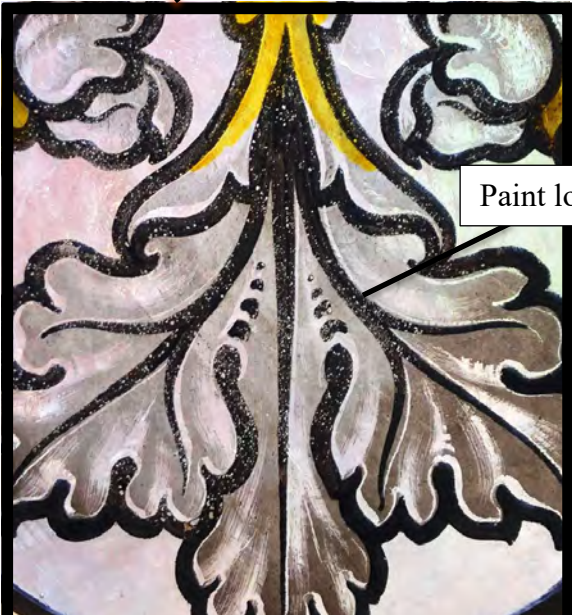
Figure 42. Example of loss in form pin-holes found on the rose windows. Photo: Eisfeldt, 2022

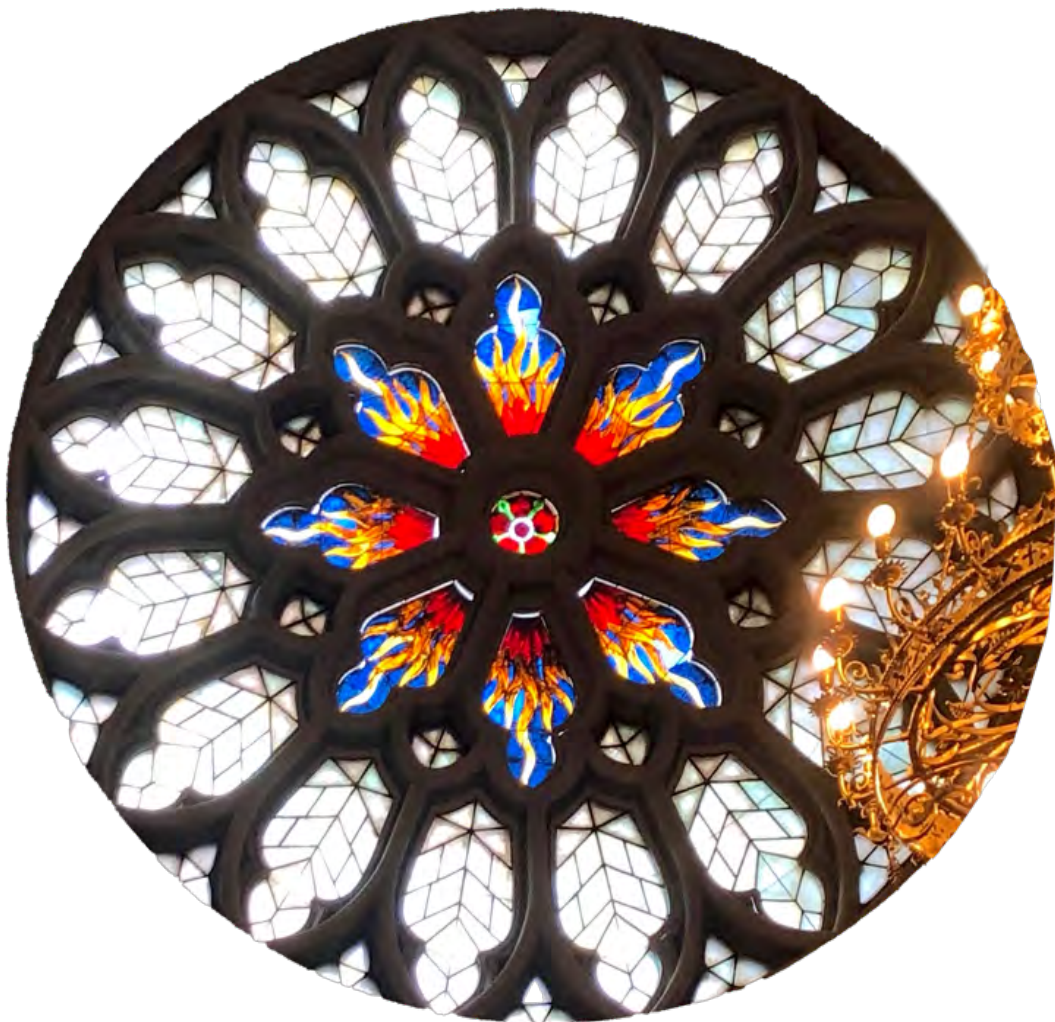
*Figure 43. The west rose window of Oscar Fredrik's church.
Photo: Eisfeldt, 2022*

As Callmänder's window in the choir was removed due to "flaking paint" only two rose windows of Callmänder remains in the church. The west (fig 43) and the south fig (45). From the ground, it is clear that one of the blue glasses of the west window has been replaced and that a large amount of grisaille paint in the red and yellow panels is lost. (Fig 43, 44) The south window also showed signs of paint loss, however as the windows are situated high up on the wall a more detailed condition assessment proved difficult.

No trace lines,
probably as a result
of paint loss

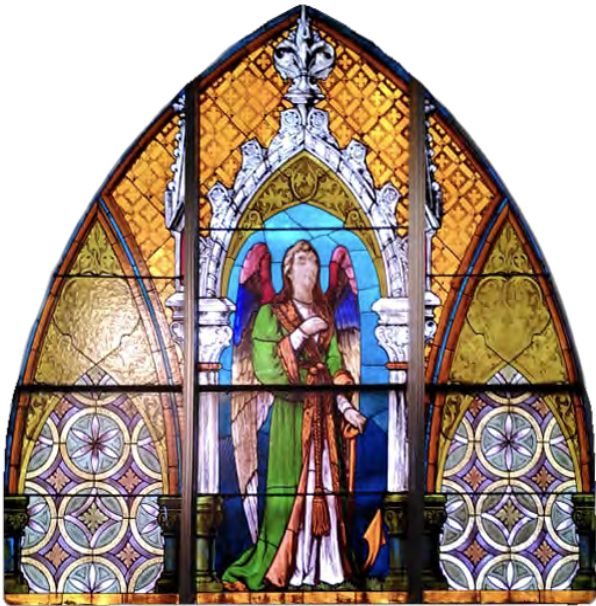
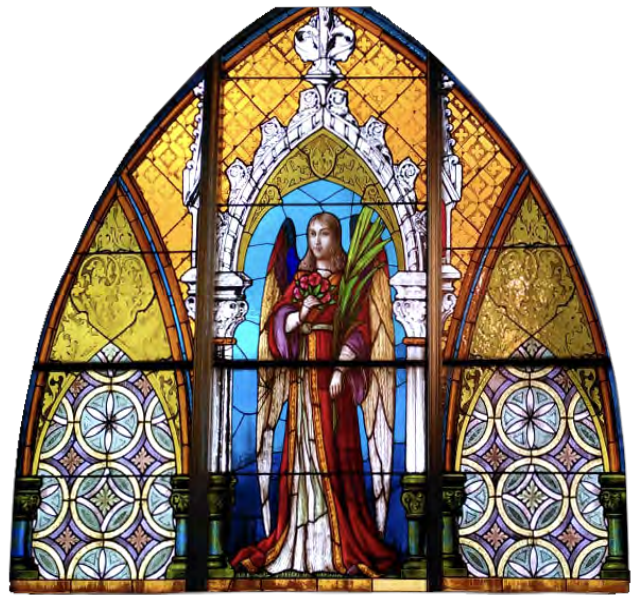
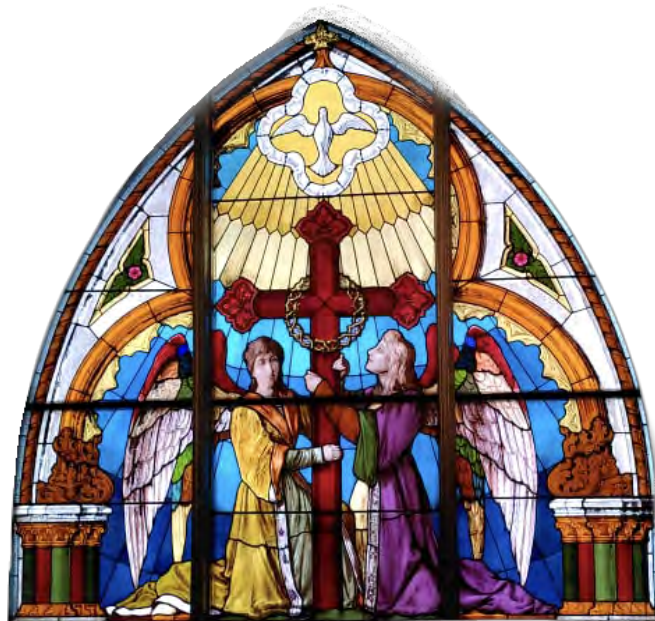
In Jonsered's church there are three windows (fig 46, 47, 48) in the choir which were all investigated. The windows have a lot of areas with lost paint. Most notable is the loss of the dark grisaille tracing used for decorative patterns on the yellow panels. The loss in these areas is similar to previous windows investigated, where the loss occurs in a circular pattern. Major loss of paint can also be seen in the faces, especially on the right window (fig 49, 50). The loss in this window is similar to the loss in *the Son's window* in Uppsala cathedral seen in chapter 2.8, where the paint had varnished and created a "negative" image as dark grisaille paint turned to transparent spaces. Looking closely at the window, both washes, matts and tracelines of grisaille has vanished, in difference to some of the other windows in this thesis where only the tracing had disappeared. The paint loss in Jonsered Church can be seen on top of all the different colored glasses and different shades of grisaille, including dark black, reddish brown and grey brown. Apart from the lost grisaille the windows were in good condition, without cracks or corrosion on the lead. The windows also felt very clean, some pits and scratches could be seen on the substrate glass.

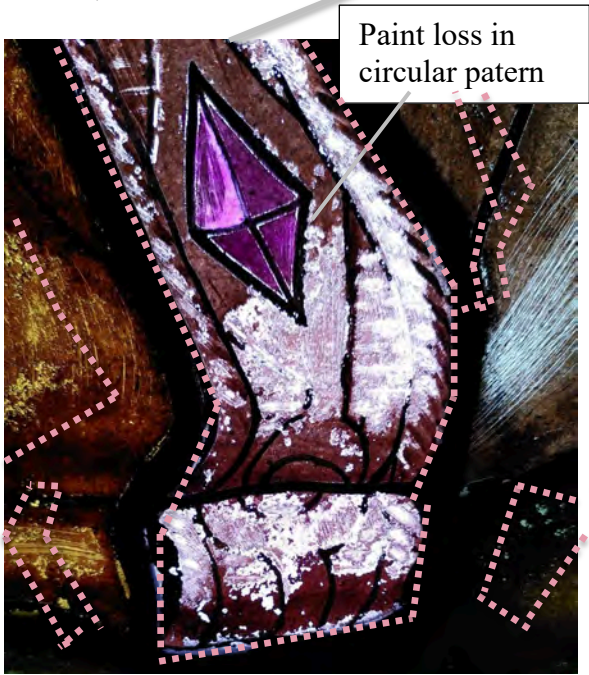
Paint loss in circular pattern

Figure 52. Circular paint-loss in the matting of glass in the middle window in the choir of Jonsæred church. Areas of loss are marked with dotted pink lines. Photo: Eisfeldt, 2022

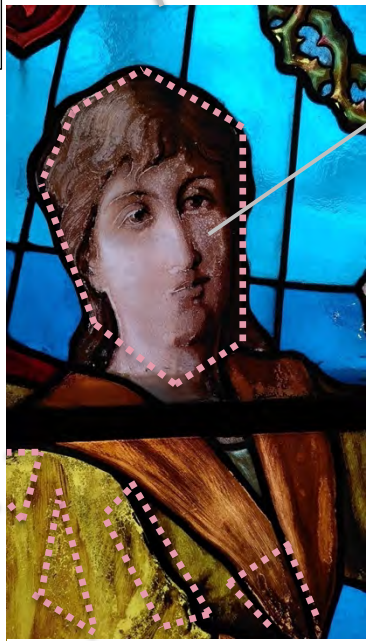
Figure 53. Paint loss on the left character of the middle window in Jonsæred church. Areas of loss are marked with dotted pink lines. Photo: Eisfeldt, 2022

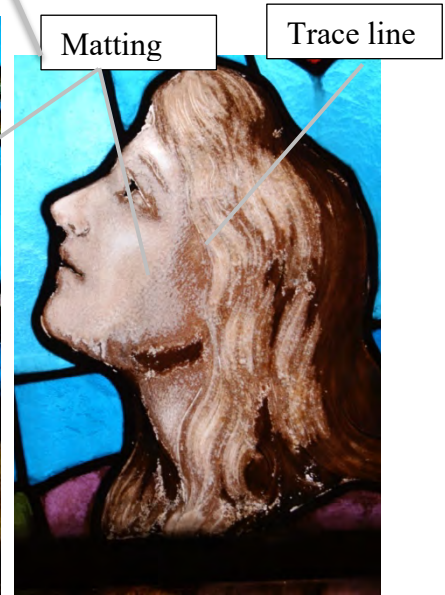
Figure 54. Paint loss of matting and tracing of the right character of the middle window in the choir of Jonsæred church. Areas of loss are marked with dotted pink lines. Photo: Eisfeldt, 2022

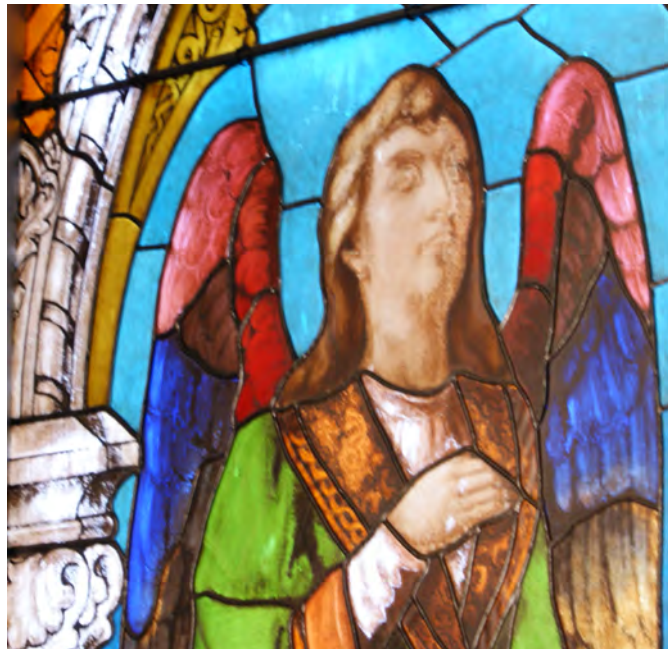
Figure 56. Photo of face with severe paint loss in the left window in the choir of Jonsered church. Photo: Eisfeldt, 2022

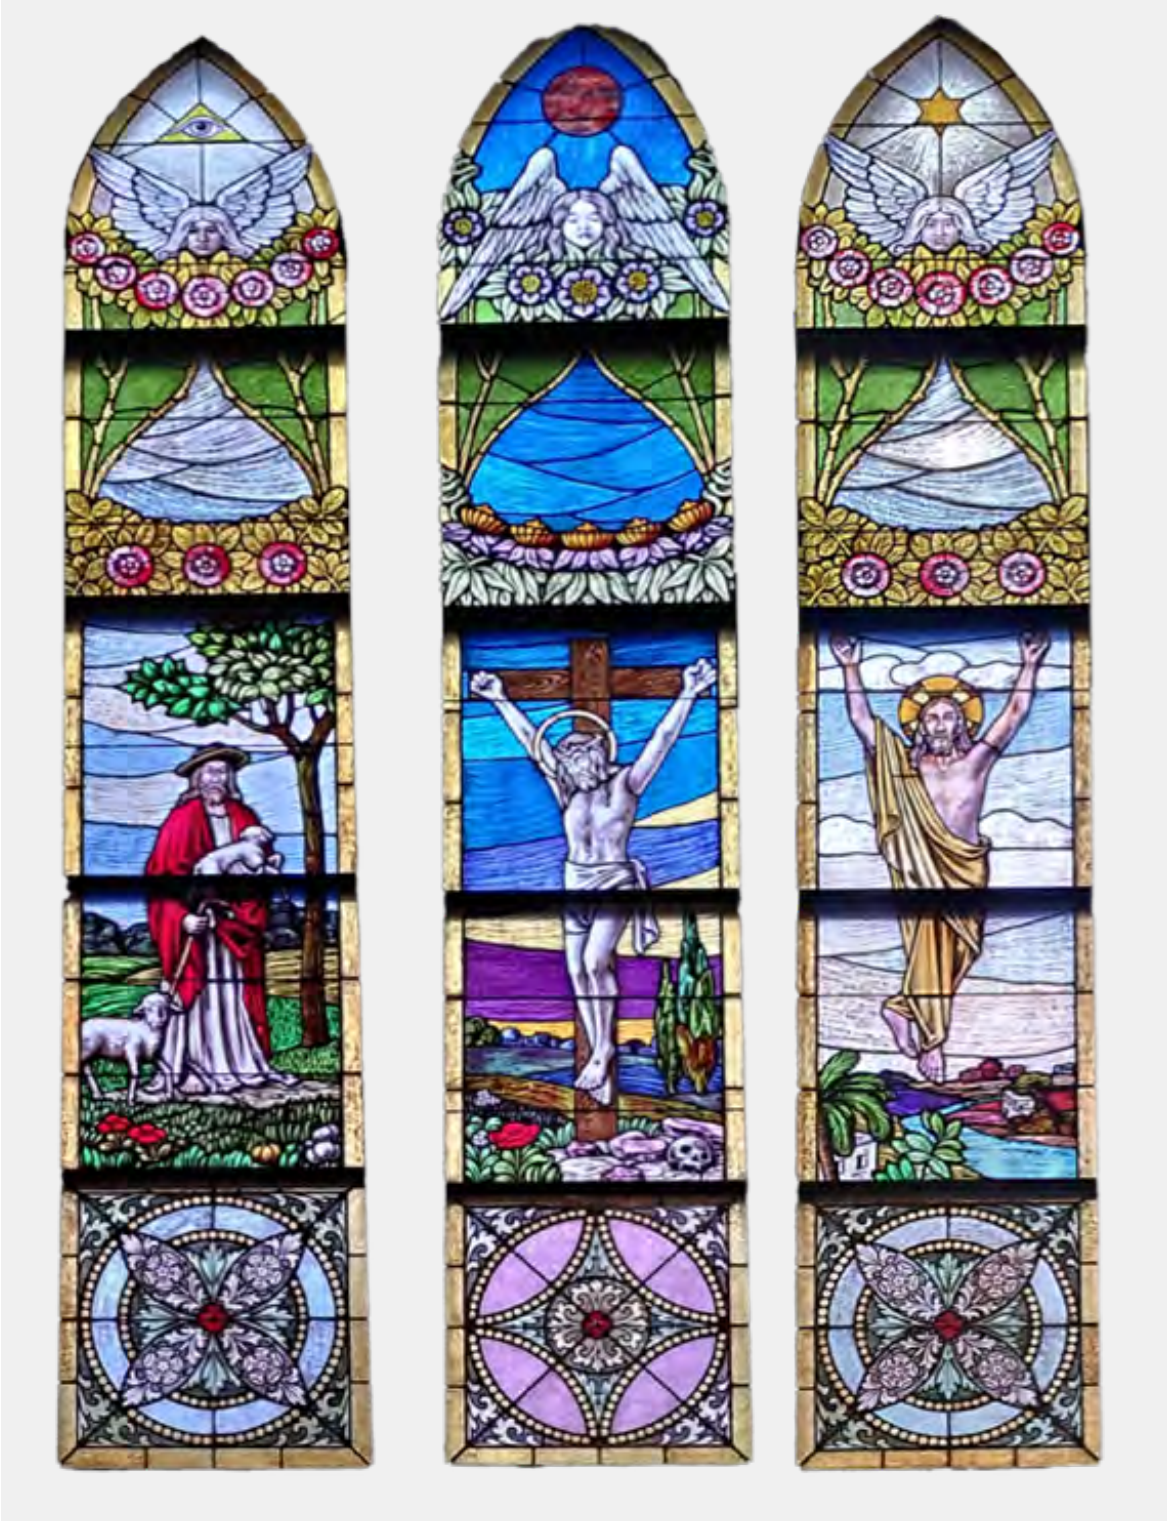
The three windows (fig 57) are painted with dark grisaille for trace lines and lighter stippled grisaille for shadings. The purple, yellow and blue glass are very similar to the ones of Jonsered. Stylistically the depictions of the characters are slightly different compared to the ones in Christinae's church and Örgryte's new church, as they appear a little flatter with less washes. Also, the detail of the hair is different than to other of Callmander's work. The lowest panels ornament style, however, has many similarities with Callmander's. The window also shares the same type of lead comes. Behind the stained-glass windows there are other exterior windows. The exterior windows consist of unpainted coloured glass in their lowest part (fig 58). The interior windows or the stained glass (fig 57) has a dark brown red and a black dark grisaille.

Figure 57. The three lancet windows in the choir of Linnea Church
Photo: Eisfeldt, 2022

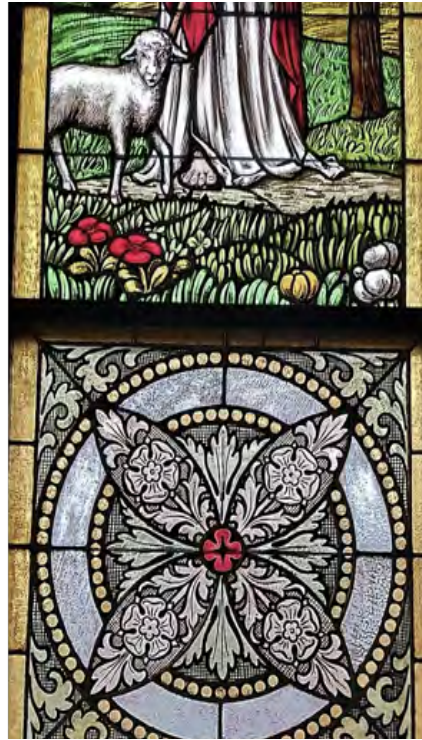
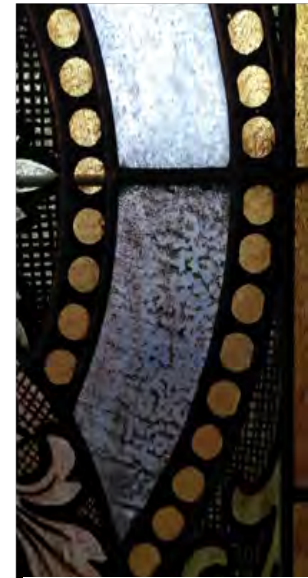
The windows are very dirty, (fig 59, 60) due to thermo-diffusion and years of attracting pollution, dust, and candle smoke. Apart from the dirt, the condition seems to be good, perhaps as they are protected by the exterior windows. Looking closely at the grisaille many small cracks could be found in the paint. The paint layer also felt quite granular and at certain places pinholes could be found. The substrate

glass did not seem to have any cracks, but due to the dirt layer it was difficult to fully examine its condition. It is also possible that much of the painted details and shadows would appear if the glass was cleaned.

Figure 59. Close-up photo of the left window of the Linnea church. Photo: Eisfeldt, 2022

Figure 60. Photo of the dirt of the left window of the Linnea church. Photo: Eisfeldt, 2022

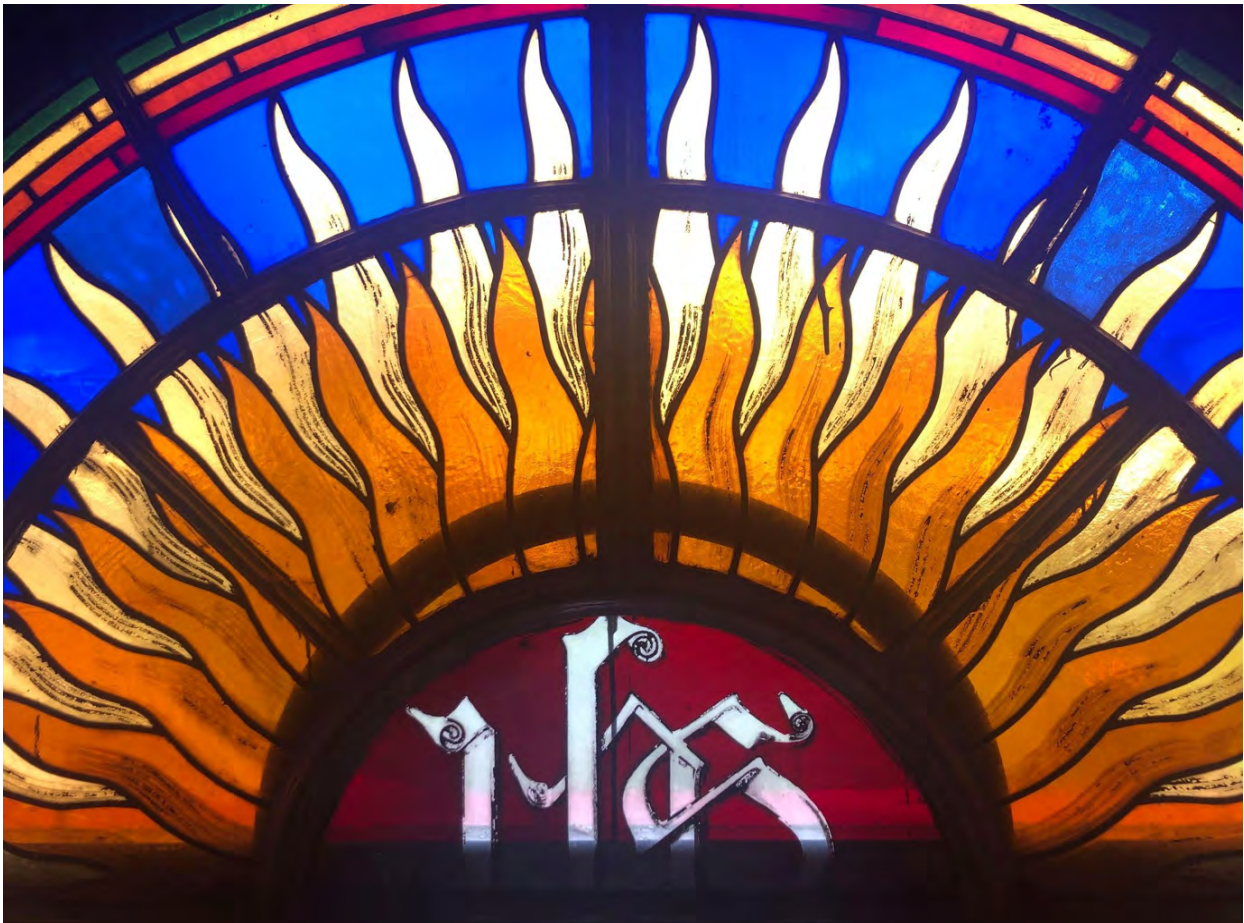
The window (fig 62) situated on the church's east wall consists of Cathedral glass and a lead network. It is painted with a dark grey, almost black grisaille. The paint seems to be quite thinly applied.

The lead seems quite new and is in good condition without any corrosions and cracks. The substrate glass was in good quality, with only few pits with and no salt precipitation nor iridescence. The paintwork, however, has a large amount of paint loss (Fig 63, 64) The paint loss can be found on all the glasses, and by eye, it seems the orange glasses has lost more paint than the yellow ones (fig 62). This might be explained by coincidence, but also by uneven firing, or the different characteristics of the substrate glass pieces. Furthermore, it could be stated that what grisaille is left, feels quite secure. No flakes were found under the window which may indicate that the window does not flake momentarily. Neither were any running stains from the paint found on the glass.

Figure 62. The stained glass window of Varberg's church.
Photo: Eisfeldt, 2022

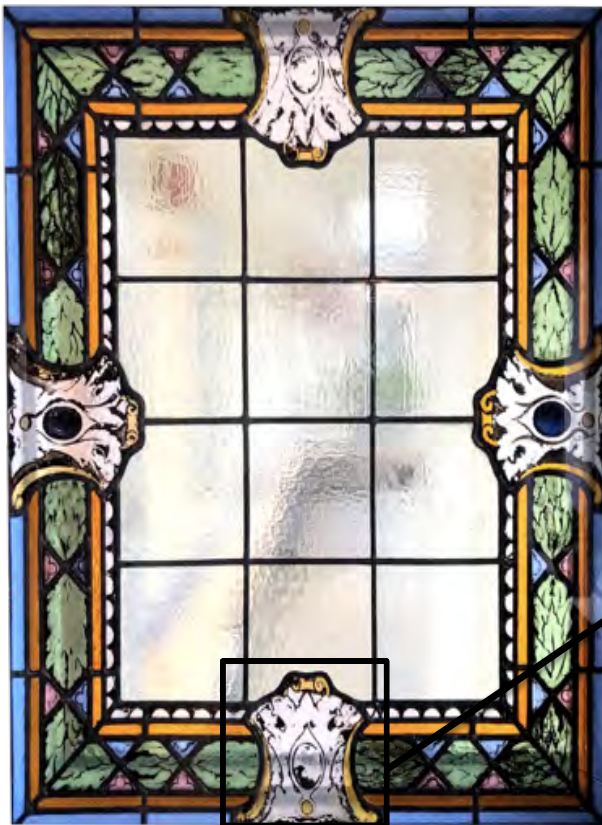
The windows consists of cathedral glass painted with a dark, almost black grisaille tracing. The glass and lead comes are in fairly good condition but the paintwork has lost much of its paint. The paint loss has occurred quite uniformly and cannot only be ascribed to one type of glass. Just like many other of Callmander's windows, the paint seems to lose adhesion with the glass by circular patterns (fig 66)

Figure 65. One of the two windows in Sollyckan's church. Photo: Eisfeldt, 2022

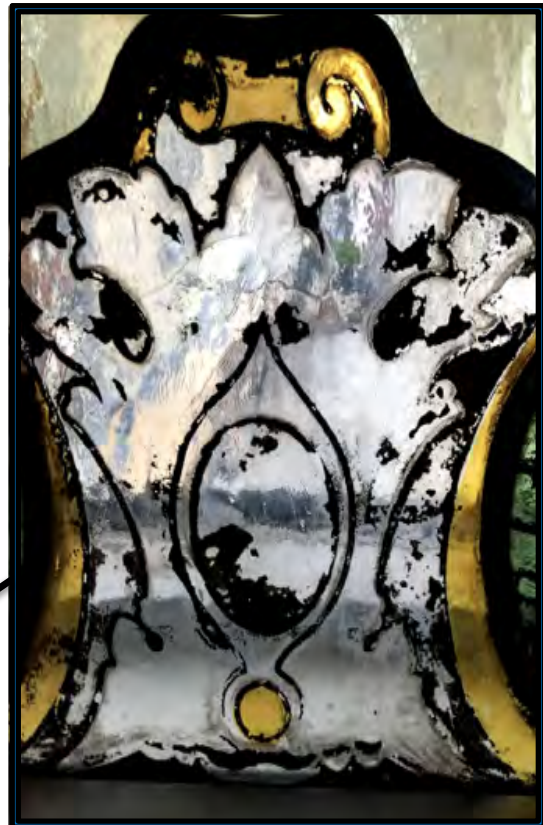
Figure 66. Close-up on the paint loss of the window shown in figure 65. Photo: Eisfeldt, 2022

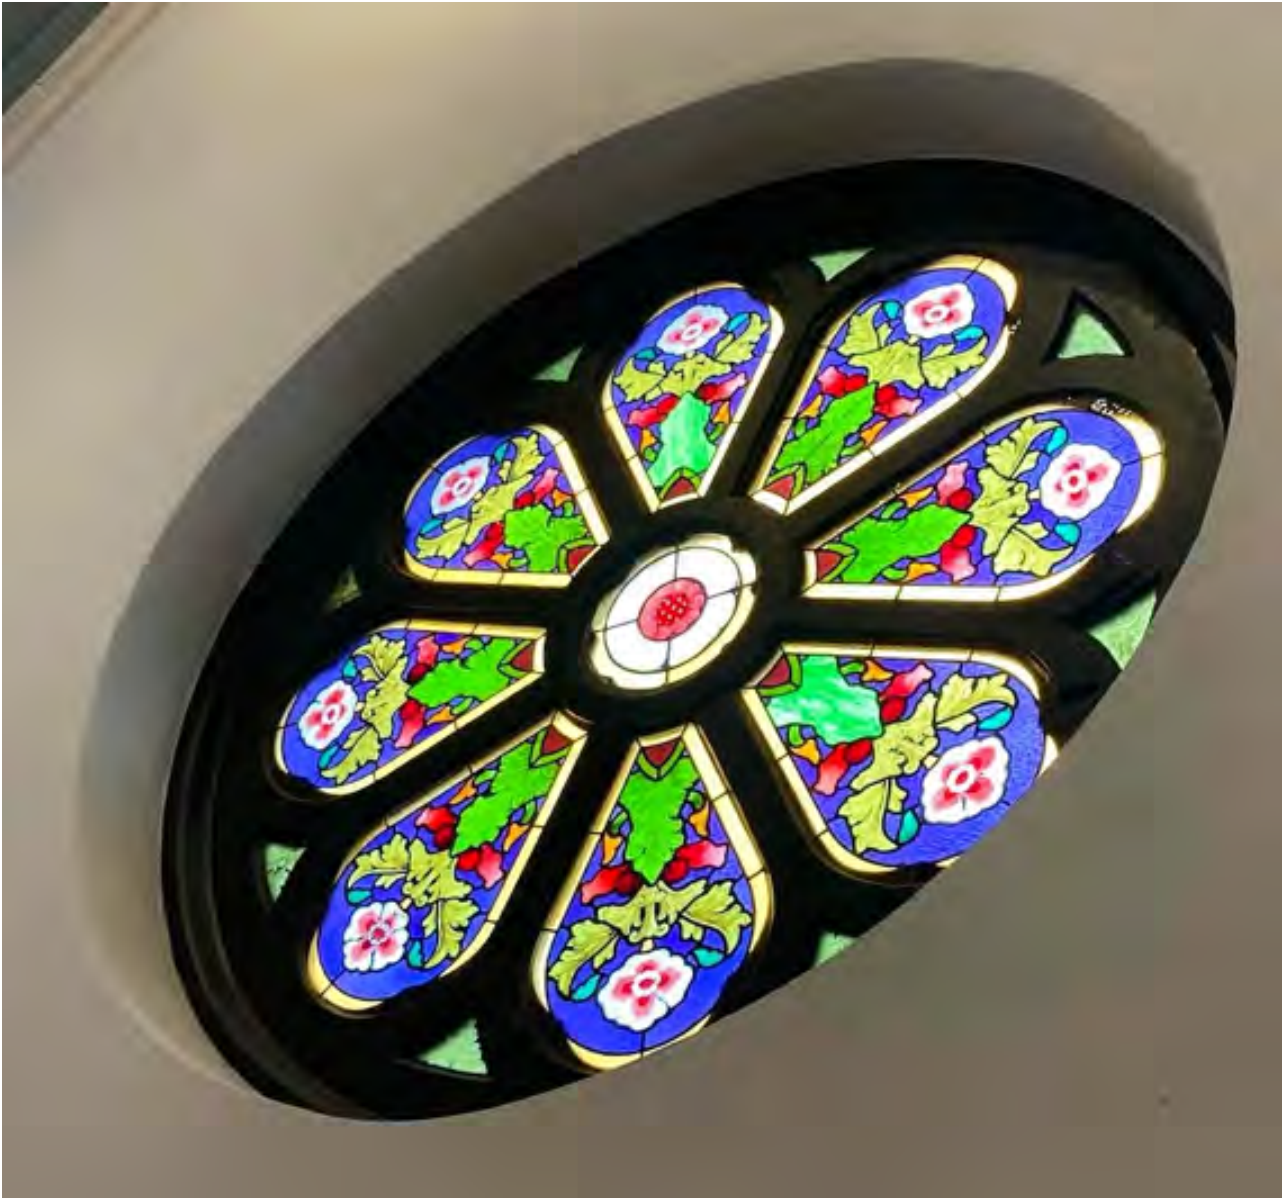
The window (fig 70) could only be inspected from below where it could be seen that the window suffered from severe paint loss of the grisaille. A closer examination of the window was impossible due to the distance.

*Figure 70. Photo of the Rose window in the East chapel
Photo: Eisfeldt 2022.*

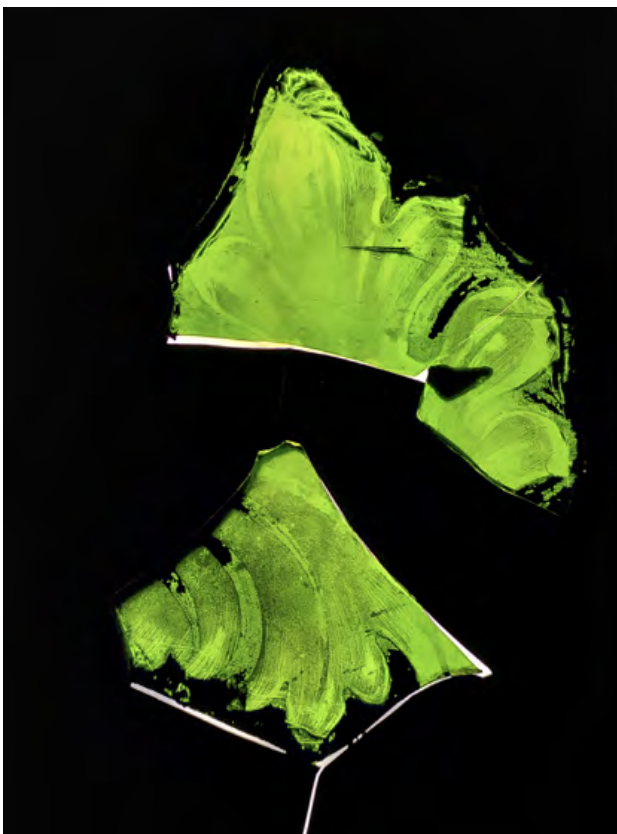
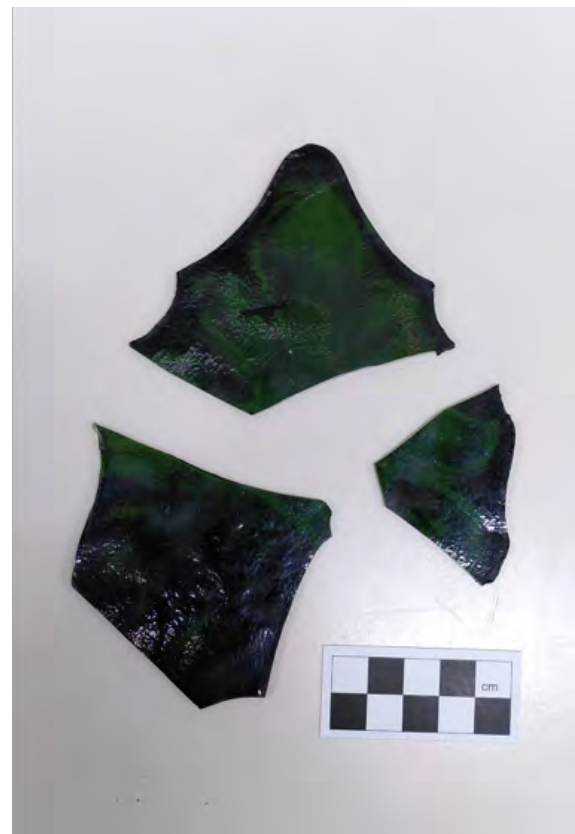
Figure 71. Photo of glass A in transmissive light. Photo: Eisfeldt, 2021

Figure 72. Photo of glass A with reflective light. Photo: Eisfeldt, 2021

Glass A (fig 71, 72) originates from the rose window of Östra Kapellet (described in 3.11) in Gothenburg and was discarded from the chapel as it was severely broken. The piece measures 130 x 95 x 2 mm. The glass is a green cathedral glass painted with a tracing of dark grisaille. The grisaille paint has been applied with a brush and then softened with a badger brush before firing. The glass is cracked and has only three pieces remaining. The grisaille paint has major paint loss, and in the middle ghost lines. The paint loss has occurred rather uniformly apart from the edges, where most of remaining paint can be seen, perhaps because it was protected by the lead comes. The grisaille which is left on the sample seems fairly stable. It can be seen that the loss of grisaille occurs in circular patterns, similar to the examined windows. On the shard there is also epoxy glue from a past restoration treatment. Apart from that there are no signs of previous conservation of the glass.

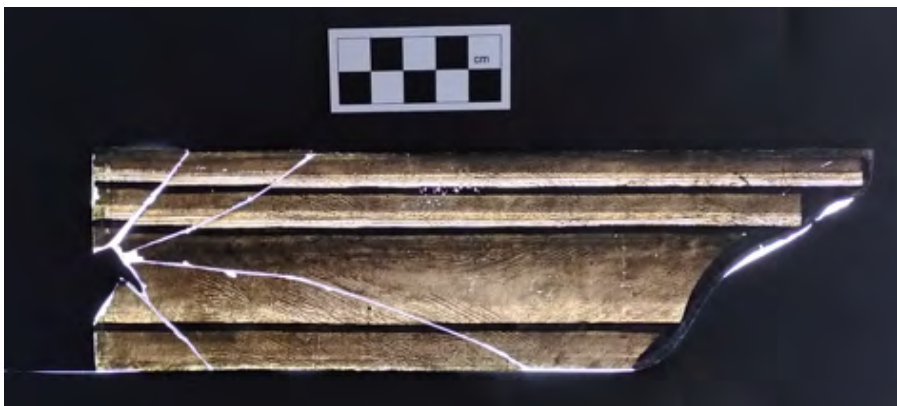
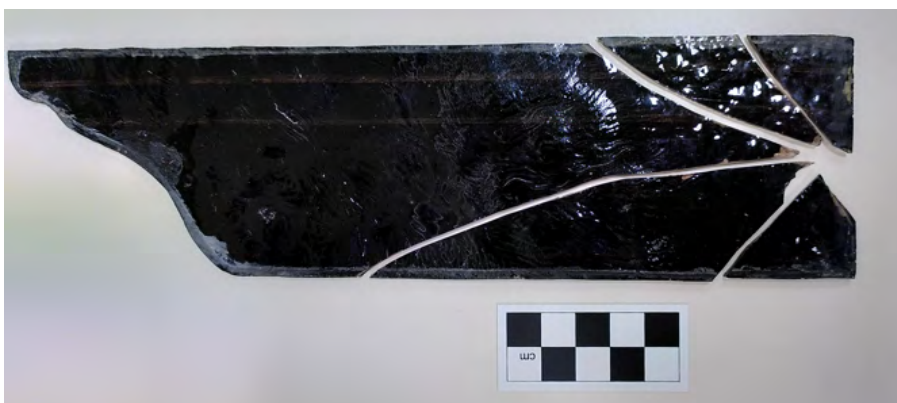
Figure 73. Photo of glass B in transmissive light. Photo: Eisfeldt, 2021

Figure 74. Photo of glass B with reflective light Photo: Eisfeldt, 2021

The second glass, B (fig 73, 74) was originally a part of one of the lancet windows in Christiane's church in Gothenburg, described in chapter (3.2) The glass was discarded in 2013, as it was cracked and had lost parts of its material (Informant 1, 2019). The measurement of the piece is 240 x 65 x 2,5 mm. The glass is a clear cathedral glass. The grisaille paint consists of tracing and matting, depicting a part of architecture, on either the windows of Lucas or Johannes. At parts the grisaille has been scraped off before the burning to create artistic effects. Beside the cracks the glass is in considerable good condition. No flaking can be found, except small pinholes. The glass carries no signs of previous conservations treatments such as refiring, or consolidation.

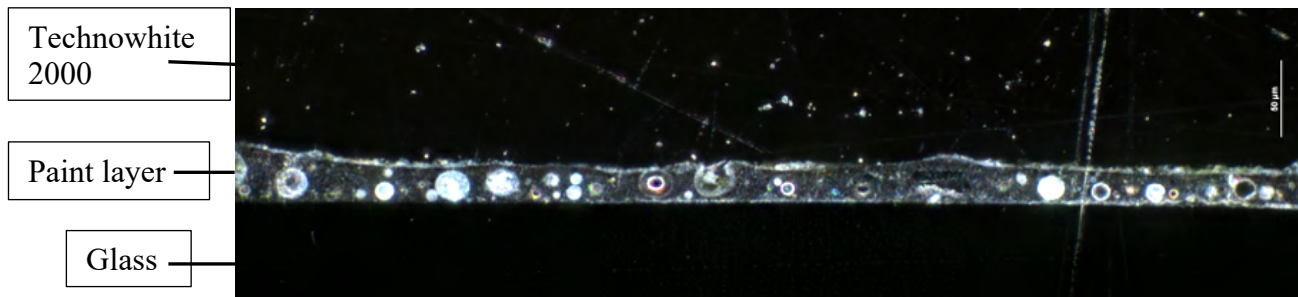
In FR microscopy the cross section of Sample A shows a large number of bubbles in the grisaille paint (fig 83, 84) It is also visible that the paint is quite inhomogeneous and granular. There is also a notion that the grisaille and the glass is not very fused together, as the interface between the paint and substrate is rather sharp. At places, there also seem to be cracks in the interface between paint and substrate. In fig 84, There is also a type of layer on top of the grisaille paint, possibly a corrosion or gel layer.

Figure 84. Microscope image of the cross section. The scale bar seen to the right is 50 μm
Photo: Eisfeldt, 2022

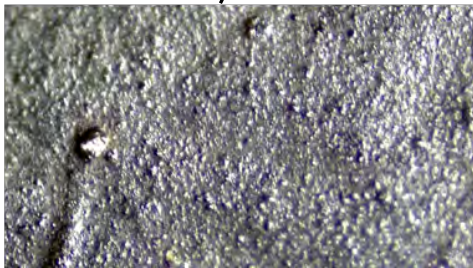
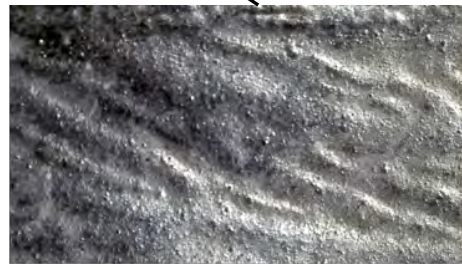
Figure 86. Microscope image 1 of the surface of glass B. Photo: Eisfeldt, 2021

Figure 87. Microscope image 2 of the surface of glass B. Photo: Eisfeldt, 2021

In stereo microscope glass B's grisaille was much different to glass A (fig 86, 87). The grisaille of the B sample looks despite its granularity coherent and well fused. Under microscope, no more signs of pitting could be found except, few which could already be seen by eye. Neither could any signs of corrosion be found in this magnitude.

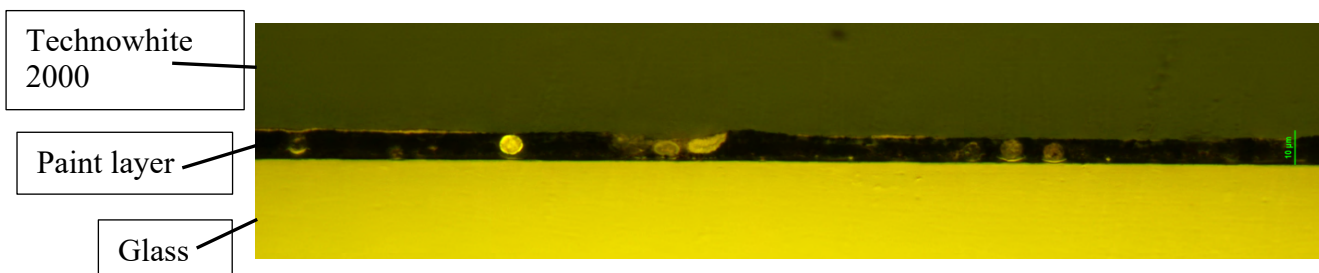
In the FR microscopy (fig 88) it is visible that the paint layer of sample B is thinner and does not have as many bubbles as sample A. The B sample also looks more homogenous. As in sample A, sample B also shows a distinct interface between grisaille and substrate glass.

Figure 88. FR microscopy image with Nikon EclipseLV100ND fitted with Nikon digital sight 10 on cross section from glass B. The measuring scale bar seen to the right is 10 μm Photo: Eisfeldt, 2022
