THE PAINT LOSS OF CALLMANDER'S STAINED GLASS WINDOWS

An investigation of the prevalence and causes
behind the paint loss on Callmander and Svenska
Glasmåleri AB's stained glass windows

Degree project for Master of Science with a major in Conservation
2023, 30 HEC
Second Cycle
2023/25

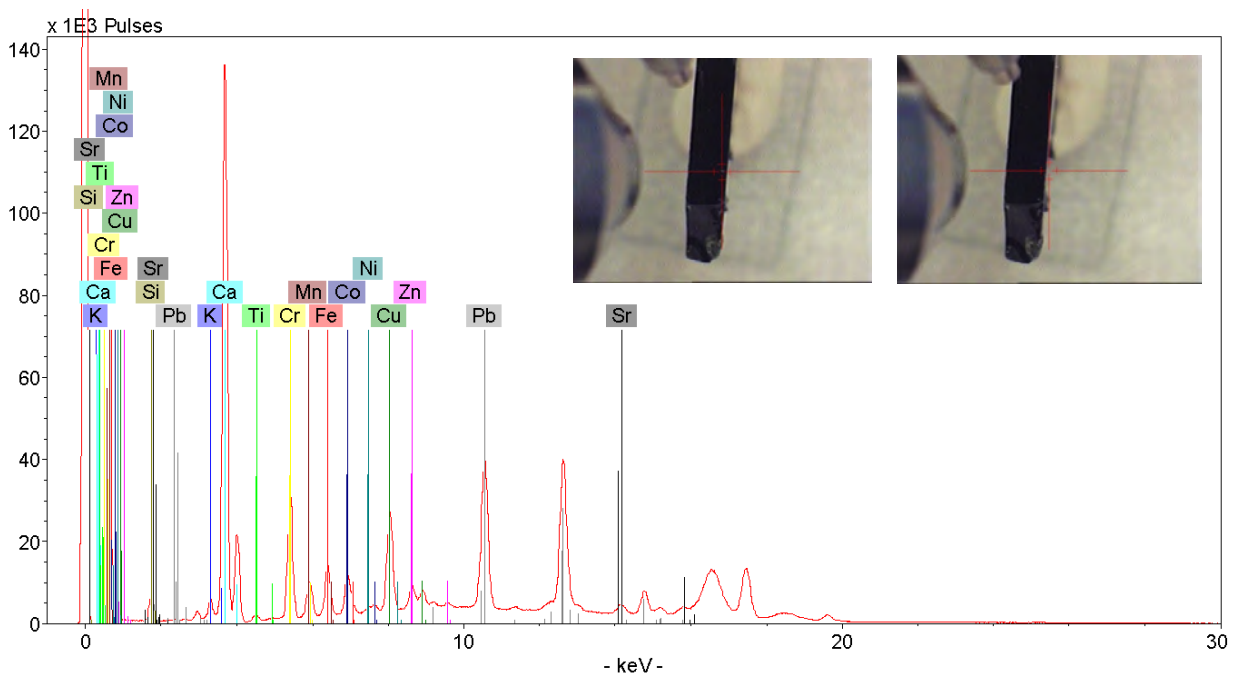
The last two graphs were acquired with a line scan on glass B. Figure 94 shows the elements for the entire line, while figure 95 shows where each corresponding element was found. In figure 95 we clearly see the difference between glass and grisaille. We can also get a notion of how the elements of the glass has merged with the elements of the grisaille, between 0.25 nm and 0.3 nm.

Figure 94. XRF line scan on the edge of glass B, examining both paint and substrate glass, collective graph. Graph: Eisfeldt, 2022

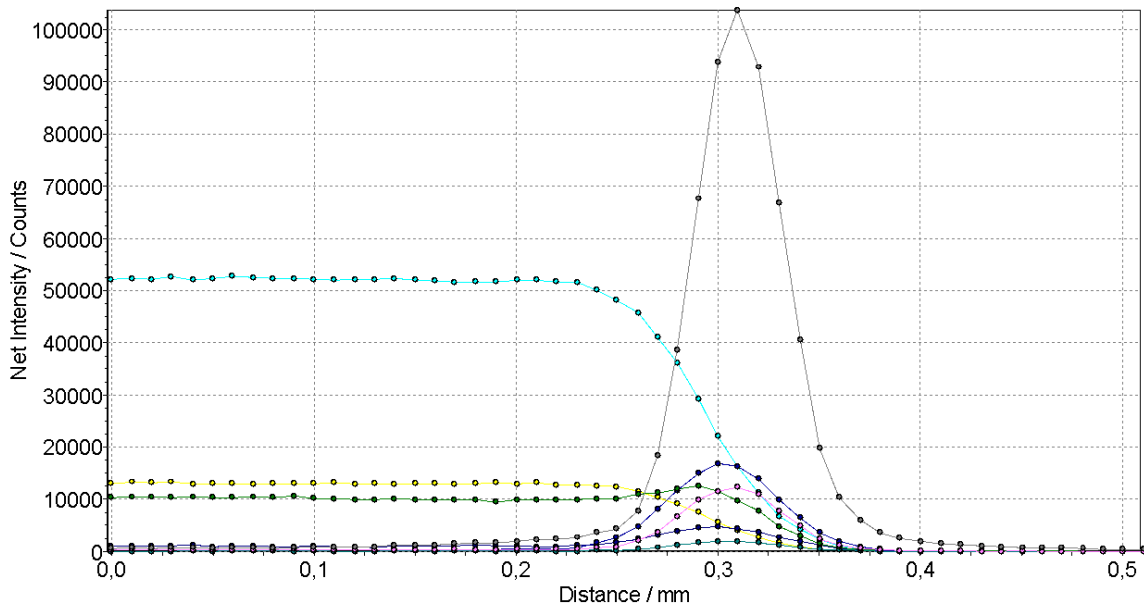
Figure 95. XRF line scan on the edge of glass B, examining both paint and substrate glass. The first peak starting from 0.0 shows the glass and the second peak shows the grisaille paint. Graph: Eisfeldt, 2022

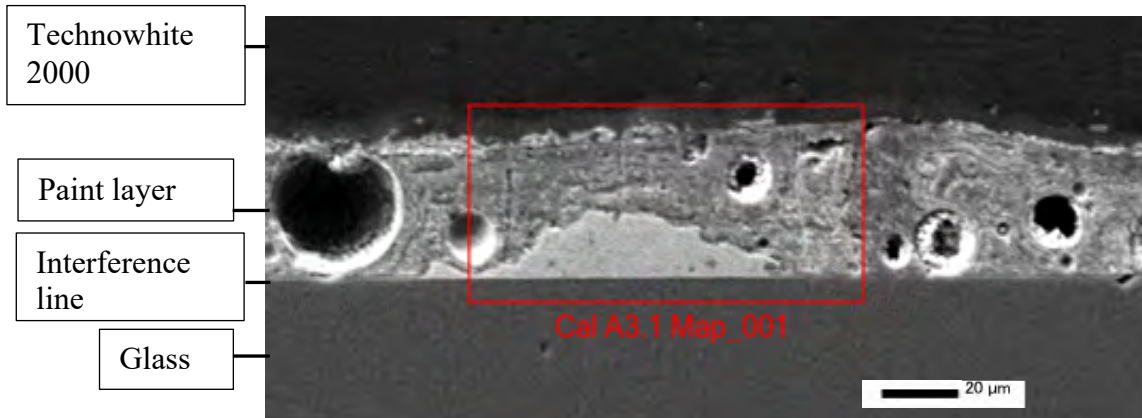
In the SEM-EDS image (fig 96) there is a clear visual difference between substrate glass and grisaille. As there is no interference line visible between the two mediums, it may indicate that the two mediums have not fused properly. With SEM-EDS it was also revealed that the grisaille has high levels of, cobalt, arsenic, iron and lead. As none of these elements are present in the substrate glass it could indicate that no ion diffusion has occurred, which in turn could indicate insufficient firing. Contrary to this, the SEM-EDS also shows a number of bubbles (fig 96), which can be an indication of high firing, as high temperatures form (Verita, et al, 2015). The bright areas seen around the bubbles, indicate heavy elements, as heavy elements backscatter more electrons, the elemental mapping shows it is re-deposition of lead, arsenic and sulphur (fig 97, 98).

Figure 96. Image of SEM-EDS map 001 of the cross section of glass A. magnification x550. The scale bar is 20 μm. Image: Eisfeldt, 2022

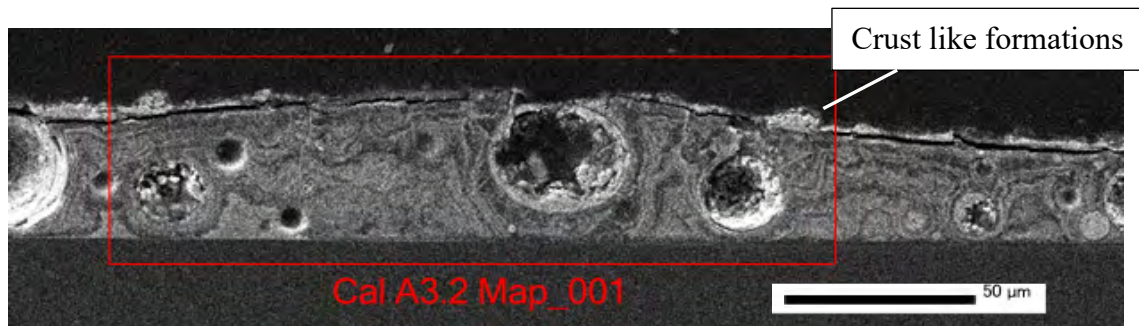
The thin white line in the surface layer of the grisaille indicates heavy elements, which perhaps is a result of leaching of metals (fig 99). There is also crust-like formation on the surface, perhaps as a result of corrosion.

Figure 99. Image of SEM-EDS map 001 of the cross section of glass A. Magnification $\times 450$. The scale bar is 50 μm . Image: Eisfeldt, 2022

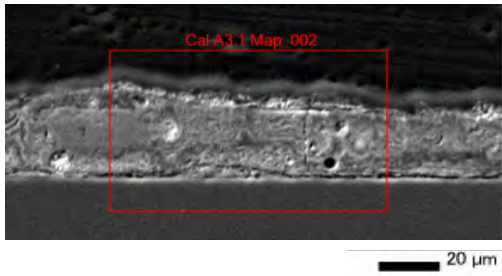
Figure 100. Image of SEM-EDS map 002 of the cross section of glass A. Magnification is x800. The scale bar is 20 μm. Image: Eisfeldt, 2022

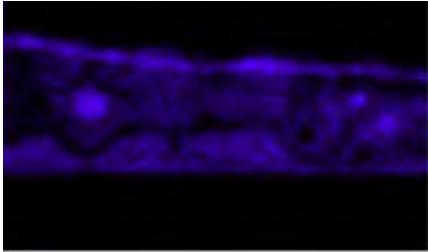
Furthermore, the results, verifies the result from the XRF investigation, as they show the occurrence of the same elements. In the SEM-EDS investigation there was no occurrence of boron. Boron is a very light element and is sometimes difficult to detect. However, as no traces were found during the investigation, it could be safe to assume that the element is not present in the sample. The SEM-EDS also showed calcium on all maps for glass A, amongst these (fig 103). For one map, it also showed potassium (fig 102). The potassium could be an indication that the glass is a potash glass, but it could also be due to impurities in the raw material. In the SEM lead (Pb) was also visible in the paint of glass A (fig 101) which further indicates that the paint was made with frits of lead glass.

Figure 101. Elemental map of lead of map 002 of glass A. Image: Eisfeldt, 2022

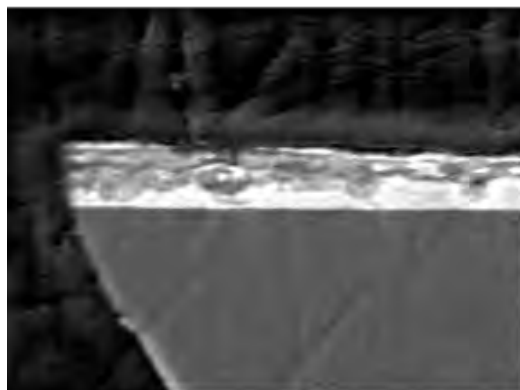
Figure 105. Image of SEM-EDS map 005 of the cross section of glass B. Magnification x1900. The scale bar shown at the bottom is 10 μm . Image: Eisfeldt, 2022

As in sample A, sample B also has a clear difference between substrate glass and grisaille, (fig 105, 106) perhaps indicating insufficient firing. Compared to sample A, by viewing the mapping of the elements there is a notion, that sample B is slightly more homogenous than the sample A. Sample, B, also seem to have less bubbles (fig 106,107). As in the microscope it can also be seen in the SEM that the paint layer of Sample B is thinner than the paint layer of sample A.

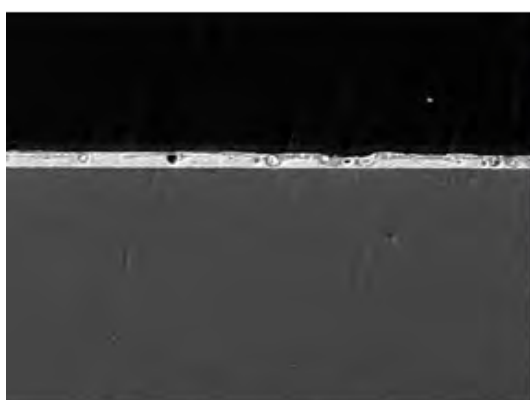
Figure 106. Image of SEM-EDS map 004 of the cross section of glass B. Magnification x550. The scale bar is 50 μm . Image: Eisfeldt, 2022

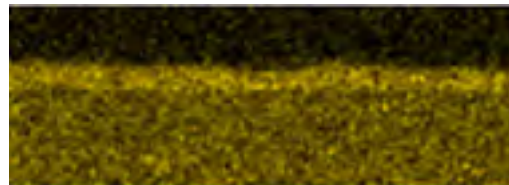
The SEM-EDS shows there is potassium present in both substrate glass and paint layer (fig 110) which could indicate the glass is a potash glass, there is also sodium and calcium present (fig 109, 111). Sodium could contrary indicate that the glass is a soda glass, however it must be noted that potash glass also contains some sodium (Musgraves, et al, 2019 p. 144). Calcium was sometimes added as a stabilizer (Davison 2003, p. 107) the glass could therefore be a lime-potash glass.

Figure 110. Elemental map of potash of map 004 of glass B. Image: Eisfeldt, 2022

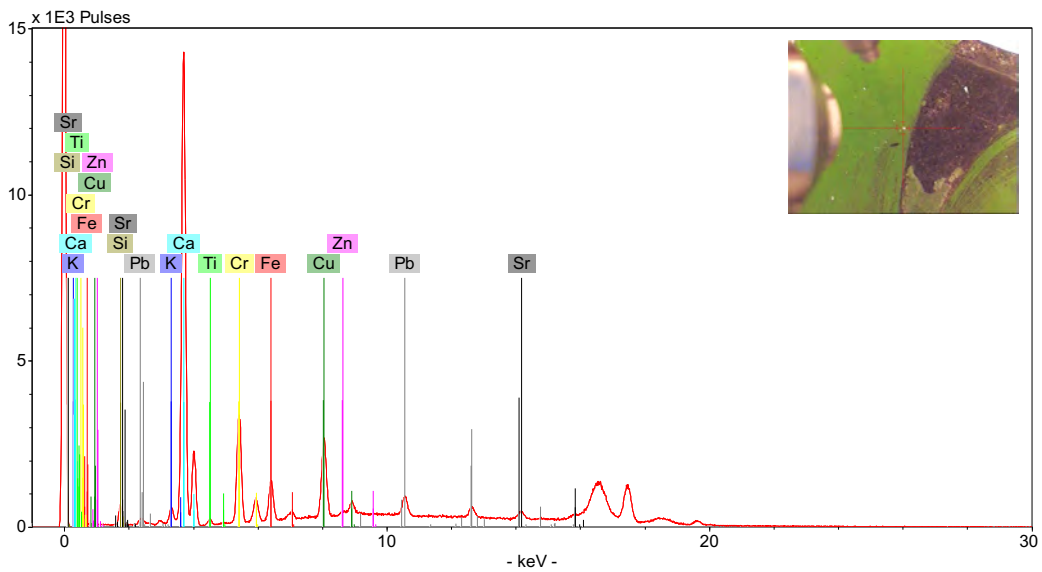
A2 grönt glas: Mest Ca, Cr och Cu. Lite Fe och Pb

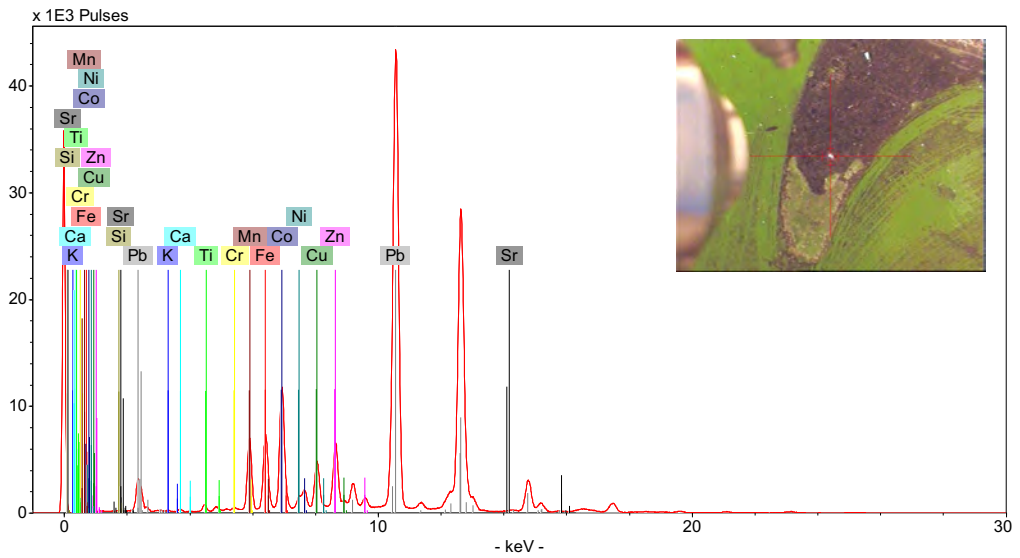
A2 svart: mest Pb och Co, ganska mycket Fe, Mn, Cu och Zn

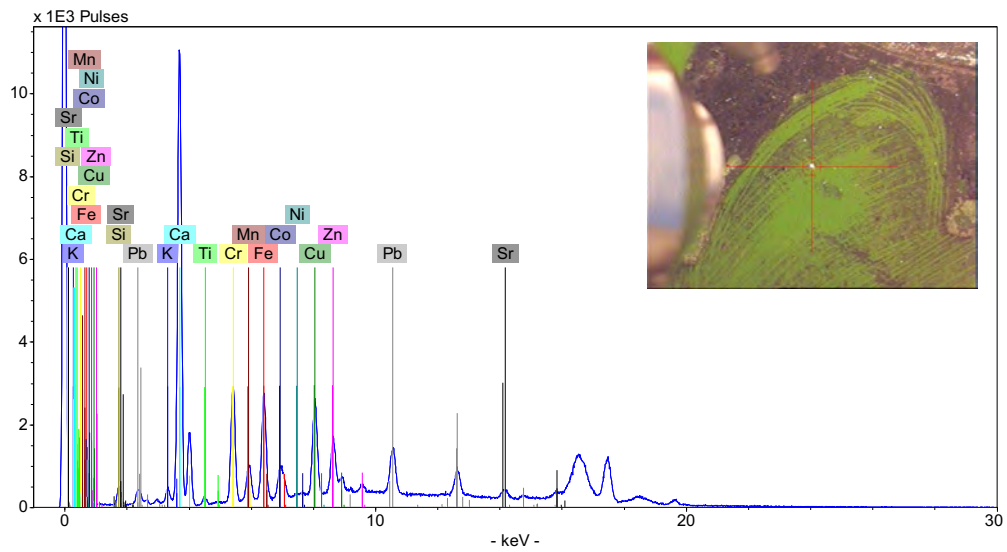
A2 tunt svart: Mest Ca, ganska mycket Cr, Fe och Cu, lite Co, Mn, Zn och Pb

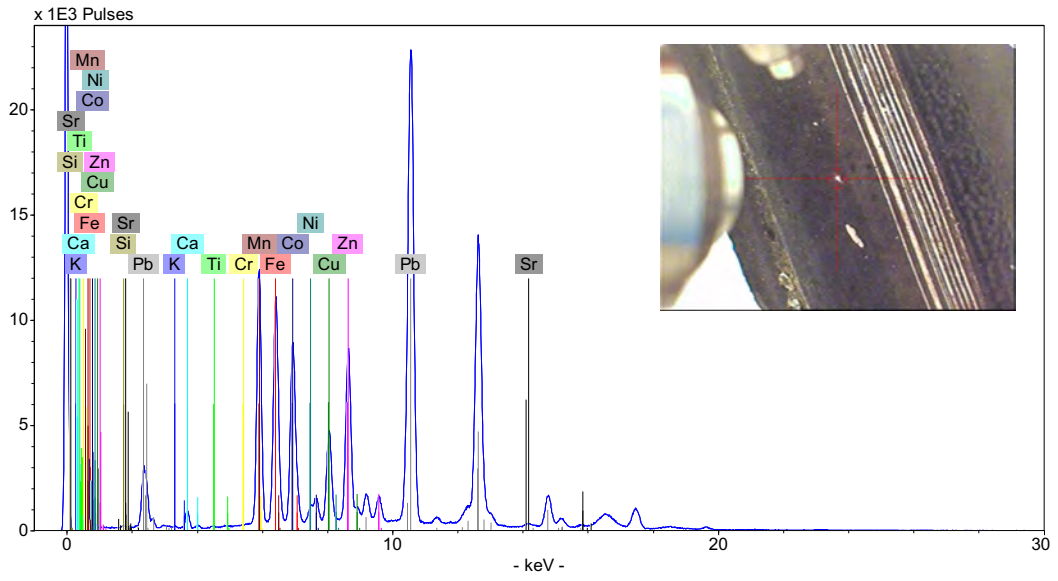
B3 svart: Mest Pb, Ganska mycket Mn, Fe, Co, Zn och Cu

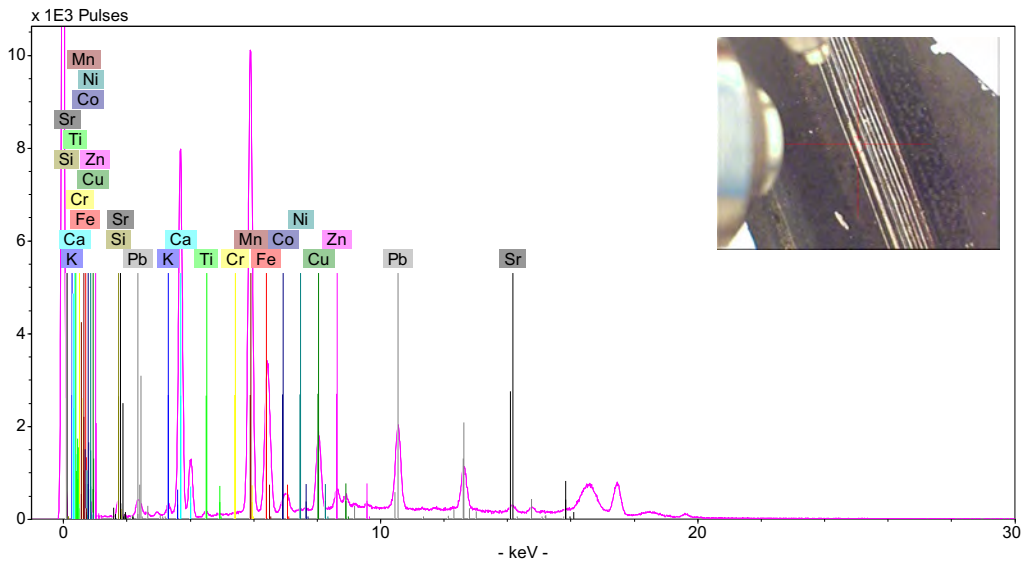
B3 vit: Mest Mn och Ca, lite Fe och Cu
